TANG FRAGMENT OF A KNIFE HR-6246 - TIN BRONZE - LATE BRONZE AGE - SWITZERLAND

Artefact name	Tang fragment of a knife HR-6246
Authors	Marianne. Senn (EMPA, Dübendorf, Zurich, Switzerland) & Christian. Degriigny (HE-Arc CR, Neuchâtel, Neuchâtel, Switzerland)
Url	/artefacts/322/

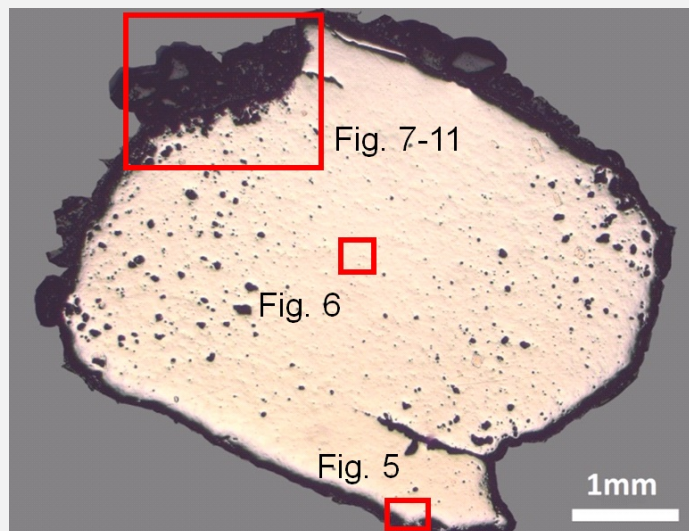
Fig. 3: Micrograph of the cross-section showing the location of Figs. 5 to 11,

The cross-section corresponds to a lateral cut (Fig. 2). The surface is covered with a thick corrosion crust (Fig. 3).

The remaining metal is a tin bronze (Table 1) with high porosity and large cracks both on the left and right edges of the sample (Fig. 3). The metal contains small, elongated copper sulphide (Table 2) and Pb inclusions that are oriented parallel to the cracks. Near the metal surface, slip lines are outlined by the development of intergranular corrosion (Fig. 5). The etched metal shows small, elongated grains with slip lines (Fig. 6). Annealing is visible in areas near the surface. The average hardness of the metal is HV1 145, but significant variations are observed, depending on where the measurements are taken.

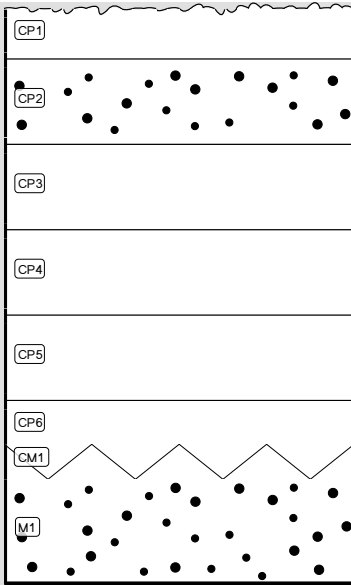
Fig. 4: Stratigraphic representation of the object in cross-section using the MiCorr application. This representation can be compared to Fig. 8.
