TANG FRAGMENT OF A KNIFE HR-6246 - TIN BRONZE - LATE BRONZE AGE - SWITZERLAND

Artefact name	Tang fragment of a knife HR-6246
Authors	Marianne. Senn (EMPA, Dübendorf, Zurich, Switzerland) & Christian. Degriigny (HE-Arc CR, Neuchâtel, Neuchâtel, Switzerland)
Url	/artefacts/322/

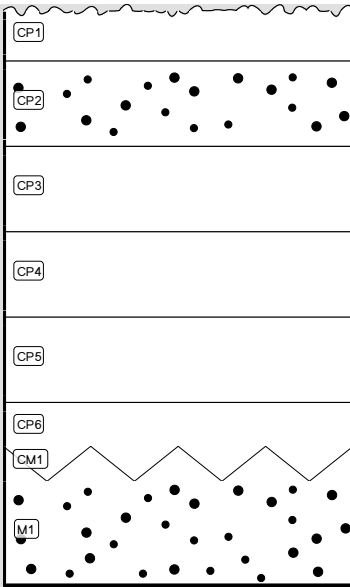
Fig. 4: Stratigraphic representation of the object in cross-section using the MiCorr application. This representation can be compared to Fig. 8.
