# TANG FRAGMENT OF A KNIFE HR-6246 - TIN BRONZE - LATE BRONZE AGE - SWITZERLAND

<b>Artefact name</b>	Tang fragment of a knife HR-6246
<b>Authors</b>	Marianne. Senn (EMPA, Dübendorf, Zurich, Switzerland) & Christian. Degriigny (HE-Arc CR, Neuchâtel, Neuchâtel, Switzerland)
<b>Url</b>	/artefacts/322/

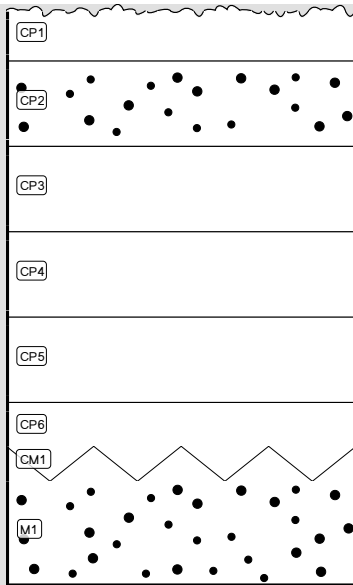
Fig. 4: Stratigraphic representation of the object in cross-section using the MiCorr application. This representation can be compared to Fig. 8.
