CIRCULAR DOOR KNOCKER STRIKING PLATE - CU ALLOY - MODERN TIMES - SWITZERLAND

Artefact name Circular door knocker striking plate

Authors Marianne. Senn (EMPA, Dübendorf, Zurich, Switzerland) & Christian. Degrigny (HE-Arc CR, Neuchâtel, Neuchâtel, Switzerland)

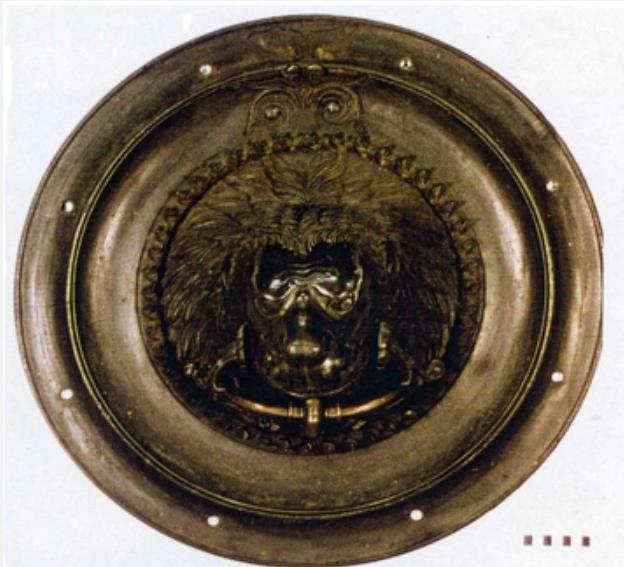
Fig. 1: Copper alloy circular base from a door knocker (after Benoit, 1994),

Description of the artefact Circular base no 2 (from a set of two) of a door knocker with a protruding lion head holding a hinge in his fangs, Ø.ext = 64cm. The circular base is covered by a gilded (?) decorative relief (Fig. 1, Benoit, 1994, 6).

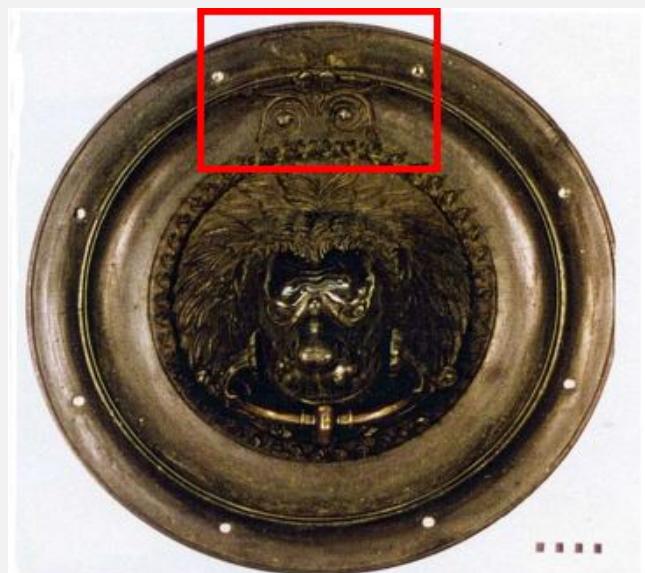
Fig. 2: Possible location of sampling area,

No information is given on where the sample has been taken. A supposed location is however illustrated in Fig. 2. The polished sample shows a well preserved metal surface with some cracks covered by a thin corrosion crust (Fig. 3).

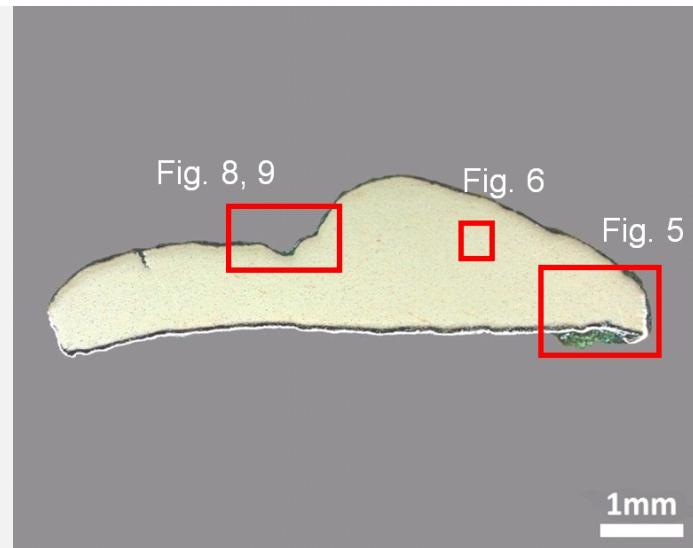
Fig. 3: Micrograph of the cross-section showing the location of Figs. 5 to 6 and 8 to 9,

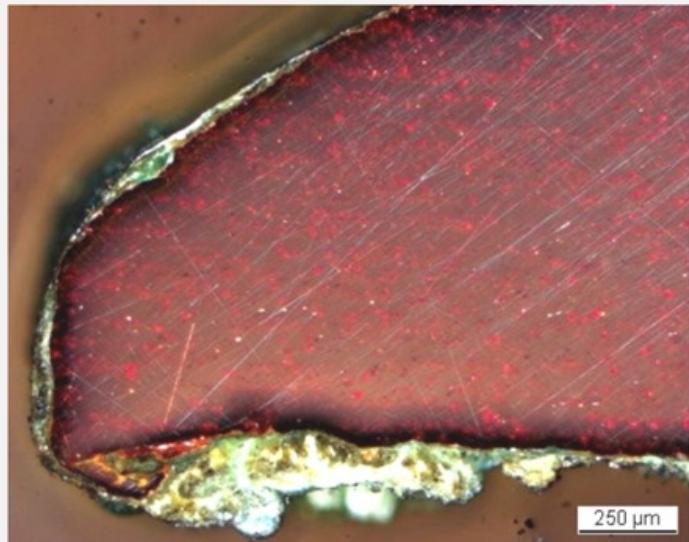
red (Figs. 5 and 8) while with SEM in BSE-mode they look light-grey (Fig. 9). Heavy metals inclusions appear white with SEM (BSE-mode, Fig. 9). Due to the rolling process the copper oxide inclusions are parallel to the longitudinal orientation of the sample (Figs. 5 and 6). They were identified as cuprite by Raman spectroscopy (Fig. 7). The etched alloy shows a structure of polygonal grains with annealing twins (Fig. 6). The grain size is variable. The average hardness of the alloy is HV1 80, which is quite high compared to the average hardness of a pure annealed copper of around HV1 40-50 (Schumann 1991, 627).

Fig. 5: Micrograph of the metal sample from Fig. 3 (reversed picture), unetched, polarised light. The red copper oxide inclusions form rows in the copper alloy matrix.,

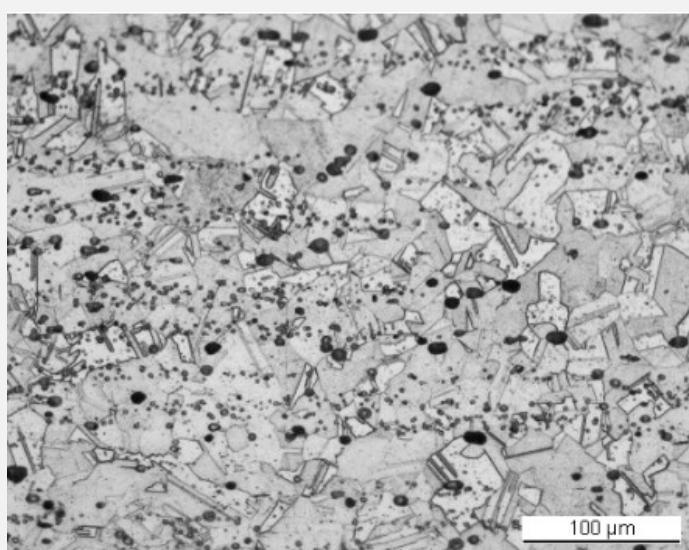
Fig. 6: Micrograph of the metal sample from Fig. 3 (detail), etched, bright field. The metal shows a structure of polygonal and twinned grains. Copper oxide inclusions are visible as dark spots,

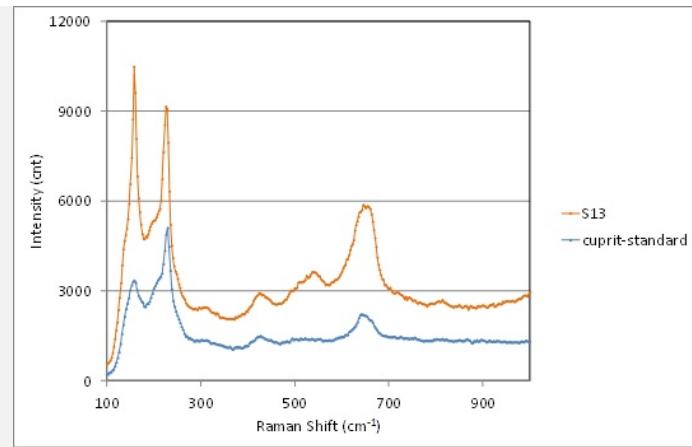
Fig. 7: Raman spectrum of a red inclusion (S13) of Fig. 5 compared to a cuprite standard spectrum. Settings: laser wavelength 532nm, acquisition time 100s, one accumulation, filter D2 (0.75-0.8mW), hole 500, slit 80, grating 600. Method of analysis: Raman spectroscopy. Lab of Swiss National Museum, Affoltern a. Albis ZH,

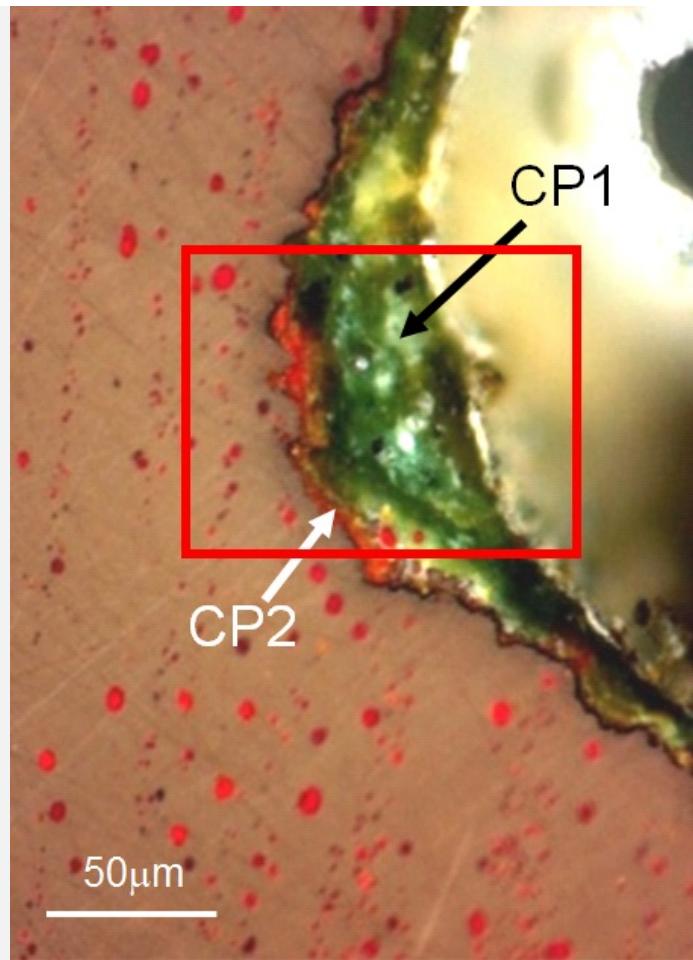
The average thickness of the corrosion crust is about 90µm, but may be thinner or thicker depending on the area of origin (Fig. 5). Under polarized light, we observe a multilayer system with a dense and thin inner red corrosion layer (CP2, probably cuprite/Cu₂O) on the metal (Fig. 8) containing chlorides (Fig. 9 and Table 3). This is followed by bands of heterogeneous green corrosion products (CP1, possibly copper chloride / sulphate / carbonate). This outer corrosion layer is contaminated with atmospheric components (Si, Al, Cl, C and O and perhaps gypsum particles (CaSO₄) (Fig. 9).

Fig. 8: Micrograph of the metal sample from Fig. 3 (rotated by 90°) and corresponding to the stratigraphy of Fig. 4, polarised light. Metal with red copper oxide inclusions. The black particles in the green corrosion layer are quartz inclusions. The mapped area of Fig. 9 is marked by a rectangle,

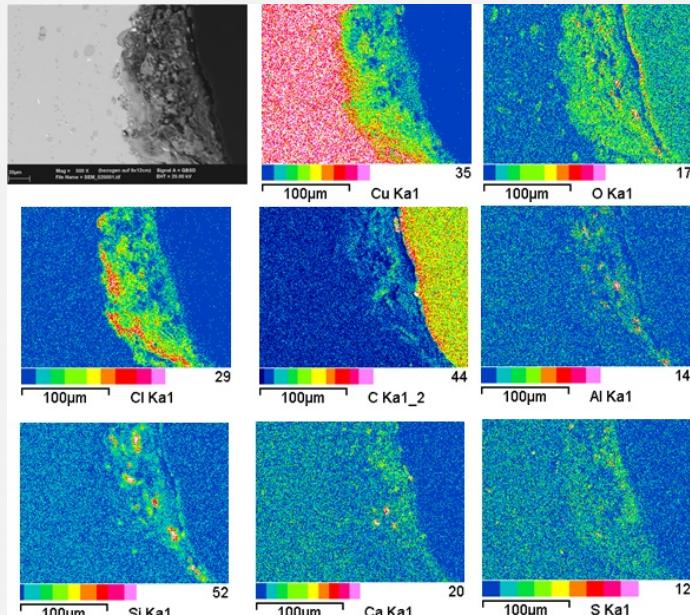
Table 2: Chemical composition (mass %) of the inclusions (light-grey and white in Fig. 9) in the metal. Method of analysis: SEM/EDS, Laboratory of Analytical Chemistry, Empa.

Fig. 9: SEM image, BSE-mode, and elemental chemical distribution of the selected area of Fig. 8. Method of examination: SEM/EDS, Laboratory of Analytical Chemistry, Empa,

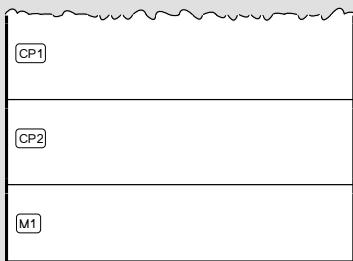
Fig. 4: Stratigraphic representation of the object in cross-section using the MiCorr application. This representation can be compared to Fig. 8.
