# CIRCULAR DOOR KNOCKER STRIKING PLATE – CU ALLOY – MODERN TIMES – SWITZERLAND

<b>Artefact name</b>	Circular door knocker striking plate
<b>Authors</b>	Marianne. Senn (EMPA, Dübendorf, Zurich, Switzerland) & Christian. Degrigny (HE-Arc CR, Neuchâtel, Neuchâtel, Switzerland)
<b>Url</b>	/artefacts/324/

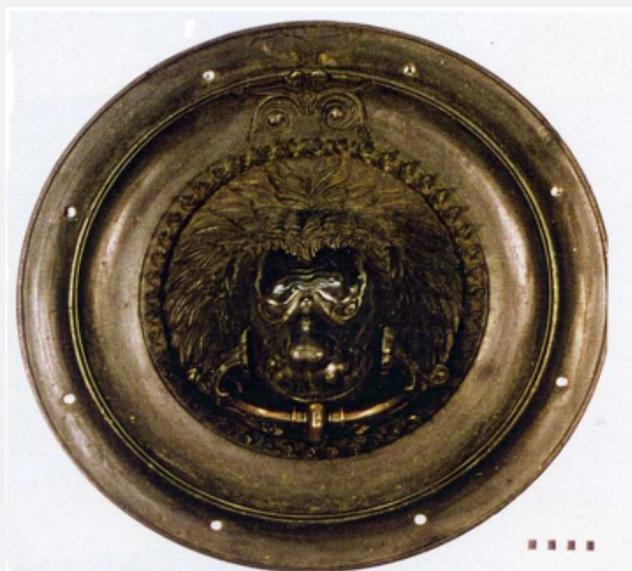
Fig. 1: Copper alloy circular base from a door knocker (after Benoît, 1994),

<b>Description of the artefact</b>	Circular base no 2 (from a set of two) of a door knocker with a protruding lion head holding a hinge in his fangs, Ø.ext = 64cm. The circular base is covered by a gilded (?) decorative relief (Fig. 1, Benoit, 1994, 6).
<b>Type of artefact</b>	Architectural element
<b>Origin</b>	Door knocker of Lausanne cathedral, Lausanne, Vaud, Switzerland
<b>Recovering date</b>	None
<b>Chronology category</b>	Modern Times
<b>chronology tpq</b>	<input type="text" value="1601"/> A.D. ▾
<b>chronology taq</b>	<input type="text" value="1700"/> A.D. ▾
<b>Chronology comment</b>	17th Century AD

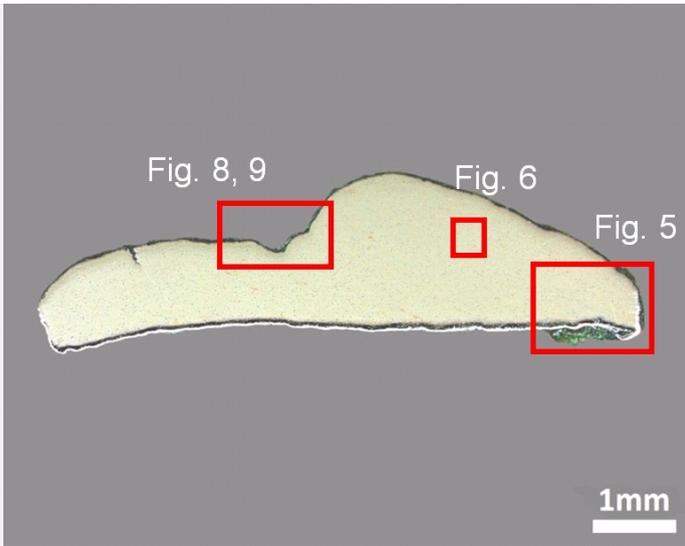
Fig. 3: Micrograph of the cross-section showing the location of Figs. 5 to 6 and 8 to 9,

<b>Description of sample</b>	No information is given on where the sample has been taken. A supposed location is however illustrated in Fig. 2. The polished sample shows a well preserved metal surface with some cracks covered by a thin corrosion crust (Fig. 3).
<b>Alloy</b>	Cu Alloy
<b>Technology</b>	Rolled, annealed after cold working
<b>Lab number of sample</b>	MAH 94-156-001
<b>Sample location</b>	Musées d'art et d'histoire, Genève, Geneva
<b>Responsible institution</b>	Musées d'art et d'histoire, Genève, Geneva
<b>Date and aim of sampling</b>	1994, metallography and presence or not of a gilding treatment

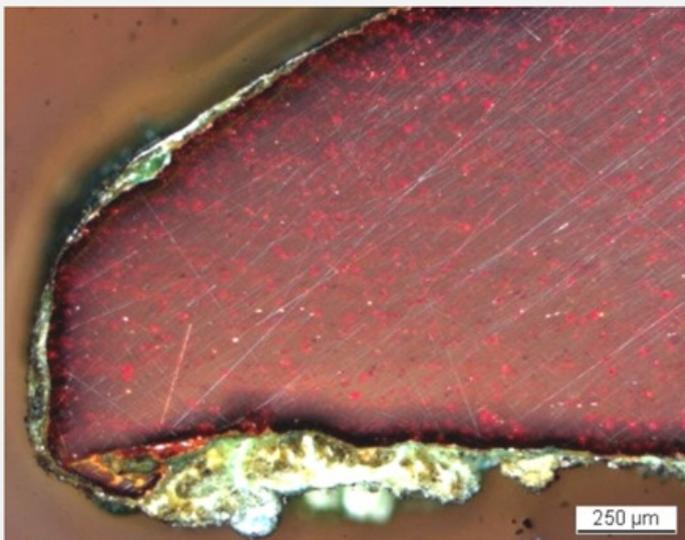
red (Figs. 5 and 8) while with SEM in BSE-mode they look light-grey (Fig. 9). Heavy metals inclusions appear white with SEM (BSE-mode, Fig. 9). Due to the rolling process the copper oxide inclusions are parallel to the longitudinal orientation of the sample (Figs. 5 and 6). They were identified as cuprite by Raman spectroscopy (Fig. 7). The etched alloy shows a structure of polygonal grains with annealing twins (Fig. 6). The grain size is variable. The average hardness of the alloy is HV1 80, which is quite high compared to the average hardness of a pure annealed copper of around HV1 40-50 (Schumann 1991, 627).

Fig. 5: Micrograph of the metal sample from Fig. 3 (reversed picture), unetched, polarised light. The red copper oxide inclusions form rows in the copper alloy matrix.,

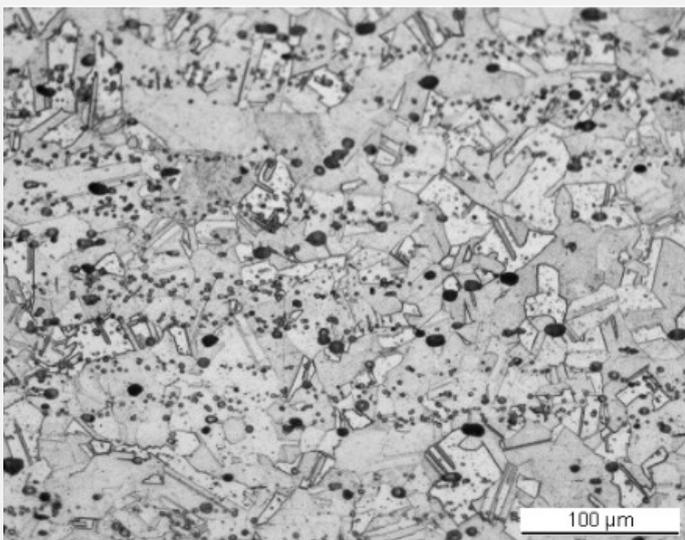
Fig. 6: Micrograph of the metal sample from Fig. 3 (detail), etched, bright field. The metal shows a structure of polygonal and twinned grains. Copper oxide inclusions are visible as dark spots,

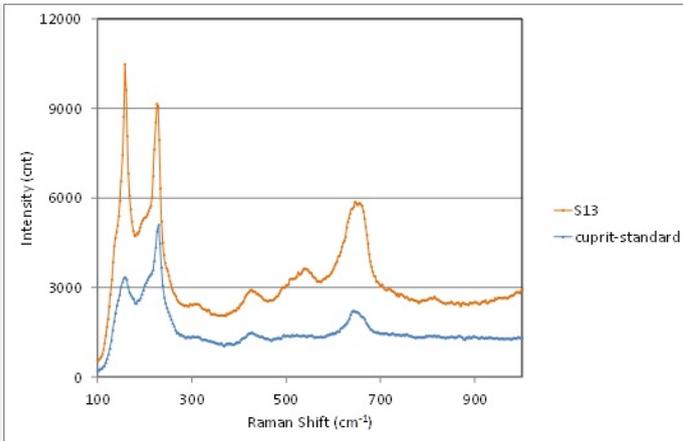
Fig. 7: Raman spectrum of a red inclusion (S13) of Fig. 5 compared to a cuprite standard spectrum. Settings: laser wavelength 532nm, acquisition time 100s, one accumulation, filter D2 (0.75-0.8mW), hole 500, slit 80, grating 600. Method of analysis: Raman spectroscopy. Lab of Swiss National Museum, Affoltern a. Albis ZH,

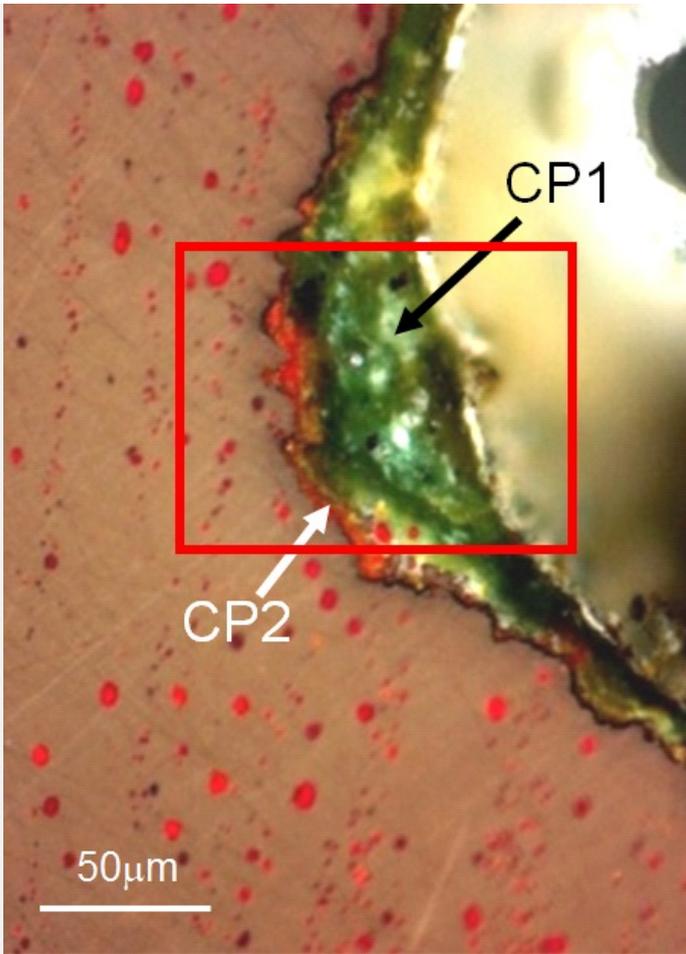
The average thickness of the corrosion crust is about 90µm, but may be thinner or thicker depending on the area of origin (Fig. 5). Under polarized light, we observe a multilayer system with a dense and thin inner red corrosion layer (CP2, probably cuprite/Cu<sub>2</sub>O) on the metal (Fig. 8) containing chlorides (Fig. 9 and Table 3). This is followed by bands of heterogeneous green corrosion products (CP1, possibly copper chloride / sulphate / carbonate). This outer corrosion layer is contaminated with atmospheric components (Si, Al, Cl, C and O and perhaps gypsum particles (CaSO<sub>4</sub>)) (Fig. 9).

Fig. 8: Micrograph of the metal sample from Fig. 3 (rotated by 90°) and corresponding to the stratigraphy of Fig. 4, polarised light. Metal with red copper oxide inclusions. The black particles in the green corrosion layer are quartz inclusions. The mapped area of Fig. 9 is marked by a rectangle,

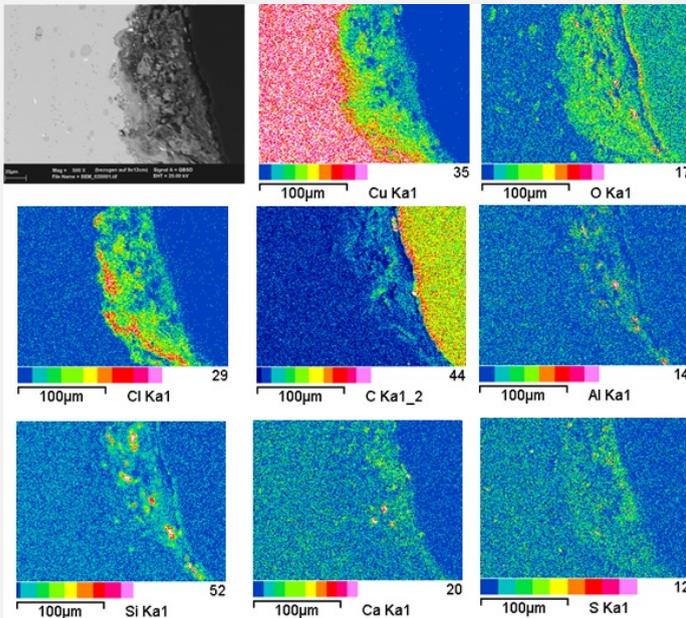
Table 2: Chemical composition (mass %) of the inclusions (light-grey and white in Fig. 9) in the metal. Method of analysis: SEM/EDS, Laboratory of Analytical Chemistry, Empa.

Fig. 9: SEM image, BSE-mode, and elemental chemical distribution of the selected area of Fig. 8. Method of examination: SEM/EDS, Laboratory of Analytical Chemistry, Empa,

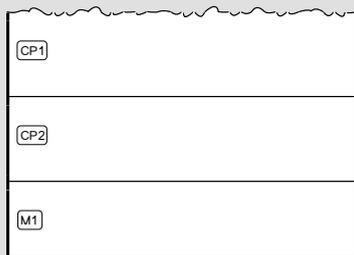
Fig. 4: Stratigraphic representation of the object in cross-section using the MiCorr application. This representation can be compared to Fig. 8.
