# CIRCULAR DOOR KNOCKER STRIKING PLATE – CU ALLOY – MODERN TIMES – SWITZERLAND

<b>Artefact name</b>	Circular door knocker striking plate
<b>Authors</b>	Marianne. Senn (EMPA, Dübendorf, Zurich, Switzerland) & Christian. Degryny (HE-Arc CR, Neuchâtel, Neuchâtel, Switzerland)
<b>Url</b>	/artefacts/324/

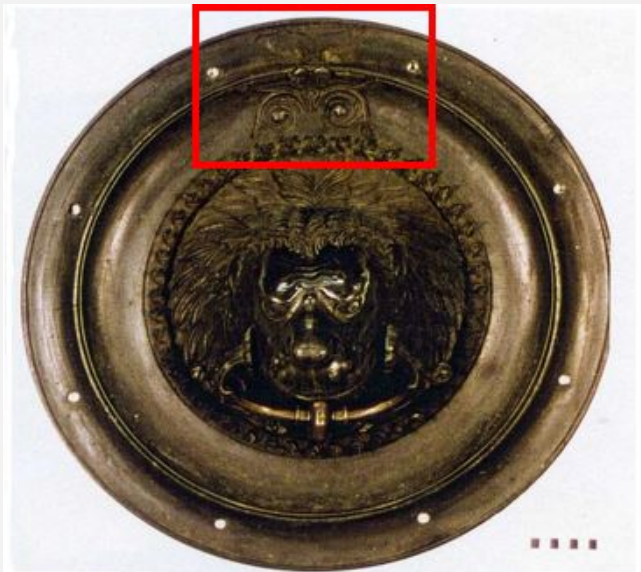
Fig. 2: Possible location of sampling area,

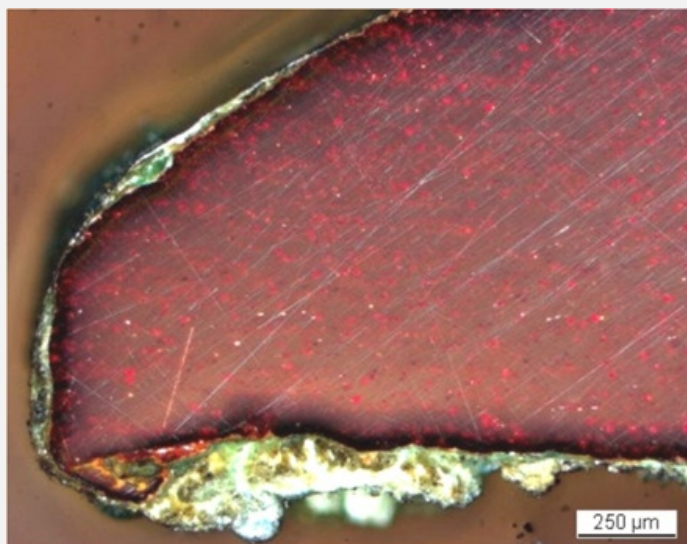
mode, Fig. 9). Due to the rolling process the copper oxide inclusions are parallel to the longitudinal orientation of the sample (Figs. 5 and 6). They were identified as cuprite by Raman spectroscopy (Fig. 7). The etched alloy shows a structure of polygonal grains with annealing twins (Fig. 6). The grain size is variable. The average hardness of the alloy is HV1 80, which is quite high compared to the average hardness of a pure annealed copper of around HV1 40-50 (Schumann 1991, 627).

Fig. 5: Micrograph of the metal sample from Fig. 3 (reversed picture), unetched, polarised light. The red copper oxide inclusions form rows in the copper alloy matrix.,

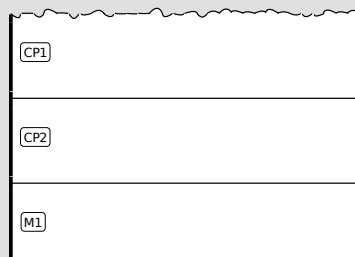
Fig. 4: Stratigraphic representation of the object in cross-section using the MiCorr application. This representation can be compared to Fig. 8.
