CIRCULAR DOOR KNOCKER STRIKING PLATE – CU ALLOY – MODERN TIMES – SWITZERLAND

Artefact name	Circular door knocker striking plate
Authors	Marianne. Senn (EMPA, Dübendorf, Zurich, Switzerland) & Christian. Degrigny (HE-Arc CR, Neuchâtel, Neuchâtel, Switzerland)
Url	/artefacts/324/

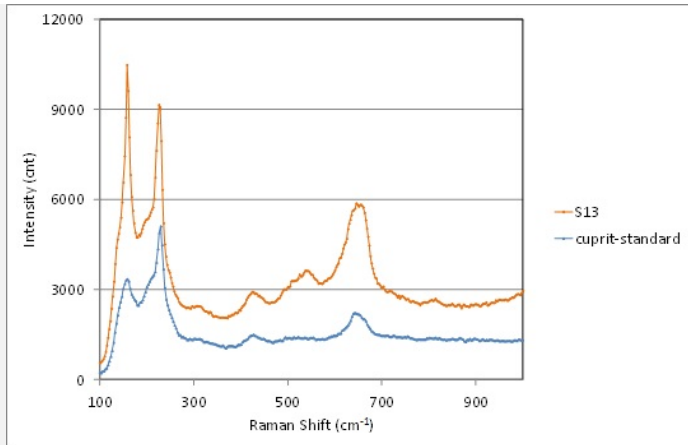
Fig. 7: Raman spectrum of a red inclusion (S13) of Fig. 5 compared to a cuprite standard spectrum. Settings: laser wavelength 532nm,

acquisition time 100s, one accumulation, filter D2 (0.75-0.8mW), hole 500, slit 80, grating 600. Method of analysis: Raman spectroscopy. Lab of Swiss National Museum, Affoltern a. Albis ZH,

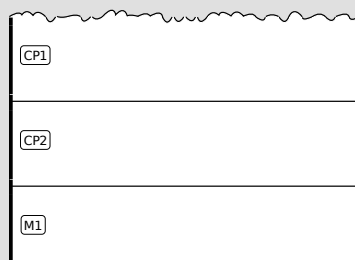
Fig. 4: Stratigraphic representation of the object in cross-section using the MiCorr application. This representation can be compared to Fig. 8.
