CIRCULAR DOOR KNOCKER STRIKING PLATE - CU ALLOY - MODERN TIMES - SWITZERLAND

Artefact name Circular door knocker striking plate

Authors Marianne. Senn (EMPA, Dübendorf, Zurich, Switzerland) & Christian. Degrigny (HE-Arc CR, Neuchâtel, Neuchâtel,

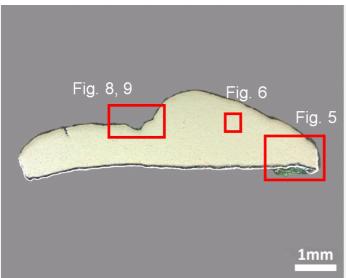
Fig. 3: Micrograph of the cross-section showing the location of Figs. 5 to 6 and 8 to 9, $\,$

Fig. 2. The polished sample shows a well preserved metal surface with some cracks covered by a thin

corrosion crust (Fig. 3).

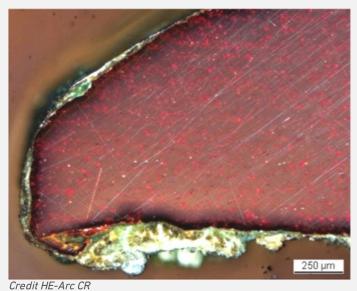
mode, Fig. 9). Due to the rolling process the copper oxide inclusions are parallel to the longitudinal orientation of the sample (Figs. 5 and 6). They were identified as cuprite by Raman spectroscopy (Fig. 7). The etched alloy shows a structure of polygonal grains with annealing twins (Fig. 6). The grain size is variable. The average hardness of the alloy is HV1 80, which is quite high compared to the average hardness of a pure annealed copper of around HV1 40-50 (Schumann 1991, 627).

Fig. 5: Micrograph of the metal sample from Fig. 3 (reversed picture), unetched, polarised light. The red copper oxide inclusions form rows in the copper alloy matrix.,

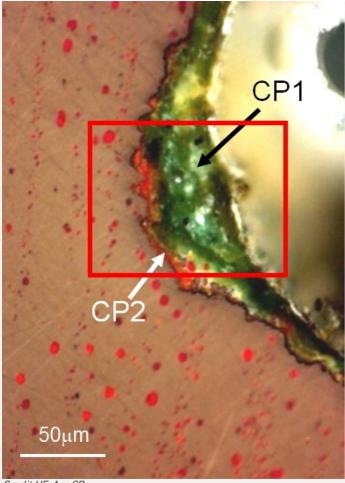
The average thickness of the corrosion crust is about $90\mu m$, but may be thinner or thicker depending on the area of origin (Fig. 5). Under polarized light, we observe a multilayer system with a dense and thin inner red corrosion layer (CP2, probably cuprite/Cu20) on the metal (Fig. 8) containing chlorides (Fig. 9 and Table 3). This is followed by bands of heterogeneous green corrosion products (CP1, possibly copper chloride / sulphate / carbonate). This outer corrosion layer is contaminated with atmospheric components (Si, Al, Cl, C and O and perhaps gypsum particles (CaSO4)) (Fig. 9).

Fig. 8: Micrograph of the metal sample from Fig. 3 (rotated by 90°) and corresponding to the stratigraphy of Fig. 4, polarised light. Metal with red copper oxide inclusions. The black particles in the green corrosion layer are quartz inclusions. The mapped area of Fig. 9 is marked by a rectangle,

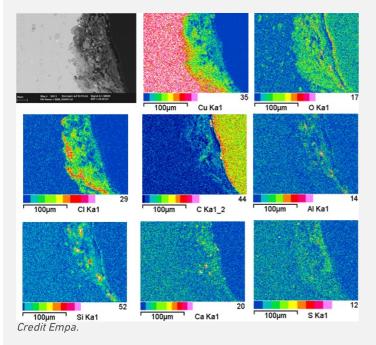
Table 2: Chemical composition (mass %) of the inclusions (light-grey and white in Fig. 9) in the metal. Method of analysis: SEM/EDS, Laboratory of Analytical Chemistry, Empa.

Fig. 9: SEM image, BSE-mode, and elemental chemical distribution of the selected area of Fig. 8. Method of examination: SEM/EDS, Laboratory of Analytical Chemistry, Empa,
