CIRCULAR DOOR KNOCKER STRIKING PLATE – CU ALLOY – MODERN TIMES – SWITZERLAND

Authors Marianne. Senn (EMPA, Dübendorf, Zurich, Switzerland) & Christian. Degriigny (HE-Arc CR, Neuchâtel, Neuchâtel, Switzerland)

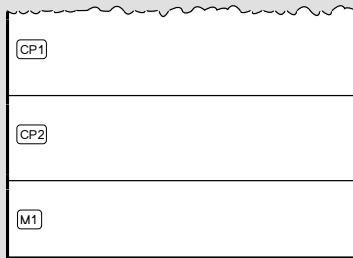
Fig. 4: Stratigraphic representation of the object in cross-section using the MiCorr application. This representation can be compared to Fig. 8.
