# CIRCULAR DOOR KNOCKER STRIKING PLATE - CU ALLOY - MODERN TIMES - SWITZERLAND

<b>Artefact name</b>	Circular door knocker striking plate
<b>Authors</b>	Marianne. Senn (EMPA, Dübendorf, Zurich, Switzerland) & Christian. Degriigny (HE-Arc CR, Neuchâtel, Neuchâtel, Switzerland)
<b>Url</b>	/artefacts/324/

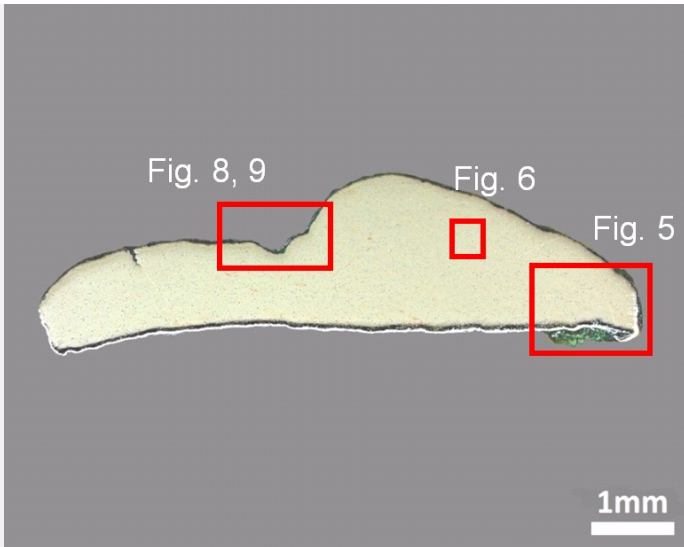
Fig. 3: Micrograph of the cross-section showing the location of Figs. 5 to 6 and 8 to 9,

<b>Description of sample</b>	No information is given on where the sample has been taken. A supposed location is however illustrated in Fig. 2. The polished sample shows a well preserved metal surface with some cracks covered by a thin corrosion crust (Fig. 3).
<b>Alloy</b>	Cu Alloy
<b>Technology</b>	Rolled, annealed after cold working
<b>Lab number of sample</b>	MAH 94-156-001
<b>Sample location</b>	Musées d'art et d'histoire, Genève, Geneva
<b>Responsible institution</b>	Musées d'art et d'histoire, Genève, Geneva
<b>Date and aim of sampling</b>	1994, metallography and presence or not of a gilding treatment

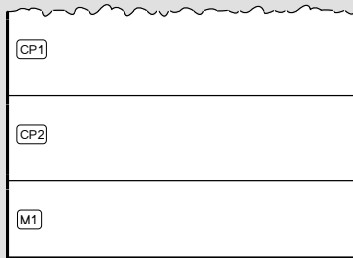
Fig. 4: Stratigraphic representation of the object in cross-section using the MiCorr application. This representation can be compared to Fig. 8.
