CIRCULAR DOOR KNOCKER STRIKING PLATE - CU ALLOY - MODERN TIMES - SWITZERLAND

| Artefact name | Circular door knocker striking plate |
| Authors | Marianne. Senn (EMPA, Dübendorf, Zurich, Switzerland) & Christian. Degriigny (HE-Arc CR, Neuchâtel, Neuchâtel, Switzerland) |

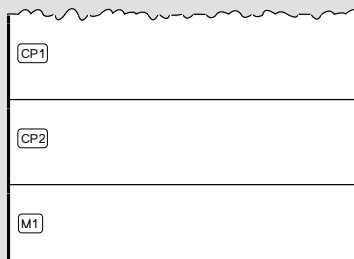
Fig. 4: Stratigraphic representation of the object in cross-section using the MiCorr application. This representation can be compared to Fig. 8.
