# HEADREST OR HORSE BIT VFIG 2003.7 - LEADED BRONZE - MODERN TIMES

**Artefact name** Headrest or horse bit VFig 2003.7

**Authors** Christian. Degriigny (HE-Arc CR, Neuchâtel, Neuchâtel, Switzerland) & Valentin. Boissonnas (HE-Arc CR, Neuchâtel, Neuchâtel, Switzerland)

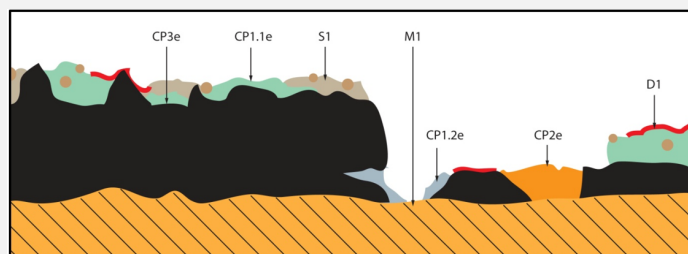
Fig. 3: Stratigraphic representation of the artefact in cross-section by macroscopic observation,

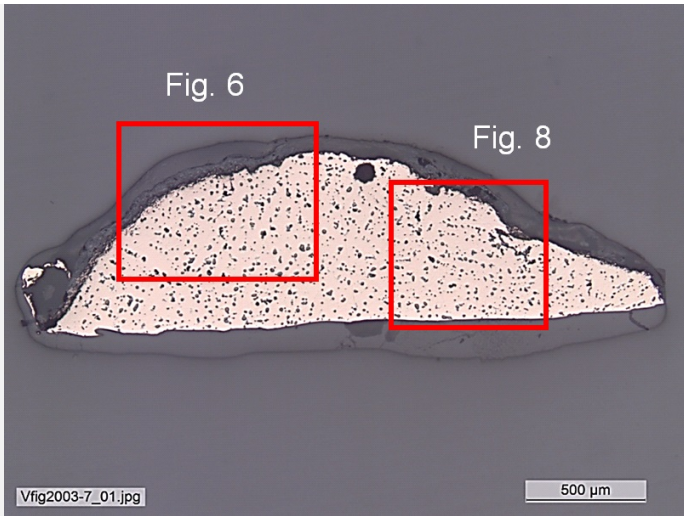
Fig. 4: Micrograph of the cross-section of sample from Fig. 2 showing the location of Figs. 6 and 8,

<b>Description of sample</b>	The sample was cut on the bottom of one of the plates (Fig. 2). On Fig. 4, the top and round shape of the sample is the outer part of the metal. It is covered with corrosion layers. The lower part of the sample corresponds to the cut metal with no corrosion products.
<b>Alloy</b>	Leaded Bronze
<b>Technology</b>	Cast and cold worked (with final annealing?)
<b>Lab number of sample</b>	None
<b>Sample location</b>	HE-Arc CR, Neuchâtel, Neuchâtel
<b>Responsible institution</b>	Bible & Orient Museum, Fribourg, Fribourg
<b>Date and aim of sampling</b>	2014, metallography and chemical analyses

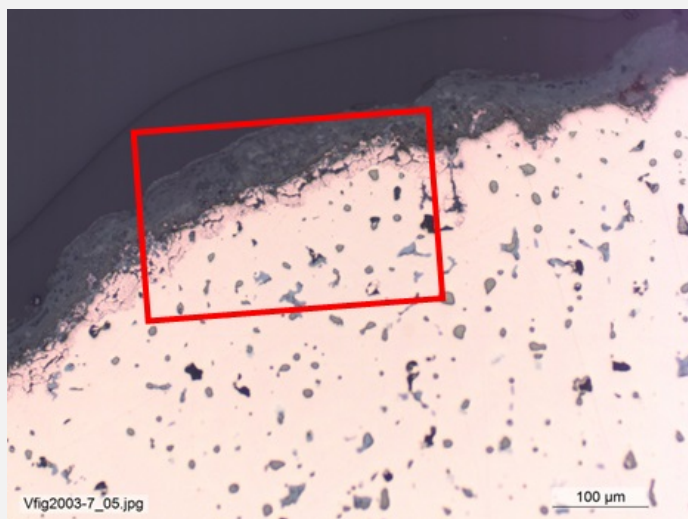
The remaining metal is a leaded bronze (Table 1) containing numerous copper sulphide and lead (Pb) inclusions (Figs. 6 and 7). The porosity is difficult to distinguish since the pores seem to have similar dimensions as the inclusions that could have been removed during the polishing of the sample (Fig. 6). After etching, the structure of the metal appears to be made up mostly of dendrites, but a grain structure seems to have developed on the right side of the sample, with occasional twin lines (Figs. 8 and 9). The twinned grain

Fig. 6: Micrograph of the cross-section of Fig. 4 (detail), unetched, bright field. Light grey copper sulphide and tiny round Pb inclusions as well as "porosities" can be observed. Area of Fig. 10 is marked by a rectangle,

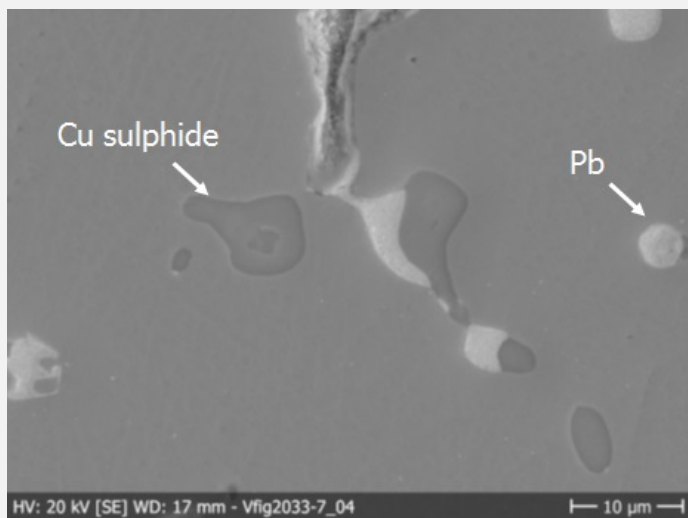
Fig. 7: SEM image, SE-mode, showing copper sulphide and lead inclusions,

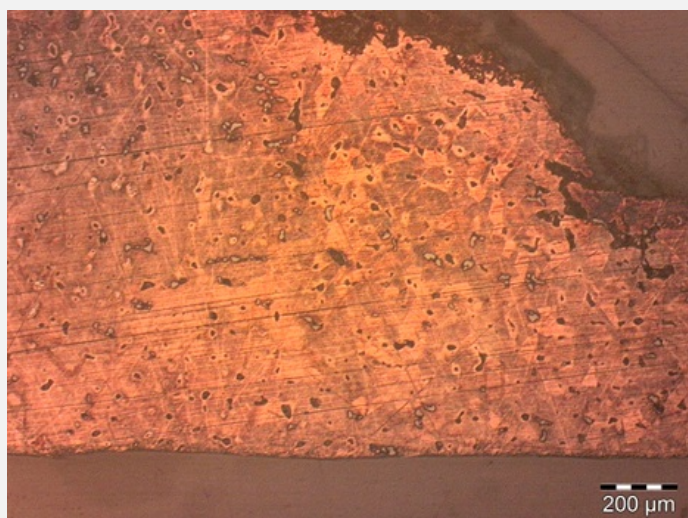
Fig. 8: Micrograph of the metal sample from Fig. 4 showing a dendritic structure and grains,

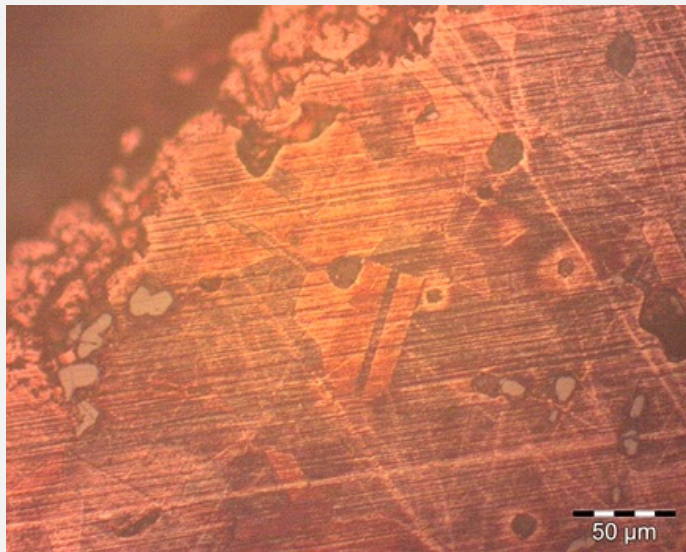
structure could be the result of cold work and annealing after casting, possibly through the application of an artificial patina under heat.

Fig. 9: Micrograph of a selected area showing grains and twin lines,

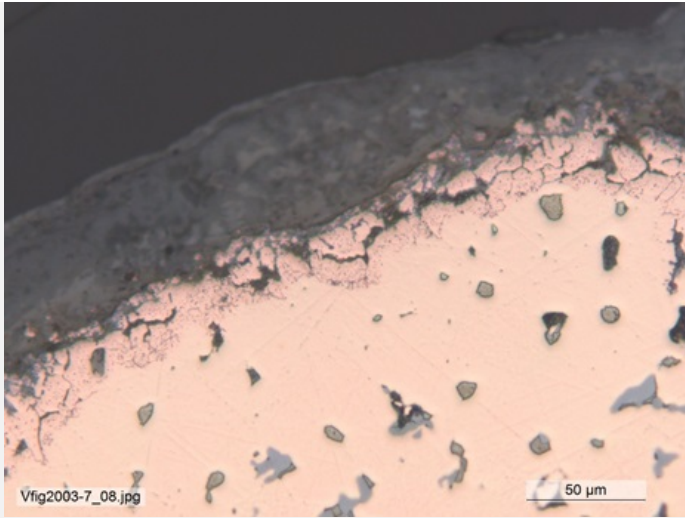
The remaining metal seems to have developed intergranular corrosion at the interface metal / corrosion layer (Fig. 10) slightly enriched in Sn (Fig. 12). The outer green corrosion product (CP2) is matte, powdery and mixed with sediments. It looks regular on Figs. 10 and 11 (around 50μm). This corrosion layer is mainly composed of lead (and/or sulphur), oxygen, silicon, chlorine and is depleted in Cu (Fig. 12 and table 2) except in its top part (CP1) where it is Cl, Cu and O-rich (Fig. 12 and table 2). FTIR seems to indicate that it is constituted of atacamite ( $\text{Cu}_2\text{Cl}(\text{OH})_3$ , Fig. 13). This is confirmed on the EDS spectra of figure 14 where Pb is clearly detected. The inner black corrosion product (CP3) is a dark brown, matte layer (Figs. 2 and 11). It covers all the surface of the object, and forms a very thin layer. It is sulphur and oxygen-rich (Fig. 15). FTIR analysis could not reveal the presence of a specific corrosion product.

Fig. 10: Micrograph of the metal sample from Fig. 6, unetched, bright field,

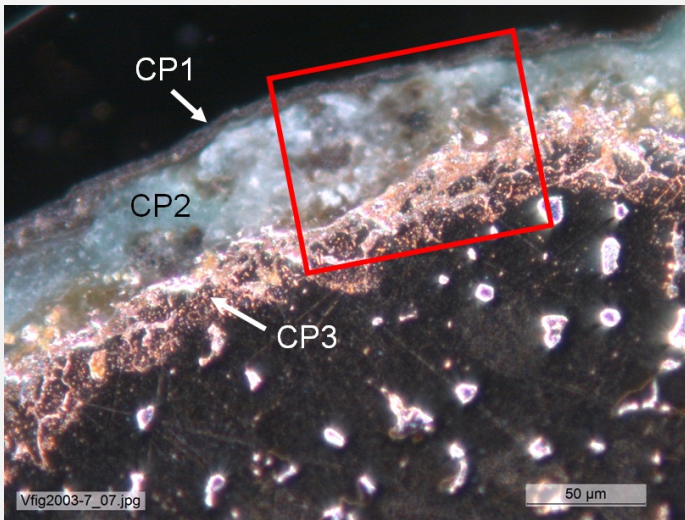
Fig. 11: Micrograph similar to Fig. 10 and corresponding to the stratigraphy of Fig. 5, polarised light. The mapped area (Fig. 12, SEM) is marked by a rectangle,

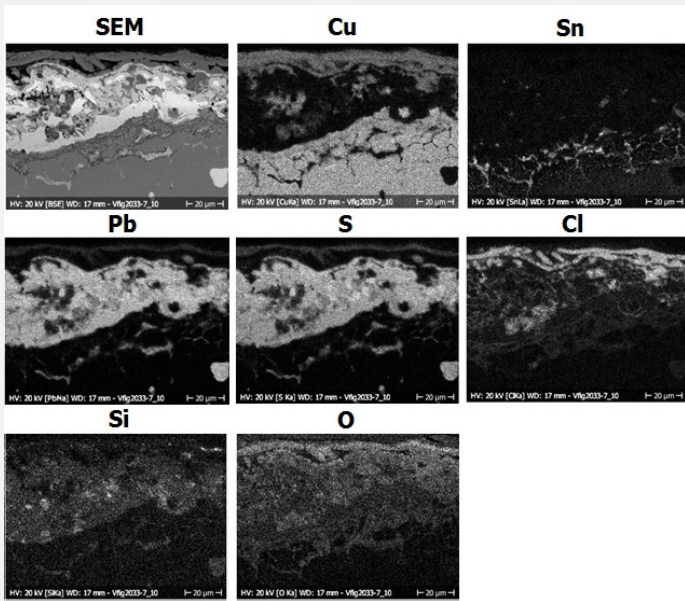
Fig. 12: SEM image, SE-mode, and elemental chemical distribution of the selected area of Fig. 11. Method of examination: SEM-EDS, Lab of Electronic Microscopy and Microanalysis, IMA (Néode), HEI Arc,

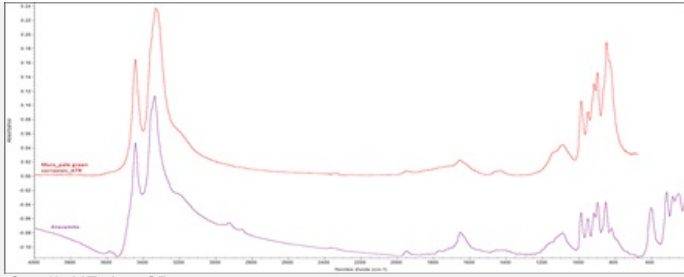
Fig. 13: FTIR spectrum (ATR mode) of the green corrosion powder and comparison to atacamite (purple) spectrum. Method of analysis: FTIR spectroscopy, HE- Arc CR,

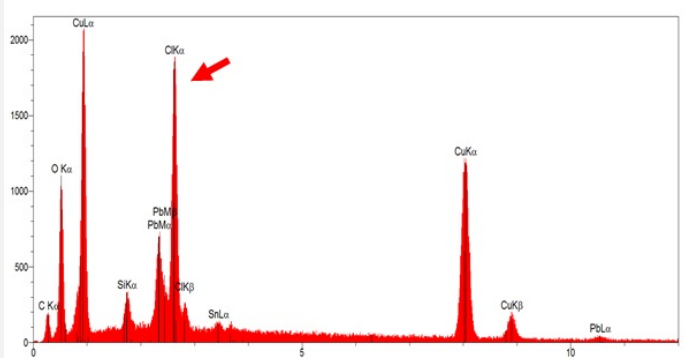
Fig. 14: EDS analysis of the green corrosion powder (Fig. 2). Method of analysis: SEM-EDS, Lab of Electronic Microscopy and Microanalysis, IMA (Néode), HEI Arc,

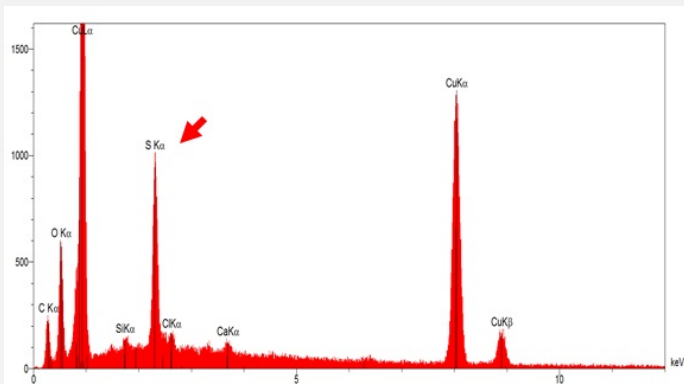
Fig. 15: EDS analysis of the black corrosion powder (Fig. 2). Method of analysis: SEM-EDS, Lab of Electronic Microscopy and Microanalysis, IMA (Néode), HEI Arc,

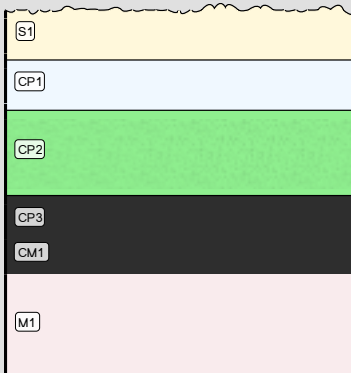
Fig. 5: Stratigraphic representation of the object in cross-section using the MiCorr application. This representation can be compared to Fig 11.

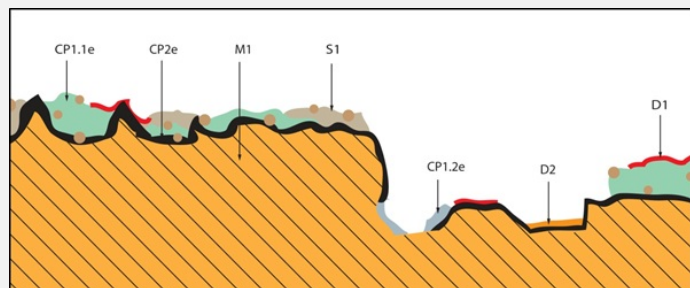
Based on the analyses carried out, the schematic representation of the stratigraphy of corrosion layers has been corrected: a thin, black sulphur-rich layer covers the metal surface. A thick green layer has developed on top and seems to be constituted mainly of atacamite enriched in lead with sediments on top.

Fig. 16: Improved stratigraphic representation of the artefact from visual observations and analyses (additional mention e or i within the coding correspond to strata in contact with the environment (e) and internal strata (i),
