# CHISEL POINT DEV 995 1069 PR – EUTECTOID TO HYPEREUTECTOID STEEL – EARLY MEDIEVAL TIMES – SWITZERLAND

<b>Artefact name</b>	Chisel point DEV 995 1069 PR
<b>Authors</b>	Marianne. Senn (EMPA, Dübendorf, Zurich, Switzerland) & Christian. Degryny (HE-Arc CR, Neuchâtel, Neuchâtel, Switzerland)
<b>Url</b>	/artefacts/328/

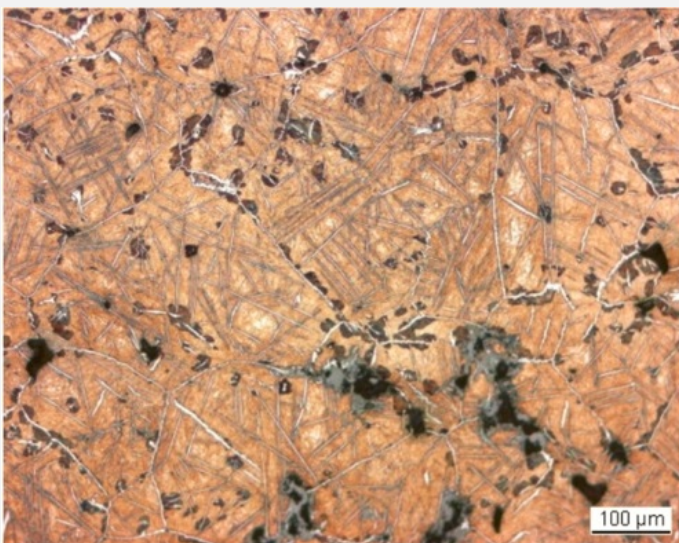
Fig. 9: Micrograph of the metal sample, detail from Fig. 5, etched, bright field. Hypereutectoid steel with a structure of cementite in white in the grain boundaries and in needle form combined with martensite (pink). Some bainite occurs around the grain boundaries,

The tool is made of hard, eutectoid to hypereutectoid steel and was, as a last manufacturing step, entirely quenched. In this state it is too hard and brittle to be used. It is likely that the quenched hypereutectoid structure provoked the breakage of the tool when it was first used. The absence of a tempering process at the end is unclear. The chemical composition of the metal and the slag inclusions indicate that the artefact was imported to the hamlet of Develier-Courtételle JU. The corrosion has, in areas, replaced the metal structure retaining a ghost structure; the outer layer has been mostly removed during surface cleaning. Extensive pitting corrosion has occurred, typical for steel with an elevated C content. The presence of S in the inner layer can be explained by putrefaction processes in the soil. Chlorides are still present at the metal-corrosion interface as no desalination process was attempted. Iron carbonates are present in the centre of a corrosion pit. The corrosion is of terrestrial type.

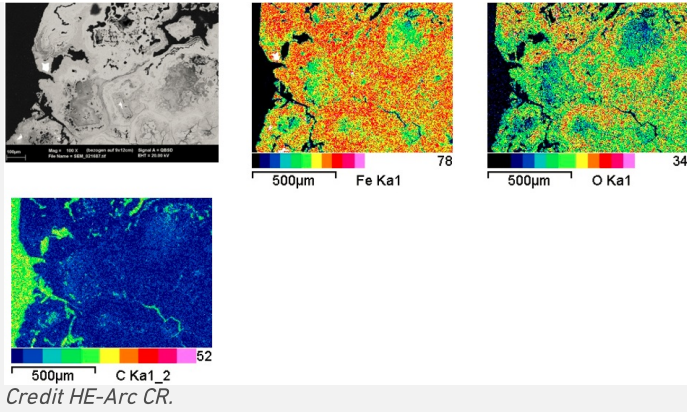
Fig. 14: SEM image, BSE-mode, and elemental chemical distribution of the selected area from Fig. 11 (rotated by 45°). Method of examination: SEM/EDS, Laboratory of Analytical Chemistry, Empa,

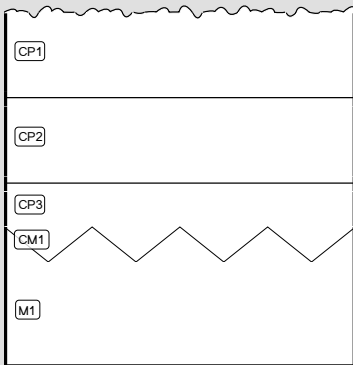
Fig. 4: Stratigraphic representation of the object in cross-section using the MiCorr application. This representation can be compared to Fig. 11.
