# CHISEL POINT DEV 995 1069 PR – EUTECTOID TO HYPEREUTECTOID STEEL – EARLY MEDIEVAL TIMES – SWITZERLAND

**Artefact name** Chisel point DEV 995 1069 PR

**Authors** Marianne. Senn (EMPA, Dübendorf, Zurich, Switzerland) & Christian. Degryny (HE-Arc CR, Neuchâtel, Neuchâtel, Switzerland)

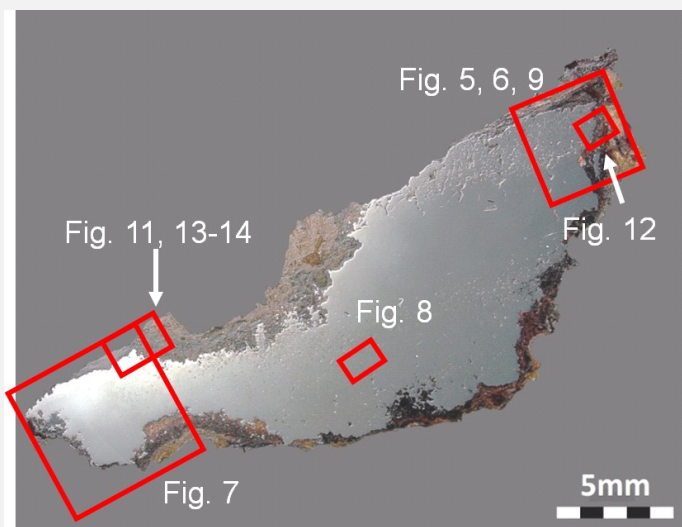
Fig. 3: Micrograph of the cross-section showing the location of Figs. 5 to 9 and 11 to 14,

<b>Description of sample</b>	A longitudinal cut from a chisel point (Figs. 2 and 3) undertaken after restoration. Dimensions: L = 30mm; W = 11mm (approximately).
<b>Alloy</b>	Eutectoid to hypereutectoid steel
<b>Technology</b>	Quench hardened
<b>Lab number of sample</b>	DEV1069
<b>Sample location</b>	Empa (Marianne Senn)
<b>Responsible institution</b>	Office de la Culture, Porrentruy, Jura
<b>Date and aim of sampling</b>	2000, metallography and chemical composition of the metal

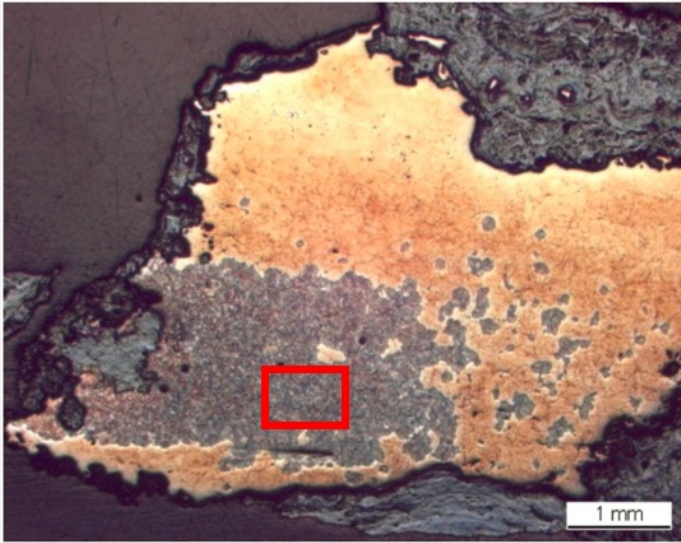
Fig. 7: Micrograph of the metal sample from Fig. 3 (inverted picture, detail), etched, bright field. We observe the metal with martensite (orange) and bainite nodules (blue). The micrograph of Fig. 10 is marked by a rectangle,

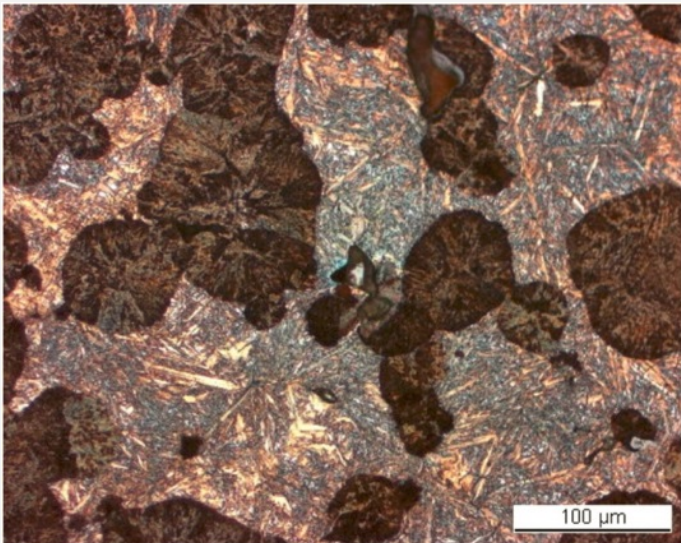
Fig. 8: Micrograph of the metal sample from Fig. 3 (detail), etched, bright field. We observe dark bainite nodules combined with martensite needles,

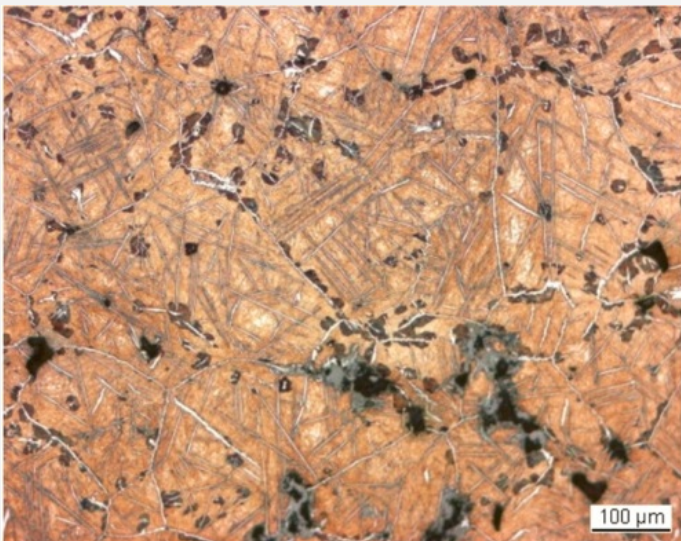
Fig. 9: Micrograph of the metal sample, detail from Fig. 5, etched, bright field. Hypereutectoid steel with a structure of cementite in white in the grain boundaries and in needle form combined with martensite (pink). Some bainite occurs around the grain boundaries,

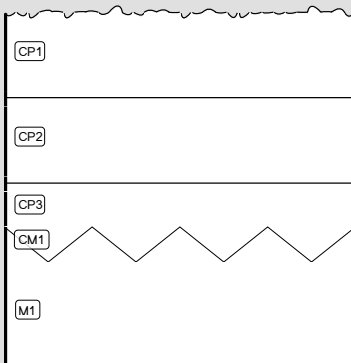
Fig. 4: Stratigraphic representation of the object in cross-section using the MiCorr application. This representation can be compared to Fig. 11.
