FITTING ON BACK PANEL OF A MILITARY CARRIAGE – THOMAS STEEL – MODERN TIMES – SWITZERLAND

Artefact name	Fitting on back panel of a military carriage
Authors	Marianne. Senn (EMPA, Dübendorf, Zurich, Switzerland) & Christian. Degriigny (HE-Arc CR, Neuchâtel, Neuchâtel, Switzerland)
Url	/artefacts/329/

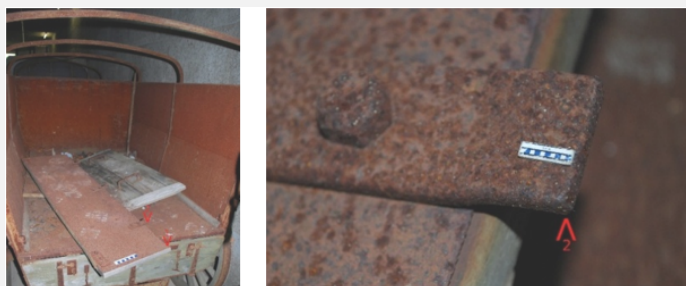
Fig. 1: Steel fitting on back panel of a military carriage (©Tarchini),

Description of the artefact	Fitting on back panel, first exposed outdoors, later indoors (Fig. 1). Uniform corrosion and pitting corrosion are visible.
Type of artefact	Military carriage
Origin	Swiss Army, Thun, Bern, Switzerland
Recovering date	Built by Konstruktions-Werkstätte, 1918
Chronology category	Modern Times
chronology tpq	<input type="text" value="1918"/> A.D. ▾
chronology taq	<input type="text" value="----"/> ▾
Chronology comment	1918
Burial conditions / environment	Outdoor to indoor atmosphere
Artefact location	Historical Swiss Army Material Foundation, Burgdorf, Bern
Owner	Historical Swiss Army Material Foundation, Burgdorf, Bern
Inv. number	n.a.
Recorded conservation data	Not conserved

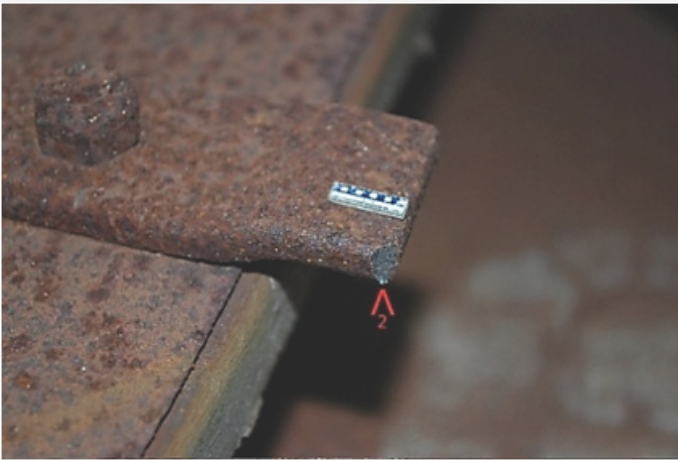
Fig. 2: Location of sampling area,

This sample is a cut from the corner of one of the two fittings on the back panel (Fig. 2). The metal is covered by a thin corrosion layer (Fig. 3).

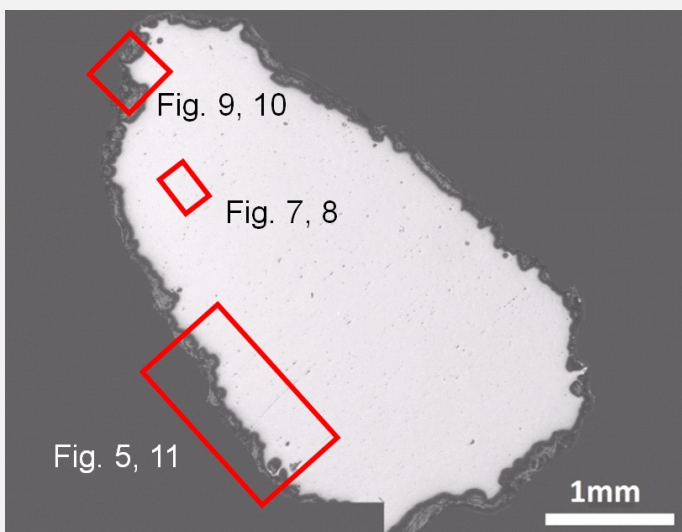
Fig. 3: Micrograph of the cross-section showing the location of Figs. 5 and 7 to 11,

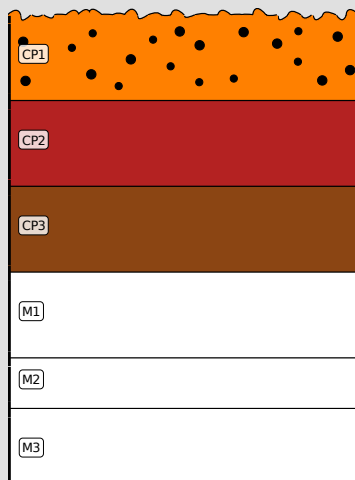
Fig. 4: Stratigraphic representation of the object in cross-section using the MiCorr application. This representation showing for the metal part a welding seam (M2) can be compared to Fig. 10.
