FITTING ON BACK PANEL OF A MILITARY CARRIAGE – THOMAS STEEL – MODERN TIMES – SWITZERLAND

Artefact name	Fitting on back panel of a military carriage
Authors	Marianne. Senn (EMPA, Dübendorf, Zurich, Switzerland) & Christian. Degryny (HE-Arc CR, Neuchâtel, Neuchâtel, Switzerland)
Url	/artefacts/329/

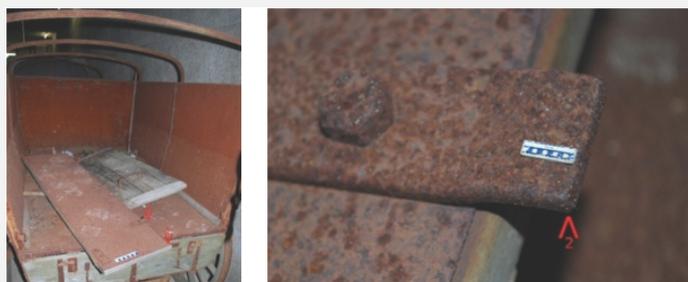
Fig. 1: Steel fitting on back panel of a military carriage (©Tarchini),

Description of the artefact	Fitting on back panel, first exposed outdoors, later indoors (Fig. 1). Uniform corrosion and pitting corrosion are visible.
Type of artefact	Military carriage
Origin	Swiss Army, Thun, Bern, Switzerland
Recovering date	Built by Konstruktions-Werkstätte, 1918
Chronology category	Modern Times
chronology tpq	<input type="text" value="1918"/> A.D. ▾
chronology taq	<input type="text" value=""/> ---- ▾
Chronology comment	1918
Burial conditions / environment	Outdoor to indoor atmosphere
Artefact location	Historical Swiss Army Material Foundation, Burgdorf, Bern
Owner	Historical Swiss Army Material Foundation, Burgdorf, Bern
Inv. number	n.a.
Recorded conservation data	Not conserved

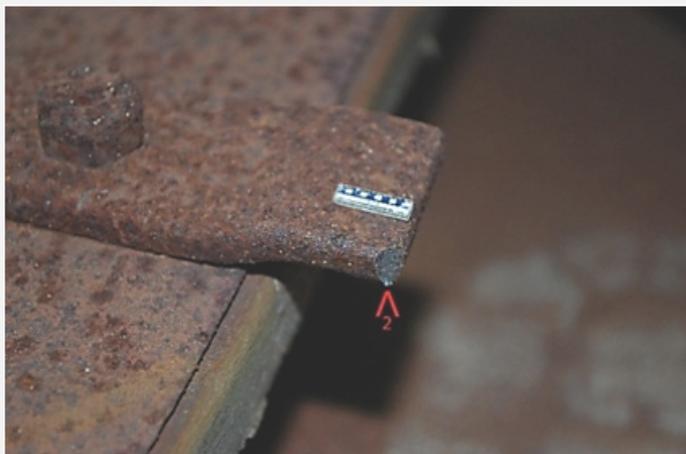
Fig. 2: Location of sampling area,

Description of sample	This sample is a cut from the corner of one of the two fittings on the back panel (Fig. 2). The metal is covered by a thin corrosion layer (Fig. 3).
Alloy	Thomas steel
Technology	Piled from several strips, hot rolled and annealed
Lab number of sample	POINT-Fe2
Sample location	Empa (Marianne Senn)
Responsible institution	Historical Swiss Army Material Foundation, Burgdorf, Bern
Date and aim of sampling	05/2009 metallography

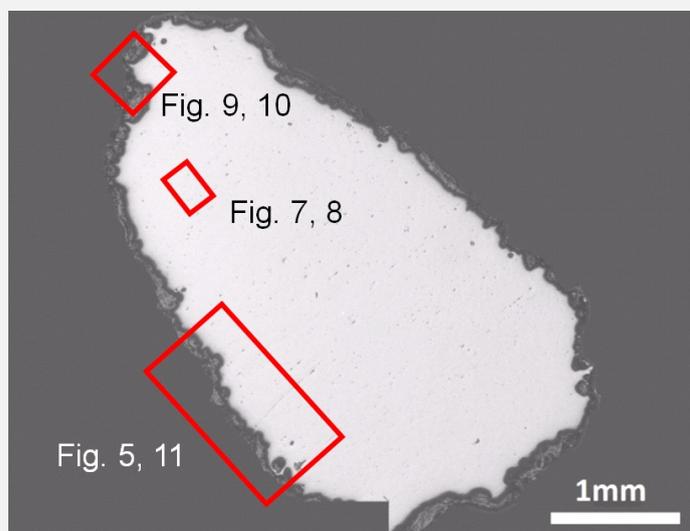
Fig. 3: Micrograph of the cross-section showing the location of Figs. 5 and 7 to 11,

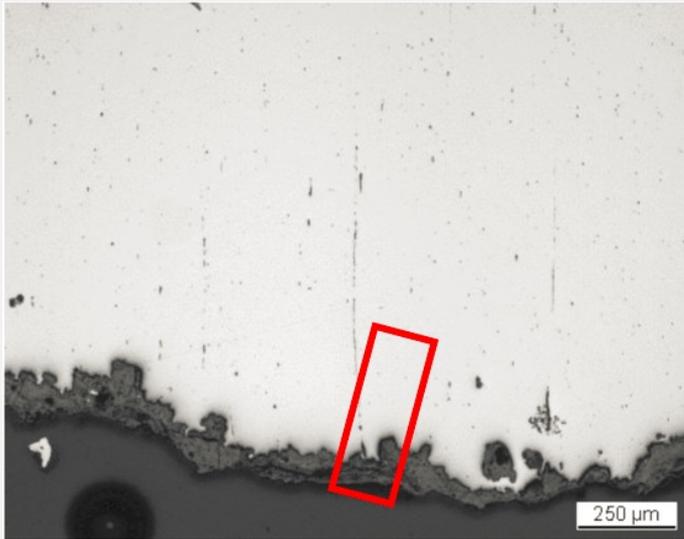
The remaining metal is a Mn-rich soft steel (C content around 0.1 mass%) containing manganese sulphide inclusions with a varying Fe content (Tables 1 and 2). The numerous inclusions form parallel rows (Fig. 5). This orientation is typical for hot rolled metal. After etching with Oberhoffer's reagent, three main welding seams (P-rich) become visible (Fig. 6). Near the surface they are also outlined by corrosion (Figs. 5 and 11). After nital etching, the metal shows a ferritic structure with tertiary cementite and lamellar pearlite at the grain boundaries (Figs. 7 and 8). The grains are small with an ASTM grain size of 10 and are recrystallized due to annealing after hot rolling. The average hardness of the metal is HV1 165. The hardness is slightly high for such a structure and this is due to the Mn content of the metal. The chemical composition, especially the Mn content and the presence of carbo-nitrides (not analysed here), is typical for Thomas steel.

Fig. 5: Micrograph of the metal sample from Fig. 3 (rotated by 270°, detail), unetched, bright field. We observe the metal including welding seams outlined by corrosion products and MnS inclusions. The mapped area of Fig. 11 is marked by the rectangle,

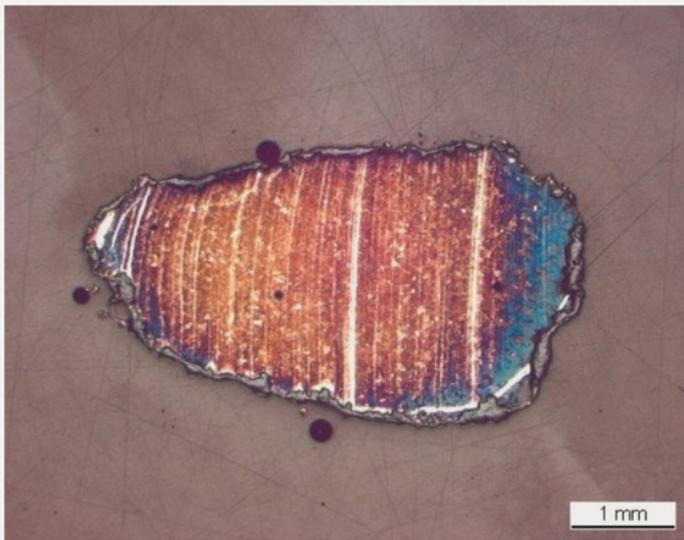
Fig. 6: Micrograph of the metal sample from Fig. 3, etched with Oberhoffer's reagent, bright field. We observe three P-rich welding seams in white,

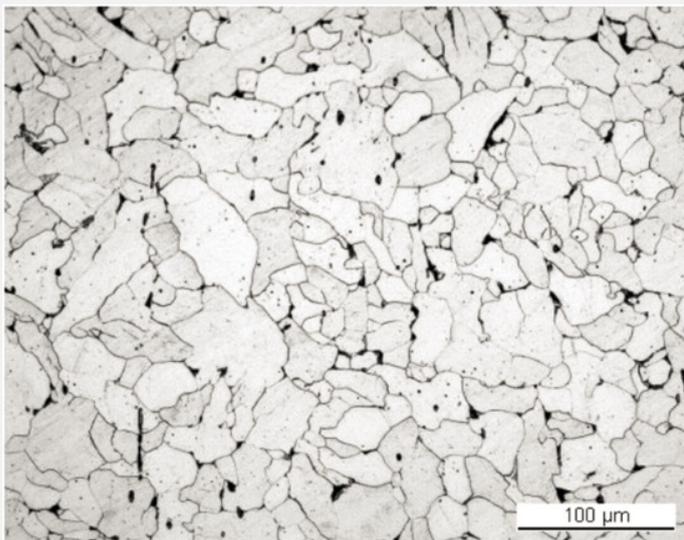
Fig. 7: Micrograph of the metal sample, nital etched, bright field. We observe tertiary cementite (black) on the grain boundaries,

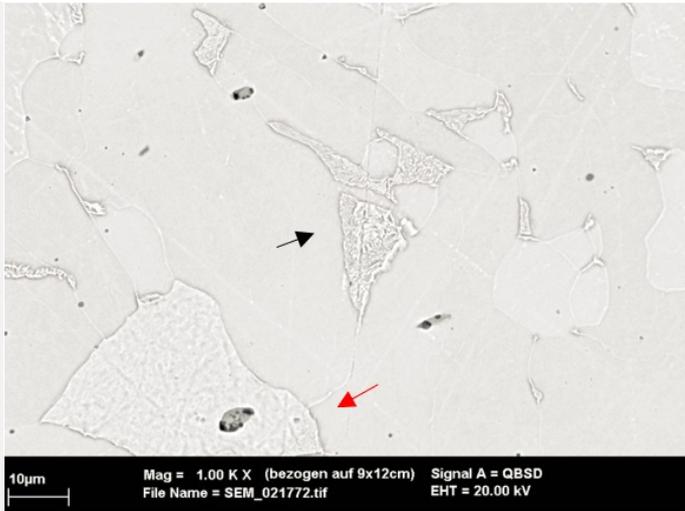
Fig. 8: SEM image of the metal sample from Fig. 3 (detail), BSE-mode, nital etched, bright field. The white ferrite grains contain lamellar pearlite (black arrow) and lenticular grey MnS inclusions (red arrow) in between the grain boundaries,

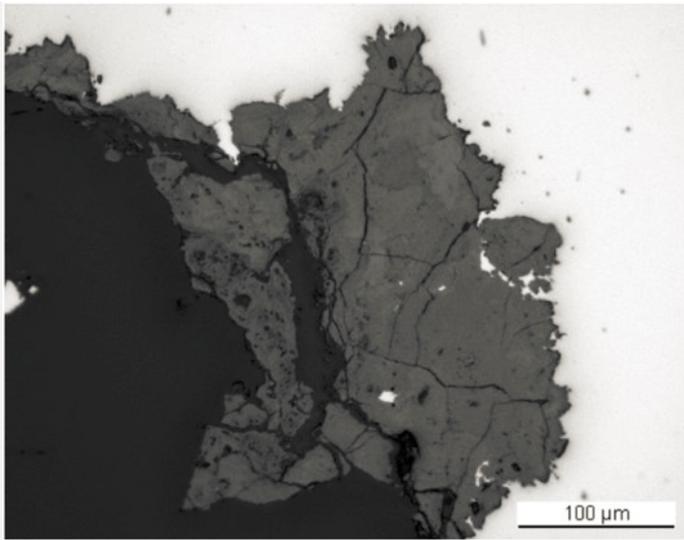
The average thickness of the corrosion products is about 80µm (Figs. 5 and 9). In bright field they appear grey, marbled and heavily cracked (Fig. 9). Under polarised light, the corrosion products appear orange to dark-brown (Fig. 10). At the metal - corrosion products interface they are dark-brown (CP3). The middle part (CP2) is red-orange and the outer part is bright orange (CP1). The elemental mapping of the corrosion layers shows no distinctive stratification, but areas near the metal - corrosion crust interface (CP3) as well as the top surface of the corrosion layer (CP1) seem to have a lower O content (Fig. 11). The O content indicates the presence of iron hydroxides (Table 3). Soil materials (such as rock fragments and dust) are found in the welding seams near the surface.

Fig. 9: Micrograph showing the metal - corrosion crust interface from Fig. 3 (rotated by 270°, detail), unetched, bright field. We observe in white the metal, in grey the corrosion products and in black the resin,

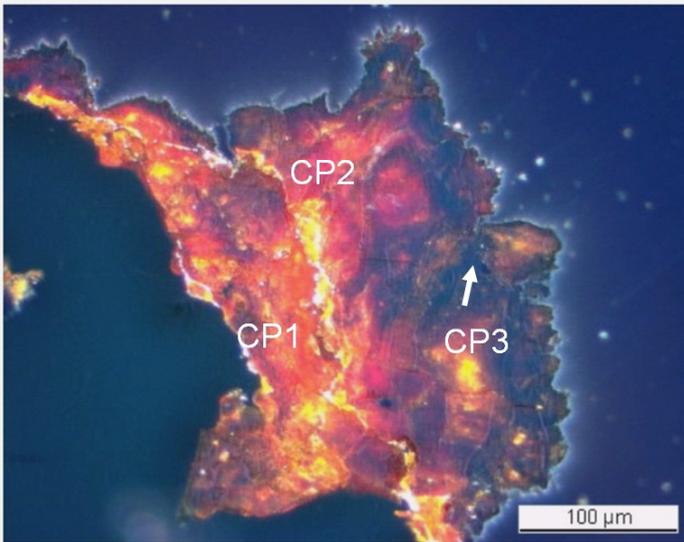
Fig. 10: Micrograph (same as Fig. 9) and corresponding to the stratigraphy of Fig. 4, unetched, polarised light. The corrosion products are dark-brown at the metal - corrosion crust interface and red-orange on the outside,

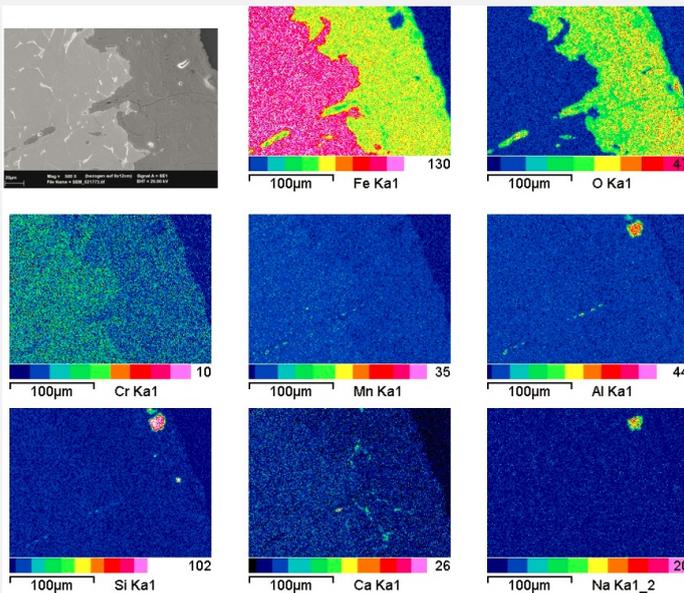
Table 3: Chemical composition (mass %) of the corrosion layer (from Fig. 11). Method of analysis: SEM/EDS, Laboratory of Analytical Chemistry, Empa.

Fig. 11: SEM image, BSE-mode, and elemental chemical distribution of the selected area from Fig. 5 (rotated by 270°, detail). Method of examination: SEM/EDS, Laboratory of Analytical Chemistry, Empa.

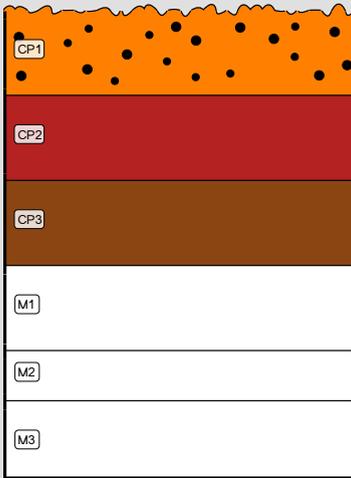
Fig. 4: Stratigraphic representation of the object in cross-section using the MiCorr application. This representation showing for the metal part a welding seam (M2) can be compared to Fig. 10.
