FITTING ON BACK PANEL OF A MILITARY CARRIAGE – THOMAS STEEL – MODERN TIMES – SWITZERLAND

Artefact name	Fitting on back panel of a military carriage
Authors	Marianne. Senn (EMPA, Dübendorf, Zurich, Switzerland) & Christian. Degryny (HE-Arc CR, Neuchâtel, Neuchâtel, Switzerland)
Url	/artefacts/329/

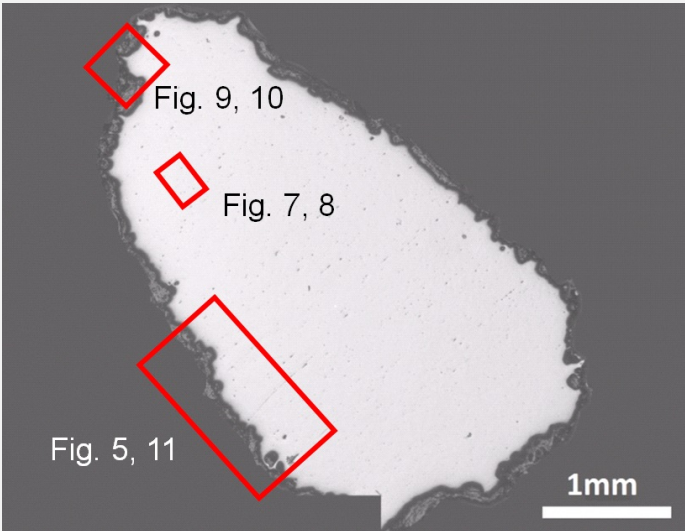
Fig. 3: Micrograph of the cross-section showing the location of Figs. 5 and 7 to 11,

This sample is a cut from the corner of one of the two fittings on the back panel (Fig. 2). The metal is covered by a thin corrosion layer (Fig. 3).
Alloy	Thomas steel
Technology	Piled from several strips, hot rolled and annealed
Lab number of sample	POINT-Fe2
Sample location	Empa (Marianne Senn)
Responsible institution	Historical Swiss Army Material Foundation, Burgdorf, Bern
Date and aim of sampling	05/2009 metallography

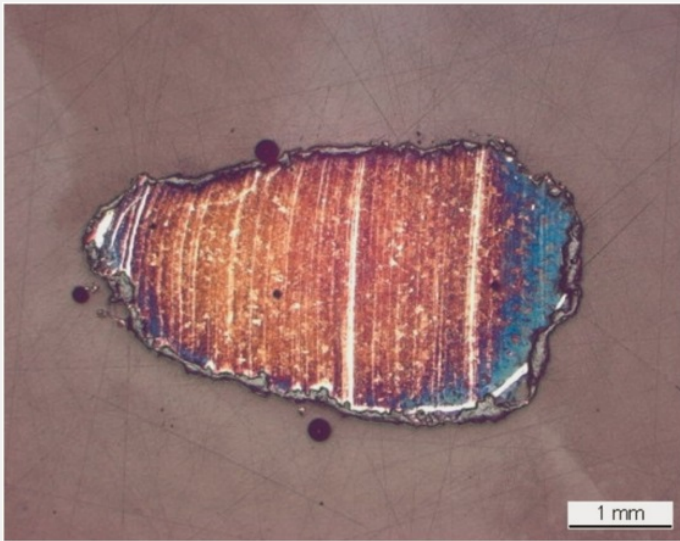
Fig. 6: Micrograph of the metal sample from Fig. 3, etched with Oberhoffer's reagent, bright field. We observe three P-rich welding seams in white,

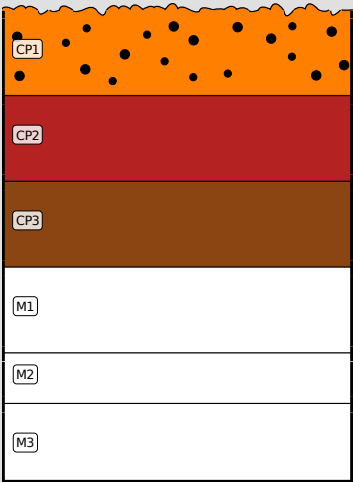
Fig. 4: Stratigraphic representation of the object in cross-section using the MiCorr application. This representation showing for the metal part a welding seam (M2) can be compared to Fig. 10.
