AIRCRAFT REAR FASTENING PLATE VHS-497 - AL ALLOY - MODERN TIMES

Artefact name Aircraft rear fastening plate VHS-497

Authors Marianne. Senn (EMPA, Dübendorf, Zurich, Switzerland) & Christian. Degrigny (HE-Arc CR, Neuchâtel, Neuchâtel, Switzerland)

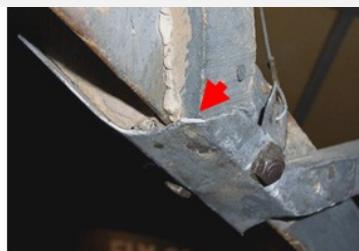
Fig. 1: Photograph of the aeroplane showing the location of the fixation plate (red dot) (www.hepta.aero).

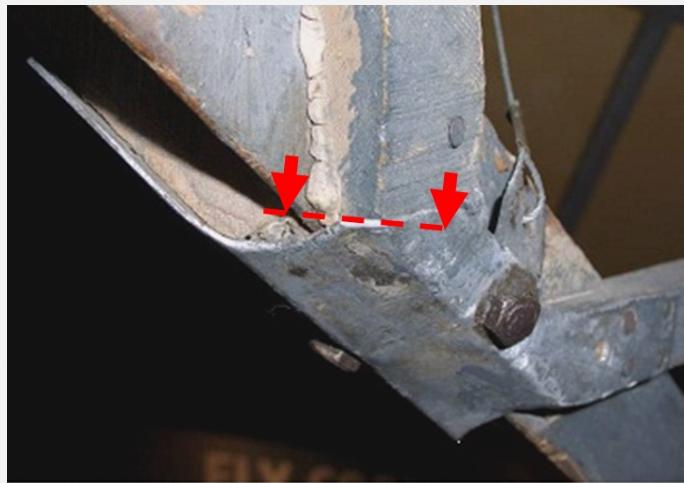
Fig. 2: Location of sampling area,

Sample cut from the corner of the fixation plate (Fig. 2). Dimensions: L = 4mm ; W = 1.2mm.

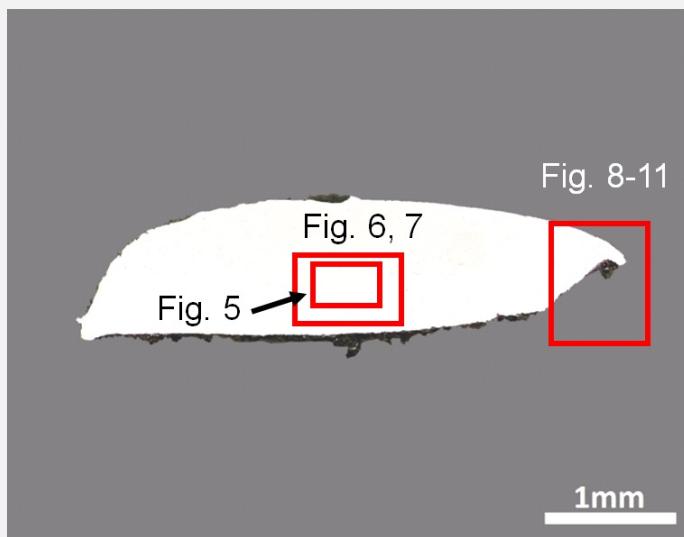
Fig. 3: Micrograph of the cross-section showing the location of Figs. 5 to 11,

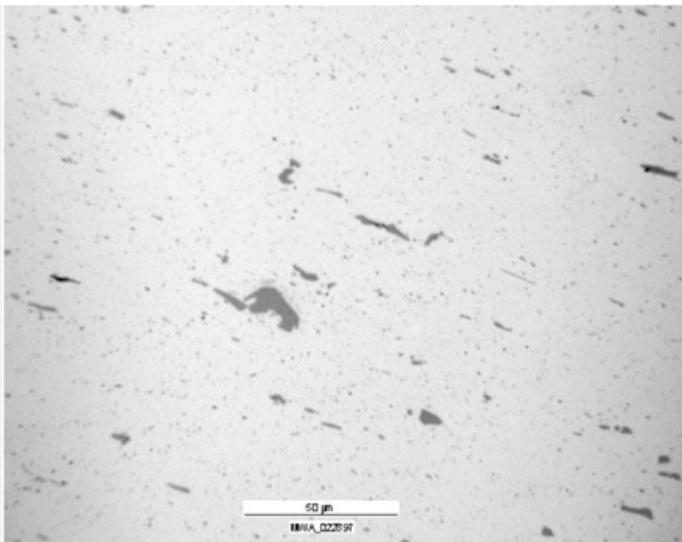
The metal is a relatively pure aluminium alloy with numerous inclusions (Table 1). From the chemical composition of the inclusions they can be interpreted as alpha-AlFeSi intermetallic compounds. In bright field we observe elongated inclusions indicating that the metal was rolled (Fig. 5). The alloy composition is similar to an unalloyed primary aluminium (Al content between 99 and 99.8 mass%). The O content reflects the immediate oxidation of the metal and is not part of the alloy. After etching the organisation of inclusions in rows is more easily seen (Fig. 6). The SEM image shows large grains formed after annealing (Fig. 7). The average hardness of the metal is HV1 40.

Fig. 5: Micrograph of the metal sample from Fig. 3 (detail), unetched, bright field. The metal matrix is in white, the elongated inclusions in grey,

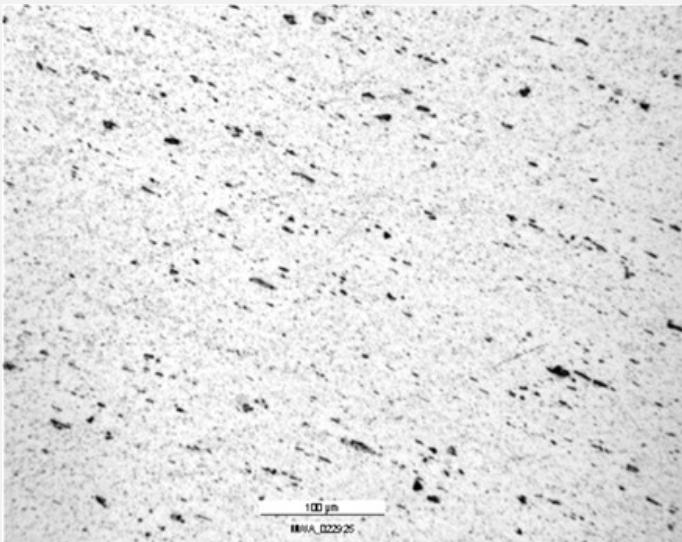
Fig. 6: Micrograph of the metal sample from Fig. 3 (detail), etched, bright field. The metal matrix is in white, the elongated inclusions in dark-grey and black,

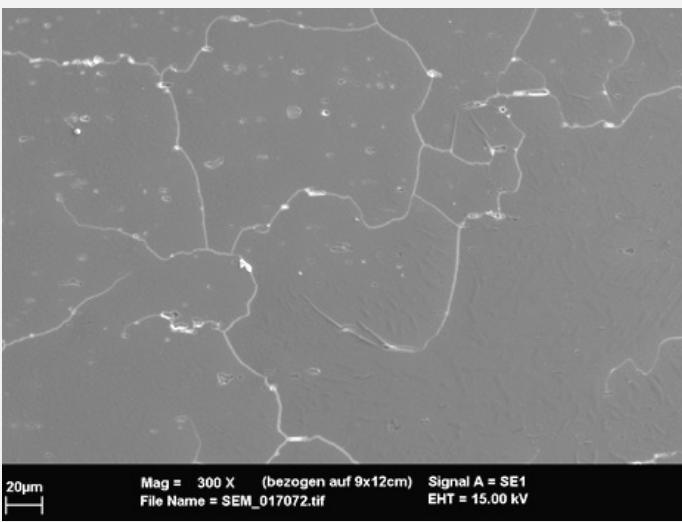
Fig. 7: SEM image of the metal sample from Fig. 3 (detail), SE-mode, etched. We observe the presence of large grains and numerous elongated inclusions,

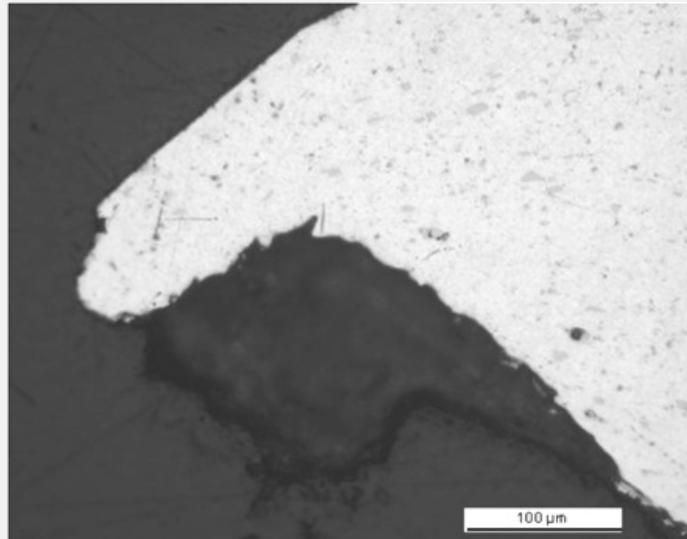
The metal is covered by a very thin corrosion layer (CP1). In addition to this, locally thicker “corrosion products” or adherent material can be observed (D1, appearing as dark-grey area in Fig. 8). Under polarized light, they appear blue-brown (Fig. 9). Analysis by SEM-EDS indicates that the metal is, as expected, covered by a very thin Al and O-rich layer whereas the particles in the adherent material contain C, O, Si, Ca, Fe, Zn, S and even Ti (Figs. 10 and 11). The location of the adherent material and the presence of both Zn and Ti suggest that it is a residue of a paint coating.

Fig. 8: Micrograph showing the metal - “corrosion products” interface from Fig. 3 (reversed picture, detail), unetched, bright field. We observe in white the metal matrix and dark-grey the adhering material,

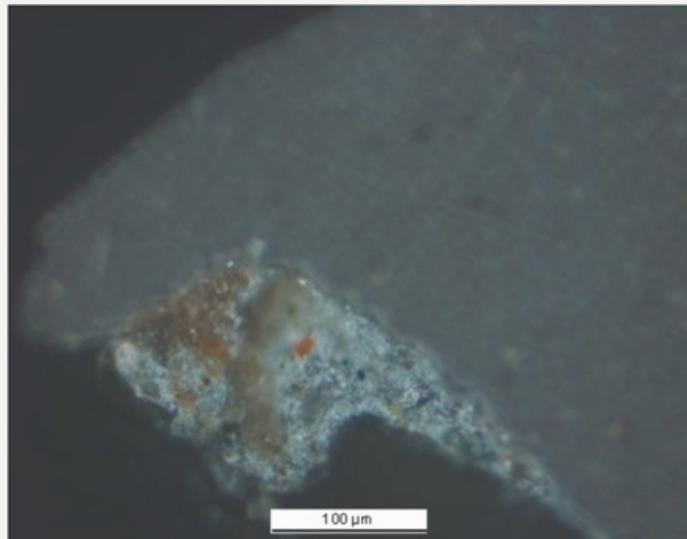
Fig. 9: Micrograph (same as Fig. 8) and corresponding to the stratigraphy of Fig. 4, unetched, polarised light. We observe in grey the metal matrix and blue-brown the adherent material,

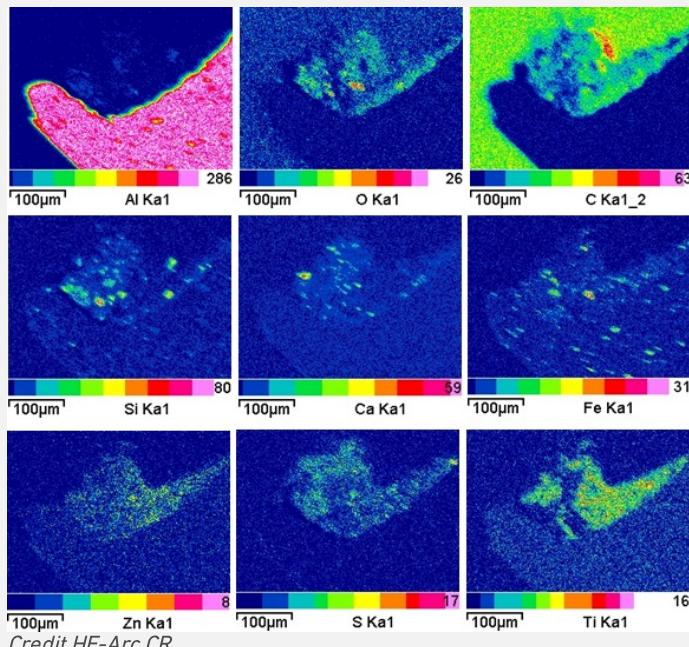
Fig. 11: Elemental chemical distribution of the selected area from Fig. 10. Method of examination: SEM/EDS, Laboratory of Analytical Chemistry, Empa,
