AIRCRAFT REAR FASTENING PLATE VHS-497 – AL ALLOY – MODERN TIMES

Artefact name Aircraft rear fastening plate VHS-497

Authors Marianne. Senn (EMPA, Dübendorf, Zurich, Switzerland) & Christian. Degrieny (HE-Arc CR, Neuchâtel, Neuchâtel, Switzerland)

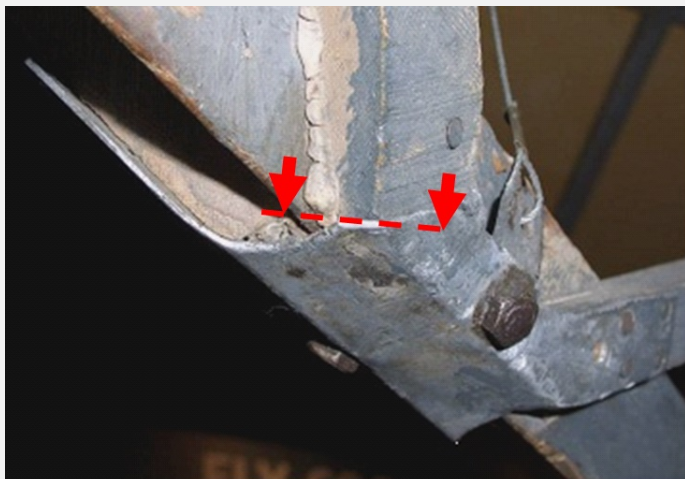
Fig. 2: Location of sampling area,

Sample cut from the corner of the fixation plate (Fig. 2). Dimensions: L = 4mm ; W = 1.2mm.

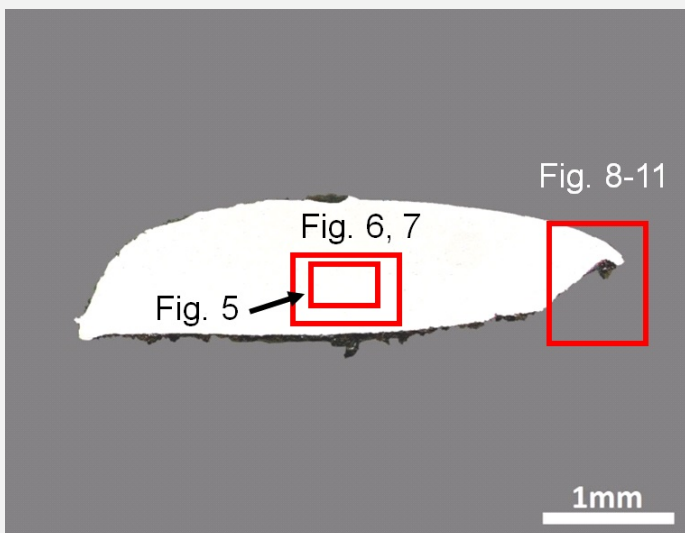
Fig. 3: Micrograph of the cross-section showing the location of Figs. 5 to 11,

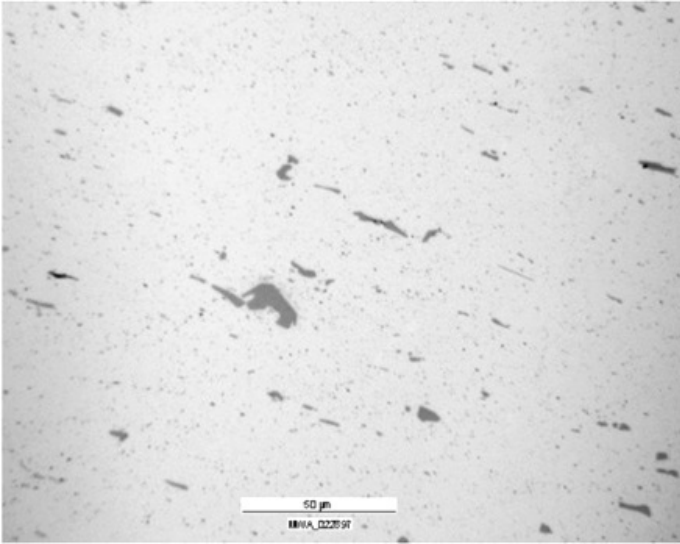
The metal is a relatively pure aluminium alloy with numerous inclusions (Table 1). From the chemical composition of the inclusions they can be interpreted as alpha-AlFeSi intermetallic compounds. In bright field we observe elongated inclusions indicating that the metal was rolled (Fig. 5). The alloy composition is similar to an unalloyed primary aluminium (Al content between 99 and 99.8 mass%). The O content reflects the immediate oxidation of the metal and is not part of the alloy. After etching the organisation of inclusions in rows is more easily seen (Fig. 6). The SEM image shows large grains formed after annealing (Fig. 7). The average hardness of the metal is HV1 40.

Fig. 5: Micrograph of the metal sample from Fig. 3 (detail), unetched, bright field. The metal matrix is in white, the elongated inclusions in grey.

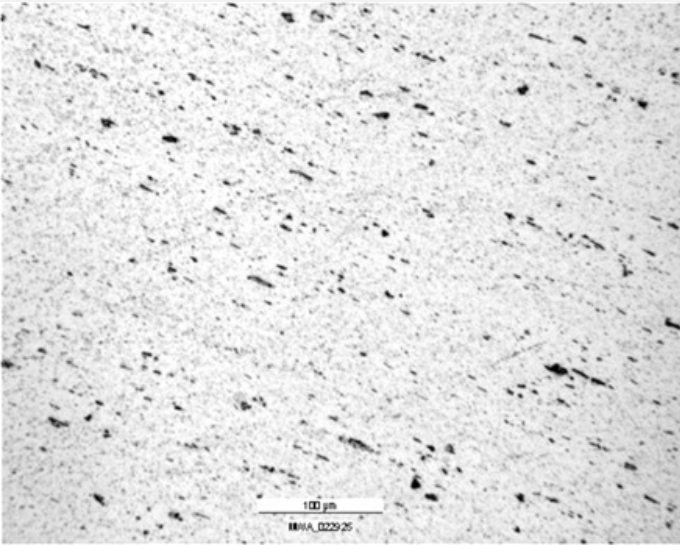
Fig. 6: Micrograph of the metal sample from Fig. 3 (detail), etched, bright field. The metal matrix is in white, the elongated inclusions in dark-grey and black,

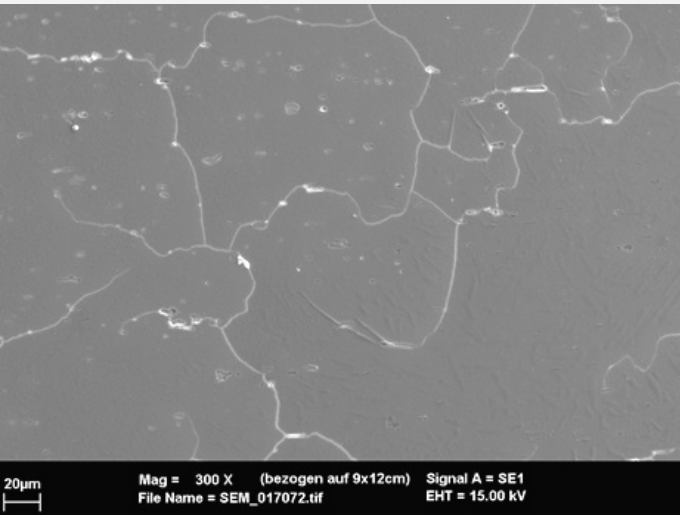
Fig. 7: SEM image of the metal sample from Fig. 3 (detail), SE-mode, etched. We observe the presence of large grains and numerous elongated inclusions,

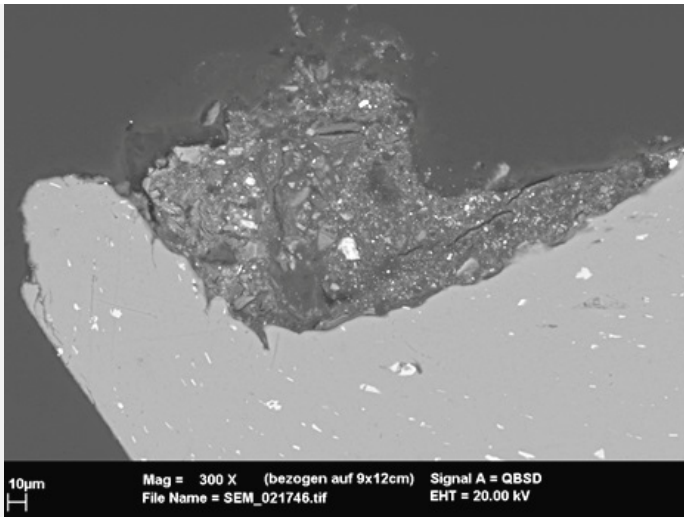
Fig. 10: SEM image (same as Fig. 8, inverted picture, detail), BSE-mode, unetched,

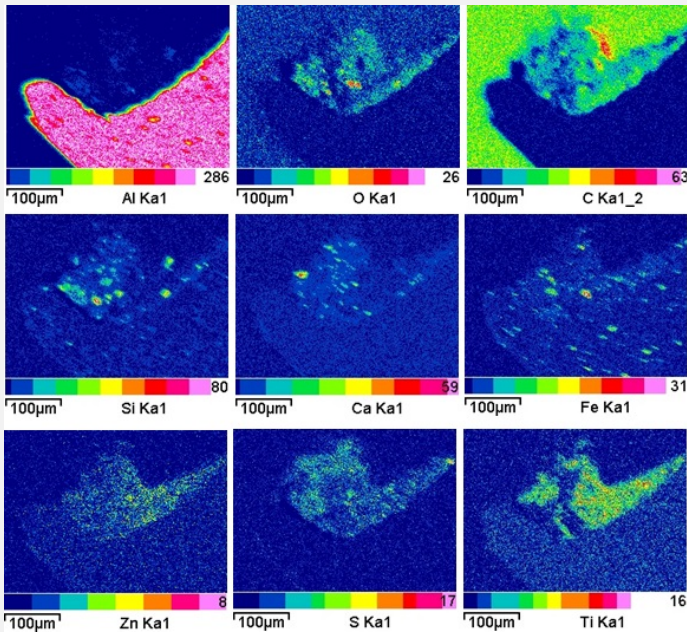
Fig. 11: Elemental chemical distribution of the selected area from Fig. 10. Method of examination: SEM/EDS, Laboratory of Analytical Chemistry, Empa,
