AIRCRAFT REAR FASTENING PLATE VHS-497 – AL ALLOY – MODERN TIMES

Artefact name Aircraft rear fastening plate VHS-497

Authors Marianne. Senn (EMPA, Dübendorf, Zurich, Switzerland) & Christian. Degriy (HE-Arc CR, Neuchâtel, Neuchâtel, Switzerland)

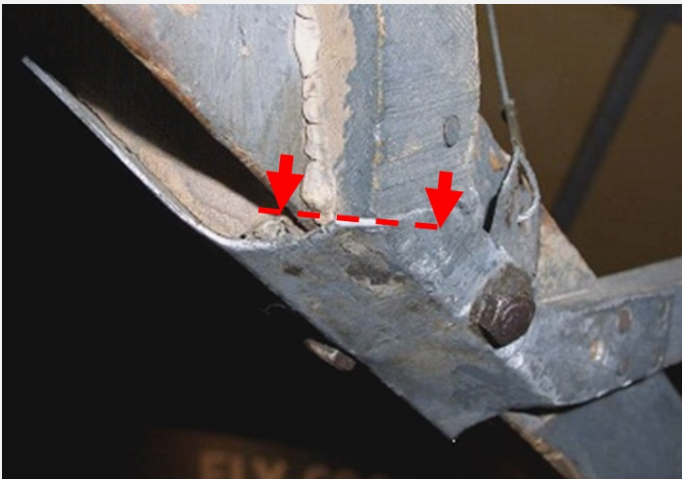
Fig. 2: Location of sampling area,

Sample cut from the corner of the fixation plate (Fig. 2). Dimensions: L = 4mm ; W = 1.2mm.

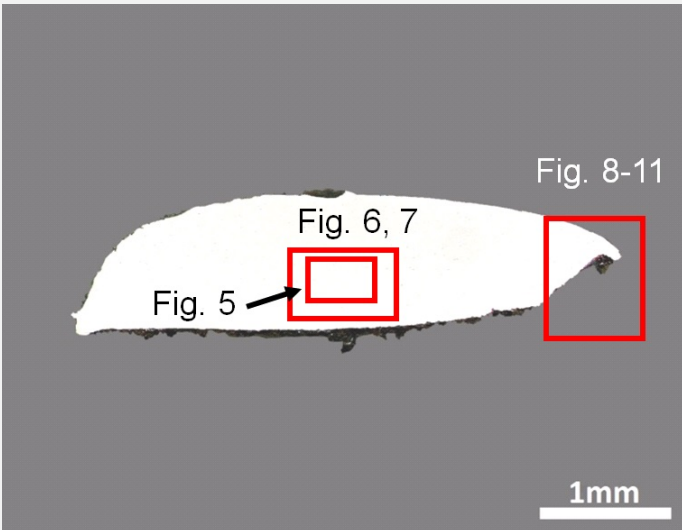
Fig. 3: Micrograph of the cross-section showing the location of Figs. 5 to 11,

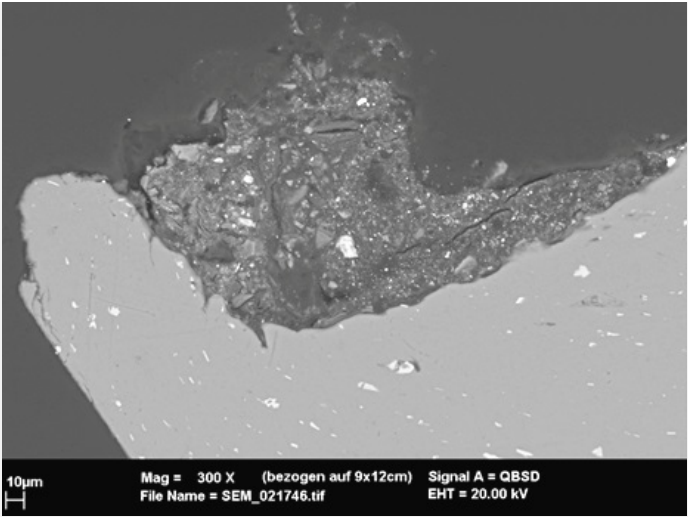
Fig. 10: SEM image (same as Fig. 8, inverted picture, detail), BSE-mode, unetched,

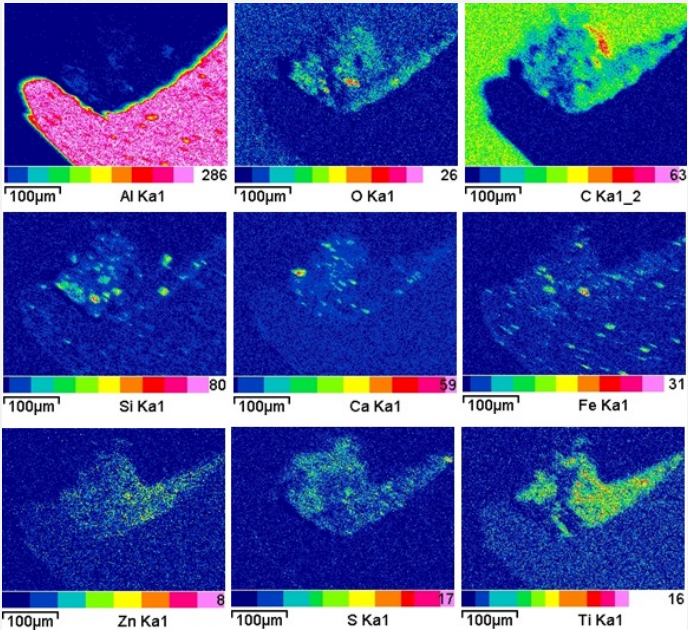
Fig. 11: Elemental chemical distribution of the selected area from Fig. 10. Method of examination: SEM/EDS, Laboratory of Analytical Chemistry, Empa,
