AIRCRAFT FRONT FASTENING PLATE VHS-497 (2) - AL CU SN ZN SI ALLOY - MODERN TIMES

Artefact name	Aircraft front fastening plate VHS-497 (2)
Authors	Marianne. Senn (EMPA, Dübendorf, Zurich, Switzerland) & Christian. Degriigny (HE-Arc CR, Neuchâtel, Neuchâtel, Switzerland)
Url	/artefacts/332/

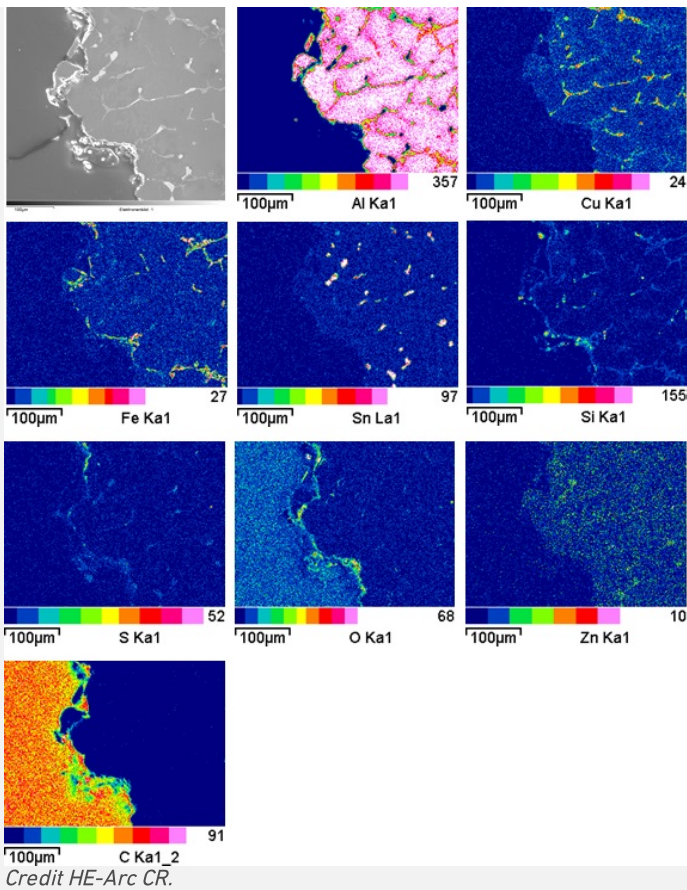
No corrosion layer can be seen on the metal surface (Figs. 3 and 7). Under polarized light small white and brown particles are visible on the broken edge (D1, Fig. 8). Their analysis reveals the presence of silica particles surrounded by dirt (Table 2 and Fig. 9). The metal surface is covered by a thin oxygen bearing skin (CP1, Fig. 9).

Fig. 9: SEM image, BSE-mode, and elemental chemical distribution of the selected area from Fig. 8 (reversed picture, detail). Method of examination: SEM/EDS, Laboratory of Analytical Chemistry, Empa,

Although not common at the beginning of the 20th, this Al-Cu-Sn-Zn-Si cast alloy was extensively used on the Dufaux IV plane. No corrosion layer has been found on the metal surface except adherent silica-rich particles and the thin oxidised skin typical of Al alloys. The presence of these materials might be explained by the regular maintenance of the metal using abrasive silicon carbide paper.
