AIRCRAFT FRONT FASTENING PLATE VHS-497 (2) - AL CU SN ZN SI ALLOY - MODERN TIMES

Artefact name Aircraft front fastening plate VHS-497 (2)

Authors Marianne. Senn (EMPA, Dübendorf, Zurich, Switzerland) & Christian. Degrigny (HE-Arc CR, Neuchâtel, Neuchâtel, Switzerland)

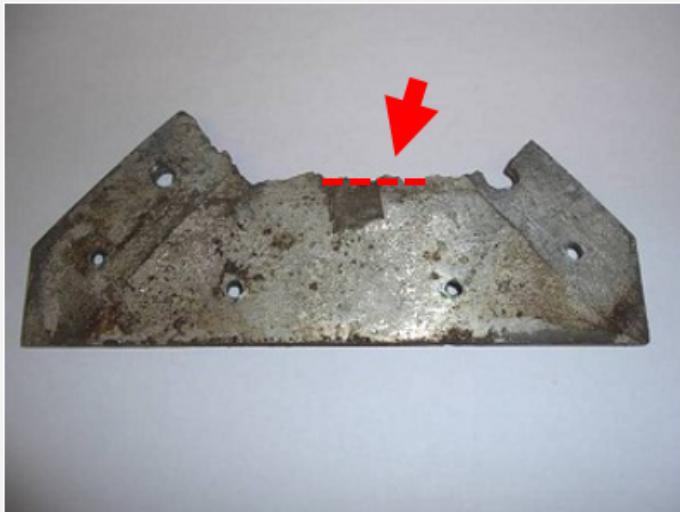
Fig. 2: Location of sampling area,

Description of sample	The top part has been cut during sampling (Fig. 2). The more regular right side is the plate surface and the irregular side is the broken edge (Fig. 3). Dimensions: L = 4mm ; W = 4mm.
Alloy	Al Cu Sn Zn Si Alloy
Technology	As-cast
Lab number of sample	DUF-4
Sample location	Empa (Marianne Senn)
Responsible institution	Swiss Museum of Transport, Luzern, Lucerne
Date and aim of sampling	September 2007, metallography and alloy composition

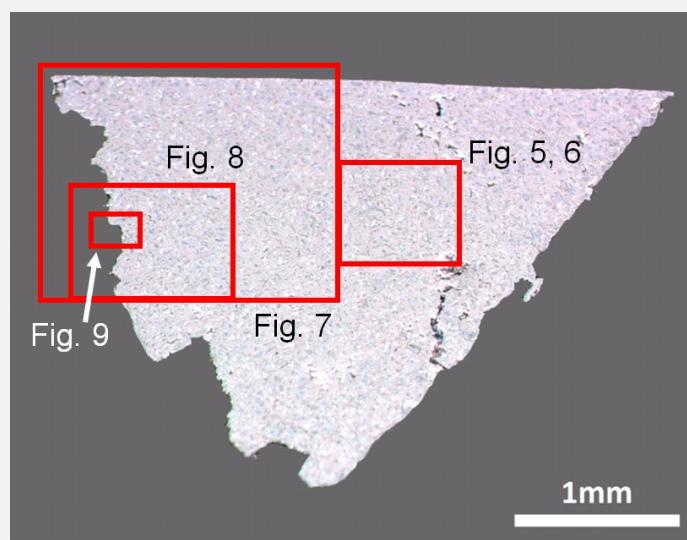
Fig. 3: Micrograph of the cross-section showing the location of Figs. 5 to 9,

No corrosion layer can be seen on the metal surface (Figs. 3 and 7). Under polarized light small white and brown particles are visible on the broken edge (D1, Fig. 8). Their analysis reveals the presence of silica particles surrounded by dirt (Table 2 and Fig. 9). The metal surface is covered by a thin oxygen bearing skin (CP1, Fig. 9).

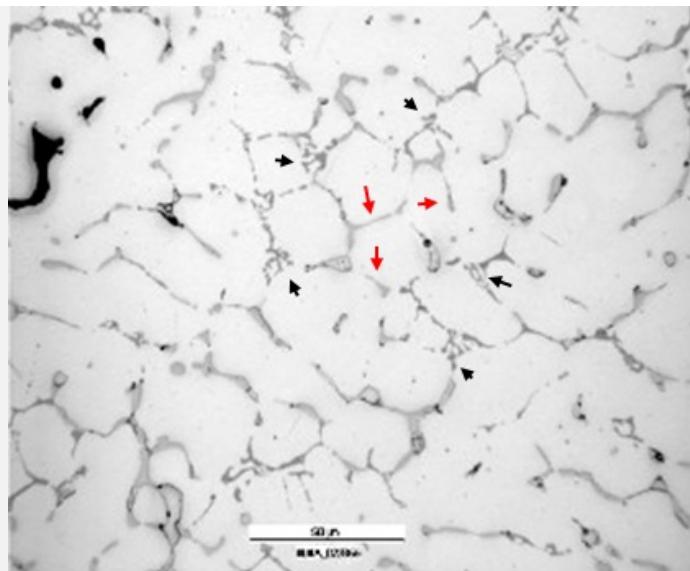
The metal is an aluminium alloy containing Cu, Sn, Zn and Si (Table 1). The unetched metal shows an as-cast structure consisting of the aluminium matrix with Sn (not soluble in Al) inclusions (Figs. 5 and 6), intermetallic compounds such as Al₂Cu (Fig. 5, red arrows) and clusters of Al,Fe,Cu & Si phases (Fig. 5, black arrows). There are porosities in the metal (Figs. 3 and 5). The average hardness of the metal is HV1.80.

Table 1: Chemical composition (mass %) of the metal and inclusions (from Fig. 5). Method of analysis: SEM/EDS, Laboratory of Analytical Chemistry, Empa.

Fig. 5: Micrograph of the metal sample from Fig. 3 (detail), unetched, bright field. The cast structure is revealed by light grey intermetallic compounds (Al₂Cu, red arrows), dark-grey Al,Fe,Si & Cu phase clusters (black arrows) and Sn inclusions (nodules). On the top left some pores can be seen,

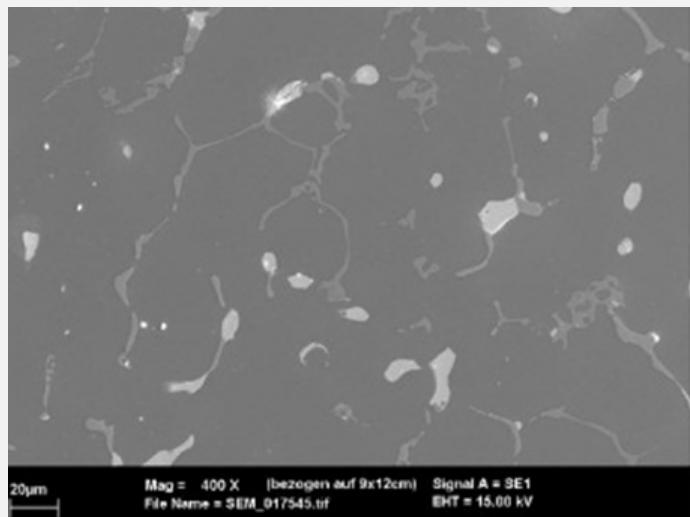
Fig. 6: SEM image of the metal sample from Fig. 3 (detail), SE-mode, unetched. We observe in dark-grey the metal matrix, in medium-grey the intermetallic compound Al₂Cu as well as Al,Fe,Si & Cu phase clusters and in light-grey the Sn inclusions,

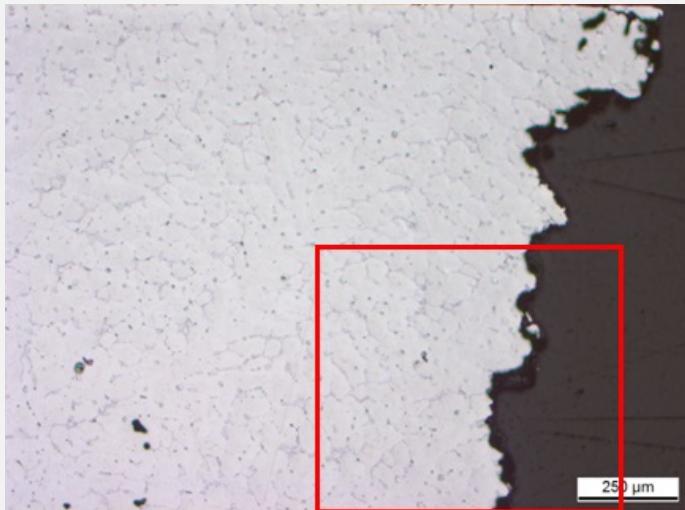
Table 2: Chemical composition (mass %) of the adhering particles to the metal surface (from Fig. 7). Method of analysis: SEM/EDS, Laboratory of Analytical Chemistry, Empa.

Fig. 7: Micrograph showing the metal - "corrosion products" interface from Fig. 3 (reversed picture, detail), unetched, bright field. We observe in white the metal matrix, in dark-grey Al,Fe, Si & Cu phase and light-grey Al₂Cu intermetallic compounds. The micrograph of Fig. 8 is marked by a rectangle,

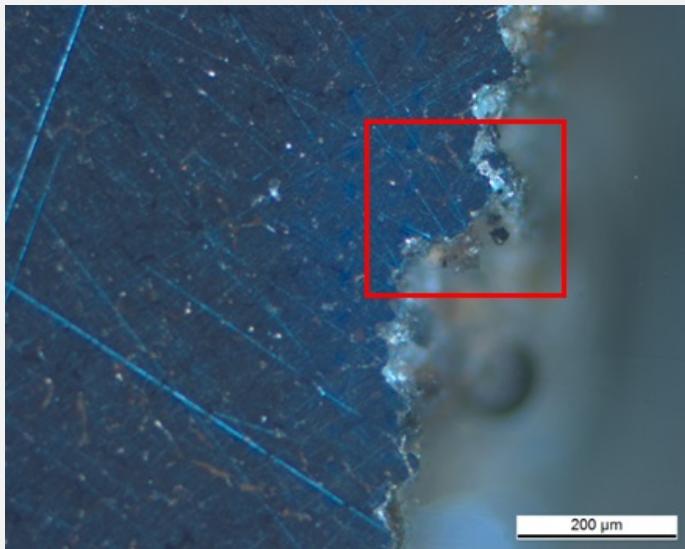
Fig. 8: Micrograph from Fig. 7 (detail) and corresponding to the stratigraphy of Fig. 4, unetched, polarised light. We observe in grey the metal matrix and blue-brown the adherent material. The micrograph of Fig. 9 is marked by a rectangle,

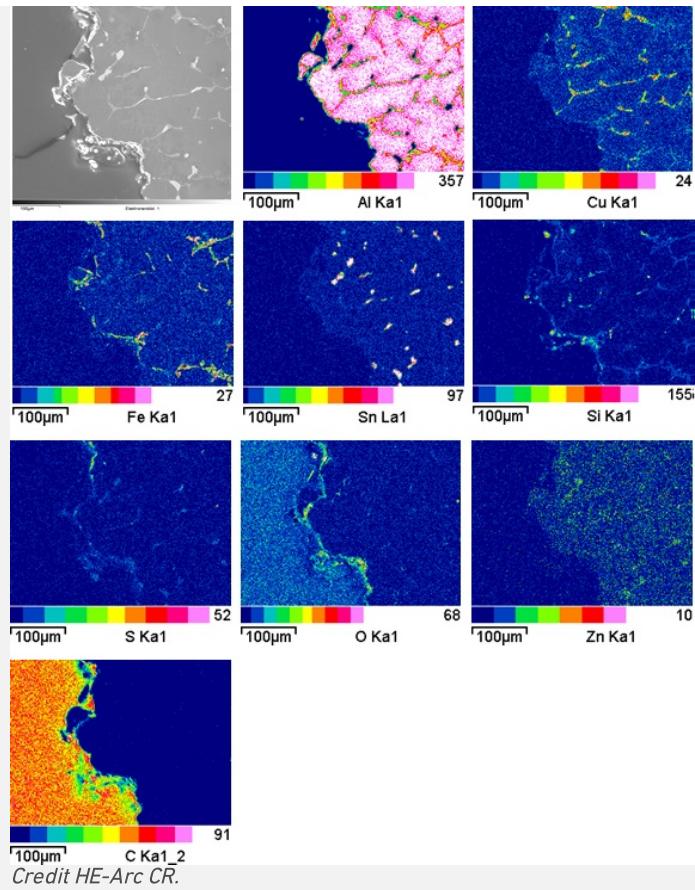
Fig. 9: SEM image, BSE-mode, and elemental chemical distribution of the selected area from Fig. 8 (reversed picture, detail). Method of examination: SEM/EDS, Laboratory of Analytical Chemistry, Empa,

Although not common at the beginning of the 20th, this Al-Cu-Sn-Zn-Si cast alloy was extensively used on the Dufaux IV plane. No corrosion layer has been found on the metal surface except adherent silica-rich particles and the thin oxidised skin typical of Al alloys. The presence of these materials might be explained by the regular maintenance of the metal using abrasive silicon carbide paper.
