AIRCRAFT FRONT FASTENING PLATE VHS-497 (2) - AL CU SN ZN SI ALLOY - MODERN TIMES

Artefact name	Aircraft front fastening plate VHS-497 (2)
Authors	Marianne. Senn (EMPA, Dübendorf, Zurich, Switzerland) & Christian. Degriigny (HE-Arc CR, Neuchâtel, Neuchâtel, Switzerland)
Url	/artefacts/332/

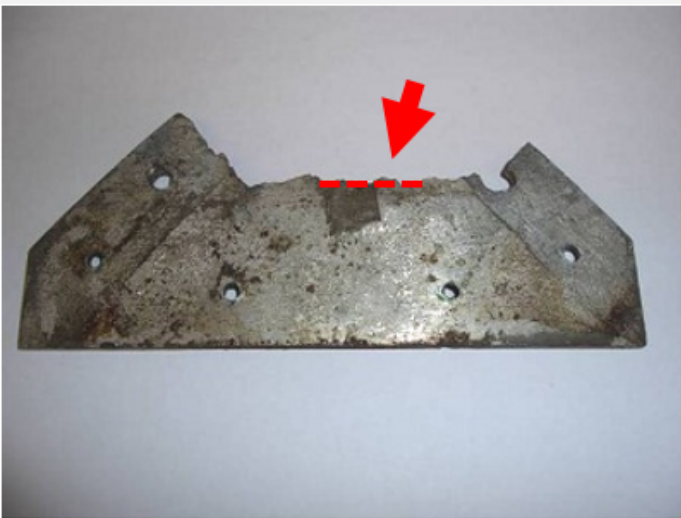
Fig. 2: Location of sampling area,

Description of sample	The top part has been cut during sampling (Fig. 2). The more regular right side is the plate surface and the irregular side is the broken edge (Fig. 3). Dimensions: L = 4mm ; W = 4mm.
Alloy	Al Cu Sn Zn Si Alloy
Technology	As-cast
Lab number of sample	DUF-4
Sample location	Empa (Marianne Senn)
Responsible institution	Swiss Museum of Transport, Luzern, Lucerne
Date and aim of sampling	September 2007, metallography and alloy composition

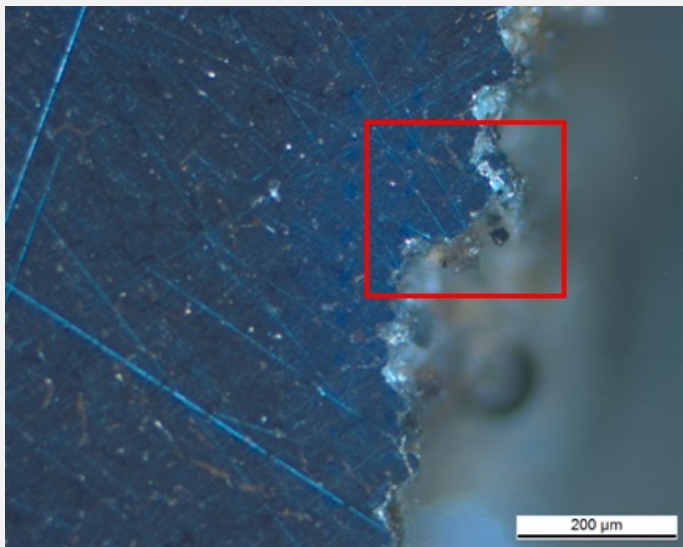
No corrosion layer can be seen on the metal surface (Figs. 3 and 7). Under polarized light small white and brown particles are visible on the broken edge (D1, Fig. 8). Their analysis reveals the presence of silica particles surrounded by dirt (Table 2 and Fig. 9). The metal surface is covered by a thin oxygen bearing skin (CP1, Fig. 9).

Fig. 8: Micrograph from Fig. 7 (detail) and corresponding to the stratigraphy of Fig. 4, unetched, polarised light. We observe in grey the metal matrix and blue-brown the adherent material. The micrograph of Fig. 9 is marked by a rectangle,
