# ARMATURE FROM A CLOCK MOVEMENT MIH IV-212 - ZN AL SN CU ALLOY - MODERN TIMES

**Artefact name** Armature from a clock movement MIH IV-212

**Authors** Marianne. Senn (EMPA, Dübendorf, Zurich, Switzerland) & Christian. Degrigny (HE-Arc CR, Neuchâtel, Neuchâtel, Switzerland)

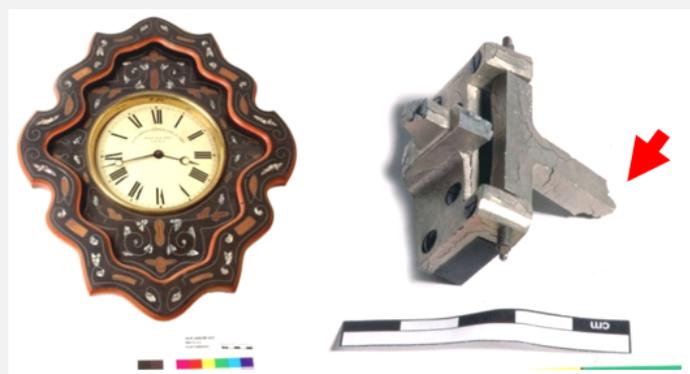
Fig. 1: Wooden wall clock, zinc alloy armature from the clock movement (after Seematter 2009),

**Description of the artefact** Armature from the clock movement of a wooden wall clock with electric movement (fig. 1).

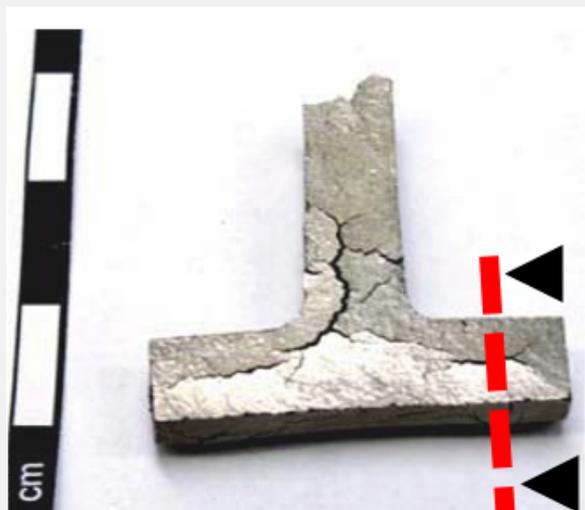
Fig. 2: Location of sampling area,

<b>Description of sample</b>	This sample is the complete cross-section from an element of the armature (Fig. 2). The metal has huge cracks radiating from the centre to the outside which have deformed the armature (Fig. 3). The metal is covered with a Ni coating.
<b>Alloy</b>	Zn Al Sn Cu Alloy
<b>Technology</b>	As-cast
<b>Lab number of sample</b>	MIH-VI-212
<b>Sample location</b>	HE-Arc CR, Neuchâtel, Neuchâtel
<b>Responsible institution</b>	International museum of horology (IMH), La Chaux-de-Fonds, Neuchâtel
<b>Date and aim of sampling</b>	2009, metal analysis

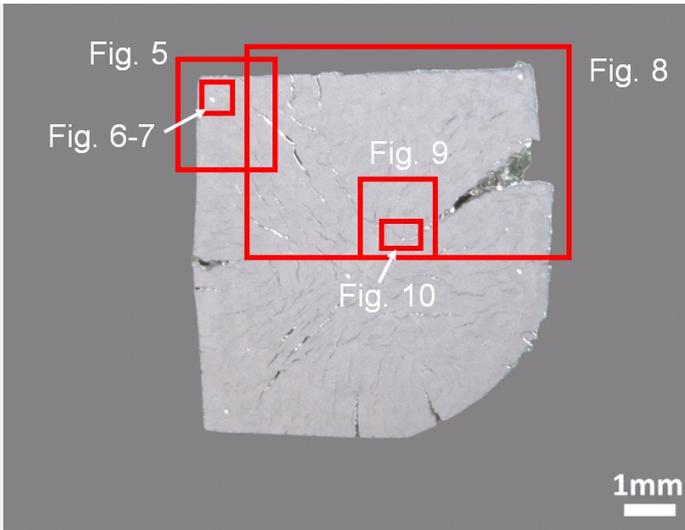
Fig. 3: Micrograph of the cross-section showing the location of Figs. 5 to 10,

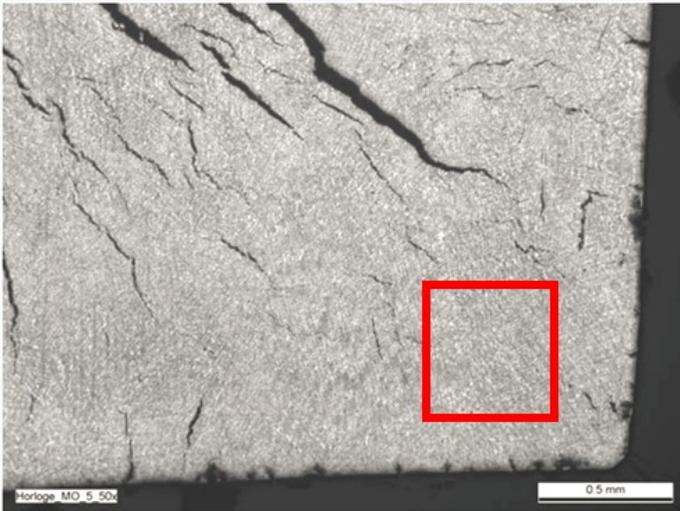
The metal is a Zn-Al-Sn-Cu alloy (Table 1) with an average hardness of HV1 105. A fine dendritic structure is observed (Fig. 5) which consists of clearly separated Zn, Al-Cu and Sn-rich phases (Figs. 6 and 7). Pb is associated with Sn but also forms tiny nodules.

Fig. 5: Micrograph of the metal sample from Fig. 3 (inverted picture, rotated by 270°, detail), unetched, bright field. A dendritic structure is visible. The micrograph of Fig. 6 is marked by a square,

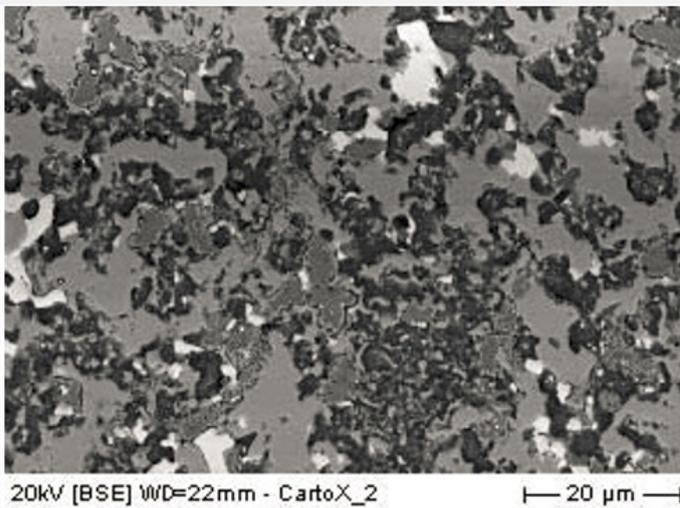
Fig. 6: SEM image, BSE-mode, detail from Fig. 5 (detail), unetched, bright field. Three phases appear: in light-grey the Zn-rich phase, in dark-grey the Al and Cu-rich phase and in white the Sn-rich phase,

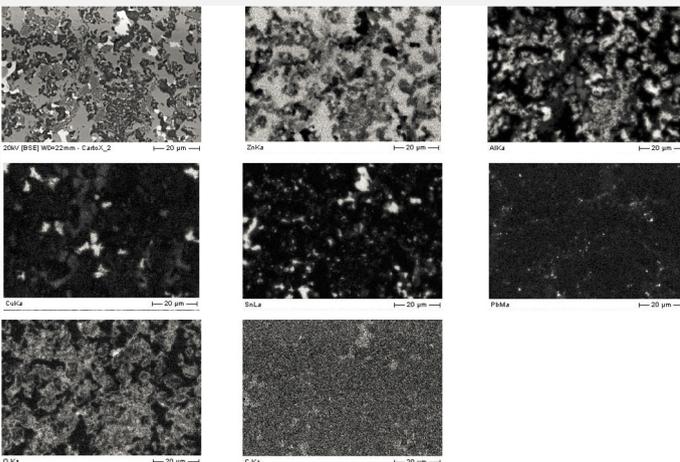
Fig. 7: SEM image, BSE-mode, and elemental chemical distribution of the selected area from Fig. 6. Method of examination: SEM/EDS, Lab of Electronic Microscopy and microanalysis, IMA (Néode), HEI Arc,

The Zn-rich phase is heavily oxidised internally (Fig. 7). The corrosion has developed throughout the entire metal body, generating cracks (Figs. 8 and 9). The cracks are Zn, O and C-rich (Fig. 10) and could be composed of zinc carbonate.

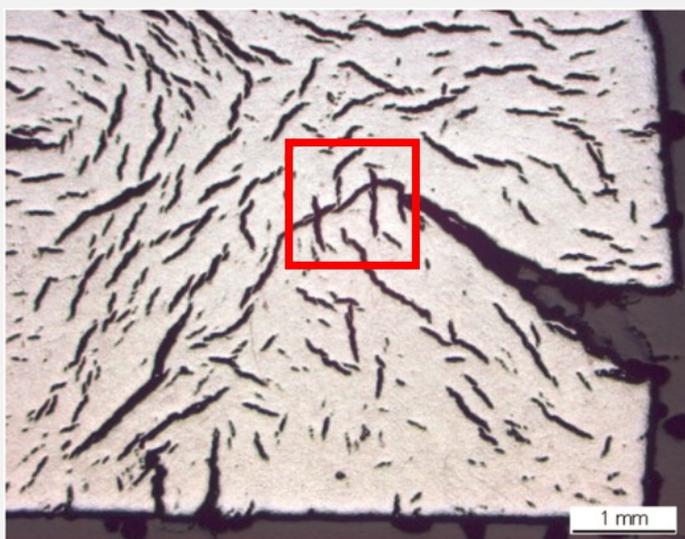
Fig. 8: Micrograph showing the metal - "corrosion products" interface from Fig. 3 (reversed picture, detail), unetched, bright field. We observe in white the metal matrix and dark-grey the adhering material,

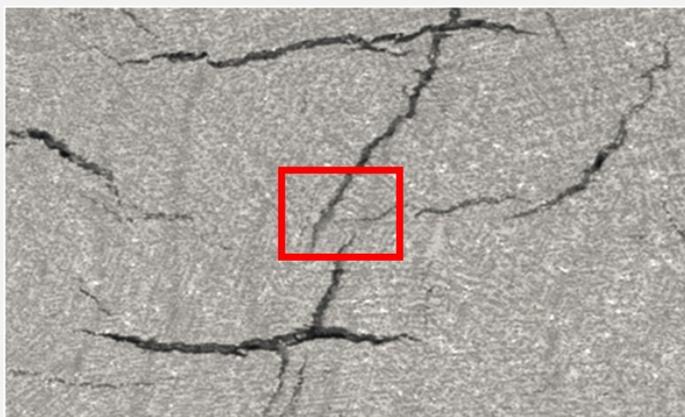
Fig. 9: Micrograph of the metal sample, detail from Fig. 8 (reversed and rotated by 90°), unetched, bright field. A dendritic structure is visible. The micrograph of Fig. 10 is marked by a rectangle,

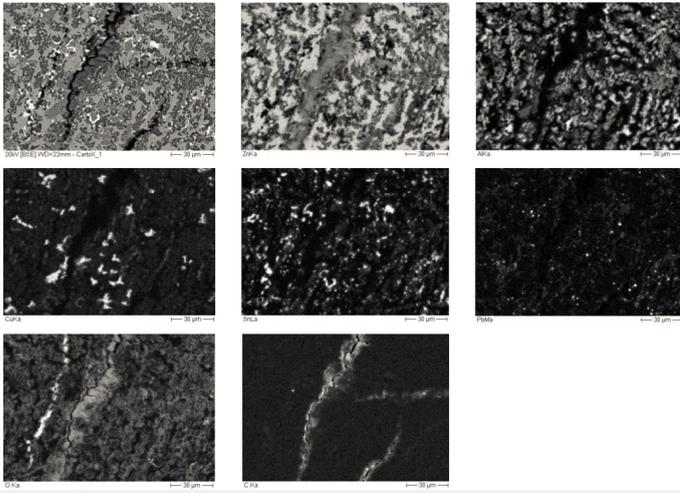
Fig. 10: SEM image, BSE-mode, and elemental chemical distribution of the selected area from Fig. 9 (detail). Method of examination: SEM/EDX, Lab of Electronic Microscopy and microanalysis, IMA (Néode), HEI Arc,
