ARMATURE FROM A CLOCK MOVEMENT MIH IV-212 – ZN AL SN CU ALLOY – MODERN TIMES

Artefact name	Armature from a clock movement MIH IV-212
Authors	Marianne. Senn (EMPA, Dübendorf, Zurich, Switzerland) & Christian. Degrigny (HE-Arc CR, Neuchâtel, Neuchâtel, Switzerland)
Url	/artefacts/334/

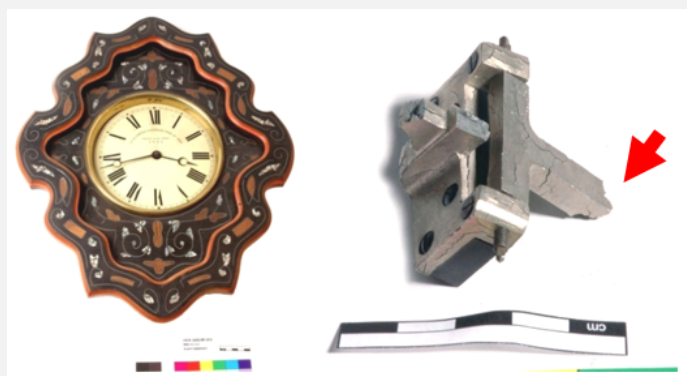
Fig. 1: Wooden wall clock, zinc alloy armature from the clock movement (after Seematter 2009),

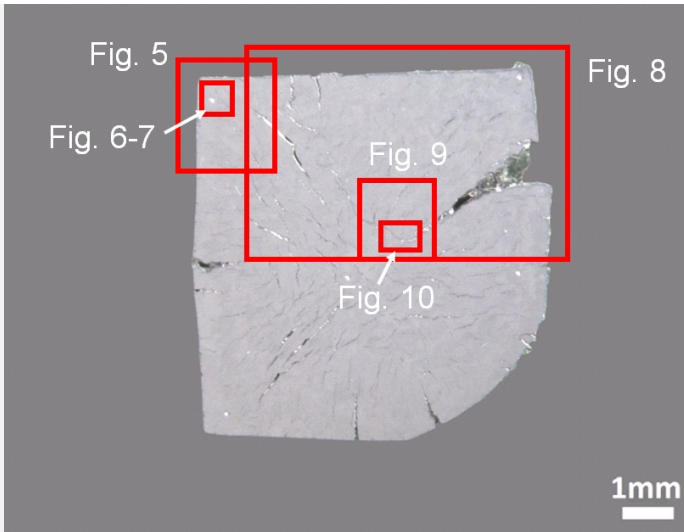
Fig. 3: Micrograph of the cross-section showing the location of Figs. 5 to 10,

Description of sample	This sample is the complete cross-section from an element of the armature (Fig. 2). The metal has huge cracks radiating from the centre to the outside which have deformed the armature (Fig. 3). The metal is covered with a Ni coating.
Alloy	Zn Al Sn Cu Alloy
Technology	As-cast
Lab number of sample	MIH-VI-212
Sample location	HE-Arc CR, Neuchâtel, Neuchâtel
Responsible institution	International museum of horology (IMH), La Chaux-de-Fonds, Neuchâtel
Date and aim of sampling	2009, metal analysis
