## SITULA EMT09-554.665 – TIN BRONZE – IRON AGE – SWITZERLAND

<b>Artefact name</b>	Situla EMT09-554.665
<b>Authors</b>	Christian. Degriigny (HE-Arc CR, Neuchâtel, Neuchâtel, Switzerland) & Marie-Jeanne. Scholl (HE-Arc CR, Neuchâtel, Neuchâtel, Switzerland) & Valentin. Boissonnas (HE-Arc CR, Neuchâtel, Neuchâtel, Switzerland)
<b>Url</b>	/artefacts/340/

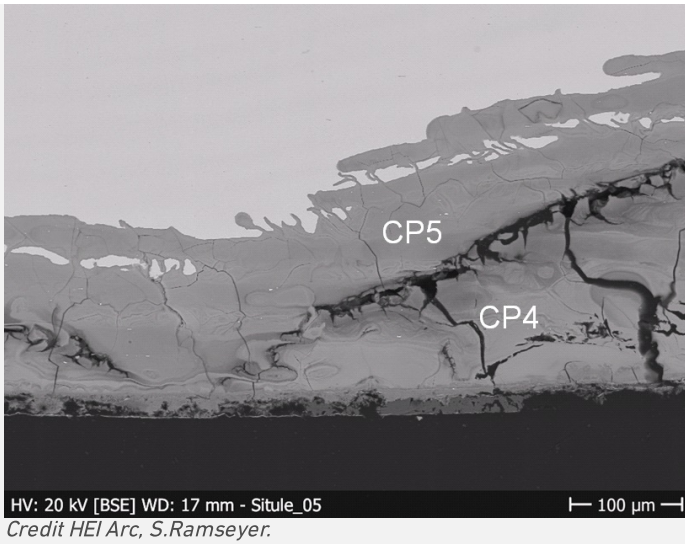
The corrosion crust is heterogeneous and has in places completely replaced the metal. The metal – corrosion products interface is irregular due to transgranular corrosion (Figs 7-8). In most cases, the corrosion crust can be divided in three main layers: an inner compact blue layer directly on the metal core (CP5, Figs. 6, 10 and 11 and CP3, Fig. 5). In areas of extensive corrosion this blue layer coexists with a friable green layer (CP4, Figs. 6, 10 and 11 and CP2, Fig. 5). Depending on the area either a very fine dark green (CP3, Fig. 6 and Fig. 10) or red corrosion layer (CP2, Fig. 6 and Fig. 10) marks the limit of the original surface. It is followed by an external fourth layer, consisting of friable and sometimes curly pale green corrosion products intermingled with soil products (CP1, Fig. 6 and Fig. 10 and 13). In heavily worked and fragile parts of the object a cleavage between the inner layers of blue and green corrosion is present, rendering the green corrosion vulnerable to loss (Fig. 11).

Fig. 11: SEM image, BSE-mode of the metal sample from Fig. 10 (detail) showing cleavage between the inner blue (CP5) and green (CP4) layers of Fig. 6,

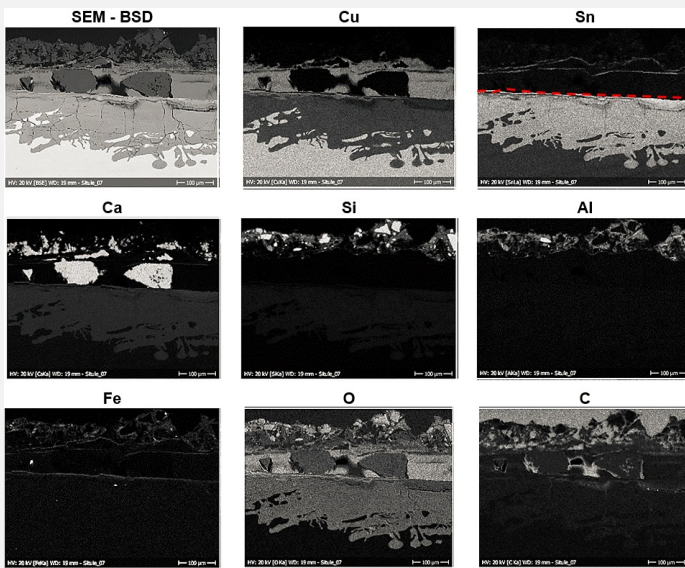
The inner layers (CP3-CP5) are Sn and O-rich and depleted in Cu (Table 2). The outer layers (CP1 and CP2) are Cu and O-rich, contain no Sn, and are contaminated with Ca, Si, Al and Fe coming from the soil (Fig. 12). The colour of the corrosion crust varies according to the content of Sn (the more Sn, the darker green or blue the corrosion). FTIR on the inner blue (CP5 and Fig. 14) and outer green (CP1 and Fig. 15) layers were difficult to interpret. Only malachite could be identified in both cases. XRD spectra could not be interpreted because of the deficiency of peaks.

Fig. 12: SEM image, SE-mode, and elemental chemical distribution of the selected area of Fig. 10. In red: the limit of the original surface highlighted by the enriched tin layer. Method of examination: SEM-EDS, Lab of Electronic Microscopy and Microanalysis, IMA (Néode), HEI Arc,

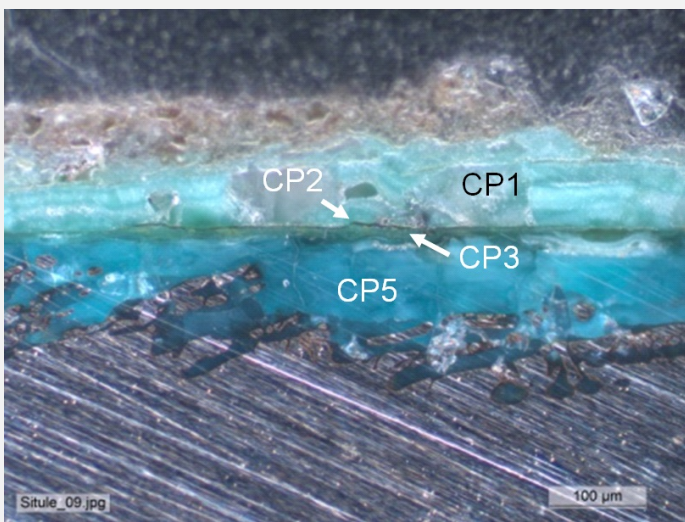
Fig. 13: Micrograph of the metal/corrosion interface (detail of Fig. 10) unetched, dark field, 100x. The outer layer (CP1 of Fig. 6) incorporates soil material and the thin dark layer (CP2 of Fig. 6) highlights the limit of the original surface,

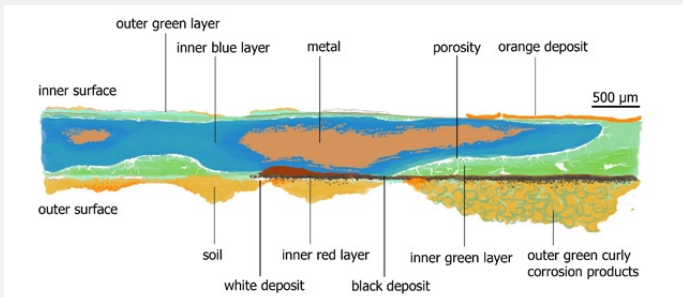
Fig. 16: Improved stratigraphic representation of the situla from visual observations and analyses,

The metal structure of this low-tin bronze shows extensive cold work and multiple annealing cycles with a final cold work. The total absence of inclusions highlights a highly developed knowledge in bronze metallurgy. The metal is much corroded. Transgranular corrosion is visible. The majority of the internal corrosion products are composed of copper carbonates that have replaced much of the metal. Curly malachite has developed in clusters on the outside of the surface. This pattern is characteristic of a long-term burial period. The presence of inner enriched Sn layers shows a decuprification phenomenon (dissolution of Cu). Because of the friable nature of the inner green layer that supports the limit of the original surface, as well as its cleavage with the blue layer underneath, the original surface has become very fragile. The corrosion is thought to be of type 1 according to Robbiola et al. 1998.
