SITULA EMT09-554.665 – TIN BRONZE – IRON AGE – SWITZERLAND

Artefact name	Situla EMT09-554.665
Authors	Christian. Degriigny (HE-Arc CR, Neuchâtel, Neuchâtel, Switzerland) & Marie-Jeanne. Scholl (HE-Arc CR, Neuchâtel, Neuchâtel, Switzerland) & Valentin. Boissonnas (HE-Arc CR, Neuchâtel, Neuchâtel, Switzerland)
Url	/artefacts/340/

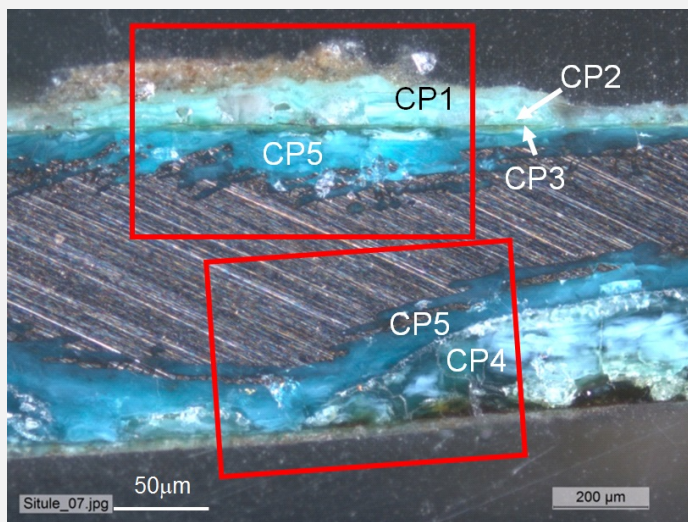
The corrosion crust is heterogeneous and has in places completely replaced the metal. The metal – corrosion products interface is irregular due to transgranular corrosion (Figs 7-8). In most cases, the corrosion crust can be divided in three main layers: an inner compact blue layer directly on the metal core (CP5, Figs. 6, 10 and 11 and CP3, Fig. 5). In areas of extensive corrosion this blue layer coexists with a friable green layer (CP4, Figs. 6, 10 and 11 and CP2, Fig. 5). Depending on the area either a very fine dark green (CP3, Fig. 6 and Fig. 10) or red corrosion layer (CP2, Fig. 6 and Fig. 10) marks the limit of the original surface. It is followed by an external fourth layer, consisting of friable and sometimes curly pale green corrosion products intermingled with soil products (CP1, Fig. 6 and Fig. 10 and 13). In heavily worked and fragile parts of the object a cleavage between the inner layers of blue and green corrosion is present, rendering the green corrosion vulnerable to loss (Fig. 11).

Table 2: Chemical composition of the corrosion crust from Fig. 10. SEM-EDS, Lab of Electronic Microscopy and Microanalysis, IMA (Néode) (+++: high concentration, ++ medium concentration, + low concentration, nd: not-detected).

Fig. 10: Micrograph of the metal sample from Fig. 4, unetched, dark field, 50x. Areas of Fig. 11 (bottom, corresponding to the stratigraphy of Fig. 5) and Figs. 12 and 13 (top, corresponding to the stratigraphy of Fig. 6) are marked by a rectangle. Codes are those of Fig. 6,
