## SITULA EMT09-554.665 – TIN BRONZE – IRON AGE – SWITZERLAND

<b>Artefact name</b>	Situla EMT09-554.665
<b>Authors</b>	Christian. Degriigny (HE-Arc CR, Neuchâtel, Neuchâtel, Switzerland) & Marie-Jeanne. Scholl (HE-Arc CR, Neuchâtel, Neuchâtel, Switzerland) & Valentin. Boissonnas (HE-Arc CR, Neuchâtel, Neuchâtel, Switzerland)
<b>Url</b>	/artefacts/340/

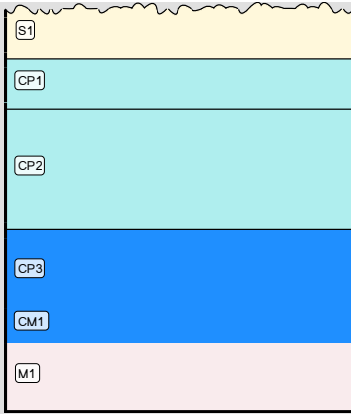
Fig. 5: Stratigraphic representation of the object in cross-section using the MiCorr application. This representation shows the exterior face and can be compared to Fig. 10 (bottom square)
