SITULA EMT09-554.665 – TIN BRONZE – IRON AGE – SWITZERLAND

Artefact name	Situla EMT09-554.665
Authors	Christian. Degriigny (HE-Arc CR, Neuchâtel, Neuchâtel, Switzerland) & Marie-Jeanne. Scholl (HE-Arc CR, Neuchâtel, Neuchâtel, Switzerland) & Valentin. Boissonnas (HE-Arc CR, Neuchâtel, Neuchâtel, Switzerland)
Url	/artefacts/340/

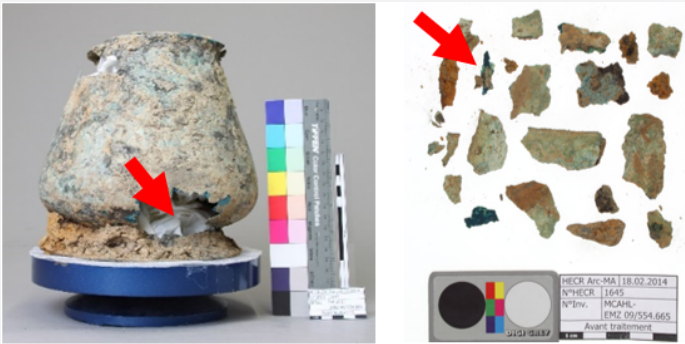
Fig. 2: Location of sampling area and sample selected from detached fragments,

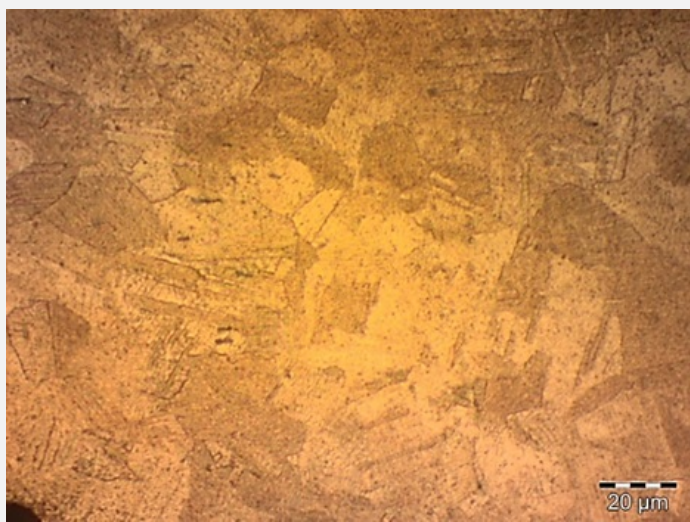
Fig. 9: Micrograph of the selected area of Fig. 8, etched, bright field, 500x. The grains show both twin and strain lines,

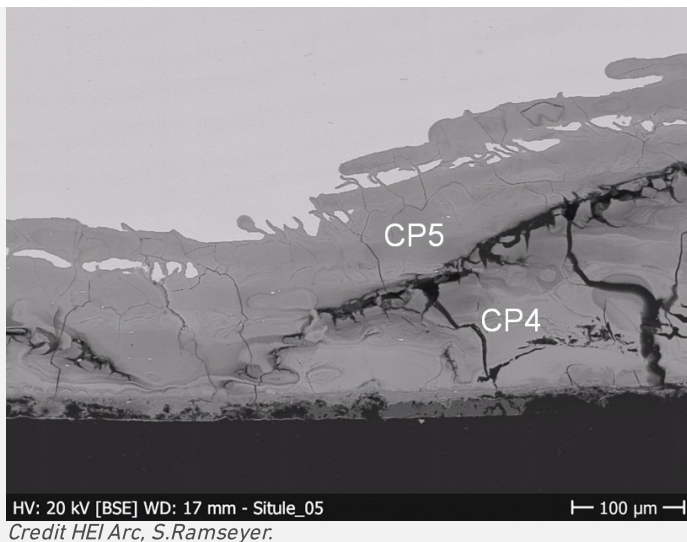
The corrosion crust is heterogeneous and has in places completely replaced the metal. The metal – corrosion products interface is irregular due to transgranular corrosion (Figs 7-8). In most cases, the corrosion crust can be divided in three main layers: an inner compact blue layer directly on the metal core (CP5, Figs. 6, 10 and 11 and CP3, Fig. 5). In areas of extensive corrosion this blue layer coexists with a friable green layer (CP4, Figs. 6, 10 and 11 and CP2, Fig. 5). Depending on the area either a very fine dark green (CP3, Fig. 6 and Fig. 10) or red corrosion layer (CP2, Fig. 6 and Fig. 10) marks the limit of the original surface. It is followed by an external fourth layer, consisting of friable and sometimes curly pale green corrosion products intermingled with soil products (CP1, Fig. 6 and Fig. 10 and 13). In heavily worked and fragile parts of the object a cleavage between the inner layers of blue and green corrosion is present, rendering the green corrosion vulnerable to loss (Fig. 11).

Fig. 11: SEM image, BSE-mode of the metal sample from Fig. 10 (detail) showing cleavage between the inner blue (CP5) and green (CP4) layers of Fig. 6,

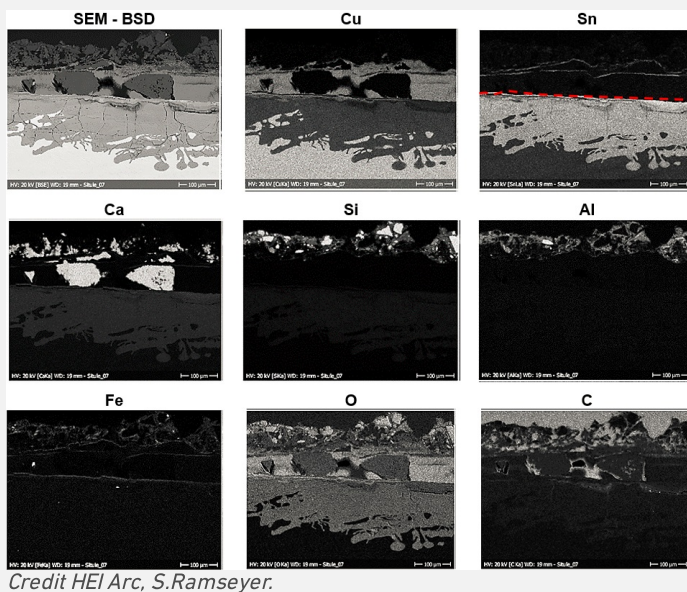
The inner layers (CP3-CP5) are Sn and O-rich and depleted in Cu (Table 2). The outer layers (CP1 and CP2) are Cu and O-rich, contain no Sn, and are contaminated with Ca, Si, Al and Fe coming from the soil (Fig. 12). The colour of the corrosion crust varies according to the content of Sn (the more Sn, the darker green or blue the corrosion). FTIR on the inner blue (CP5 and Fig. 14) and outer green (CP1 and Fig. 15) layers were difficult to interpret. Only malachite could be identified in both cases. XRD spectra could not be interpreted because of the deficiency of peaks.

Fig. 12: SEM image, SE-mode, and elemental chemical distribution of the selected area of Fig. 10. In red: the limit of the original surface highlighted by the enriched tin layer. Method of examination: SEM-EDS, Lab of Electronic Microscopy and Microanalysis, IMA (Néode), HEI Arc,

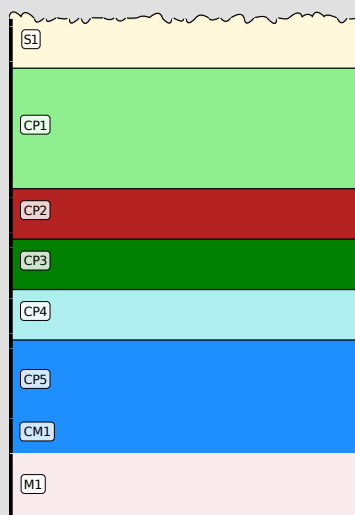
Fig. 6: Stratigraphic representation of the object in cross-section using the MiCorr application. This representation shows the interior face and can be compared to Fig. 10 (top square).

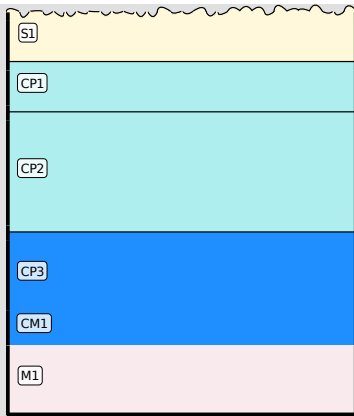
Fig. 5: Stratigraphic representation of the object in cross-section using the MiCorr application. This representation shows the exterior face and can be compared to Fig. 10 (bottom square)
