SITULA EMT09-554.665 - TIN BRONZE - IRON AGE - SWITZERLAND

Artefact name Situla EMT09-554.665

Authors Christian. Degrigny (HE-Arc CR, Neuchâtel, Neuchâtel, Switzerland) & Marie-Jeanne. Scholl (HE-Arc CR, Neuchâtel, Neuchâtel, Switzerland) & Valentin. Boissonnas (HE-Arc CR, Neuchâtel, Neuchâtel, Switzerland)

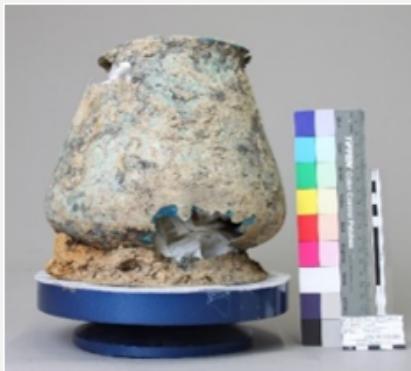
Fig. 1: Tin bronze Celtic situla (Archeodunum (Gollion), 2009) inverted as found in situ,

Description of the artefact Copper alloy situla (Fig. 1). Attached to two riveted iron loops is an iron handle terminating in two swan heads (not shown here). Dimensions of the main body: Hmax = 340mm, Ømax = 220mm.

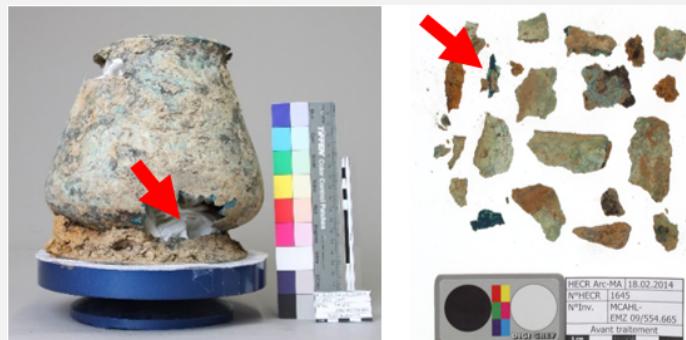
Fig. 2: Location of sampling area and sample selected from detached fragments,

The sample was cut from a detached fragment of the upper part of the main body of the situla in Fig. 2. The cross-section is representative of the entire thickness (0.5 mm) of the object's body where on the outside there is a thicker accumulation of corrosion including curly malachite clusters (Fig. 3). A metallic core is still present inside the corrosion products layers (Fig. 4).

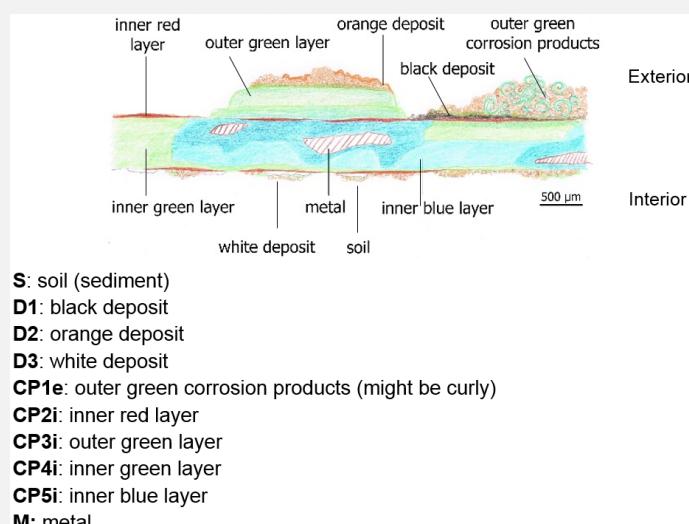
The schematic representation below gives an overview of the corrosion layers encountered on the situla from a first visual macroscopic observation (additional e and i within the coding correspond to strata in contact with the environment (e) and internal strata (i)).

Fig. 3: Stratigraphic representation of the situla in cross-section by macroscopic observation,

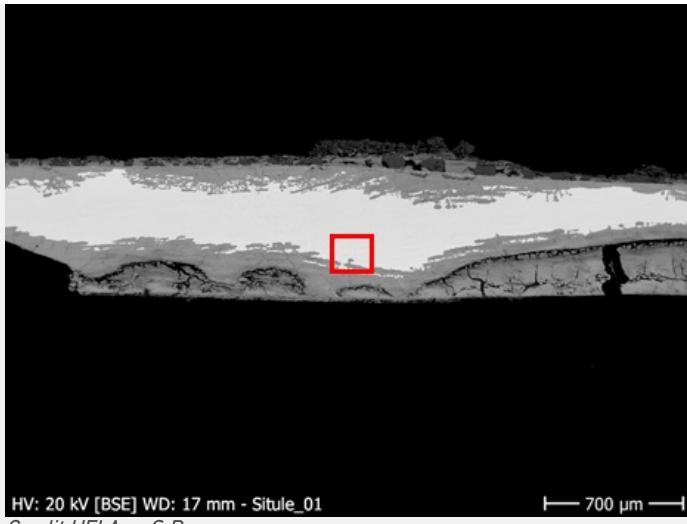
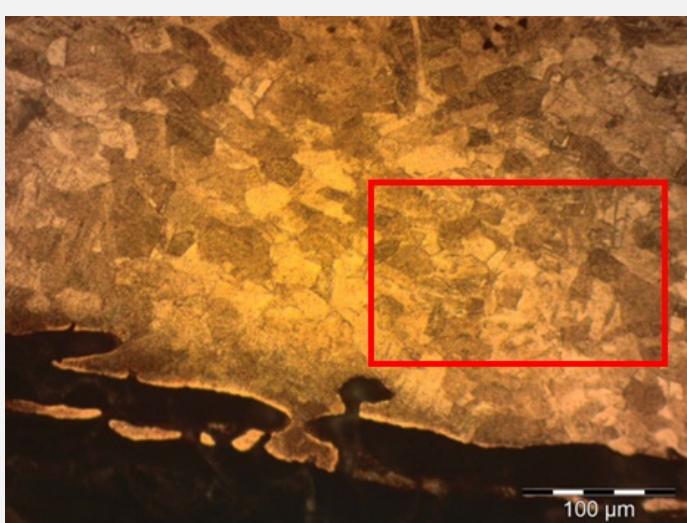
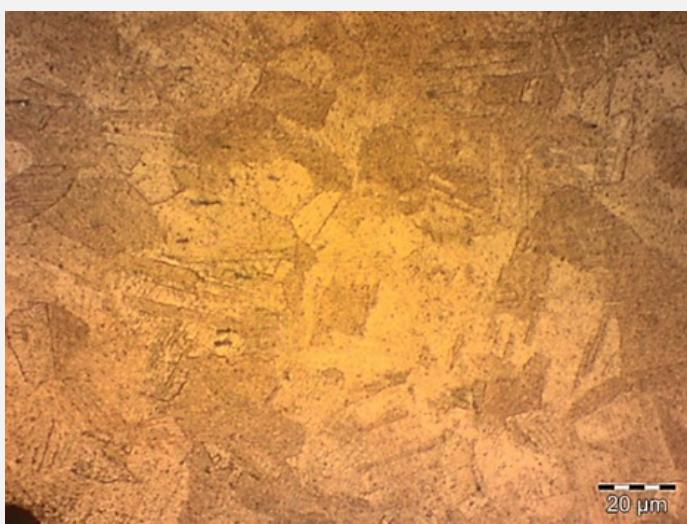
The remaining metal is a dense tin bronze (Fig. 7, Table 1), showing no inclusion. In bright field, the etched alloy shows a structure principally consisting of polygonal alpha phase grains (Fig. 8). Some of the grains include twin lines (Fig. 9). The presence of strain lines (slip lines) indicates a final cold work without annealing (Fig. 9).

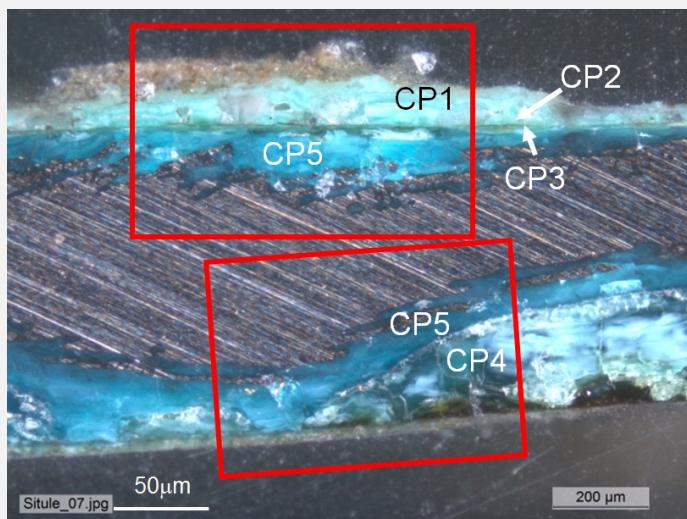
The corrosion crust is heterogeneous and has in places completely replaced the metal. The metal – corrosion products interface is irregular due to transgranular corrosion (Figs 7-8). In most cases, the corrosion crust can be divided in three main layers: an inner compact blue layer directly on the metal core (CP5, Figs. 6, 10 and 11 and CP3, Fig. 5). In areas of extensive corrosion this blue layer coexists with a friable green layer (CP4, Figs. 6, 10 and 11 and CP2, Fig. 5). Depending on the area either a very fine dark green (CP3, Fig. 6 and Fig. 10) or red corrosion layer (CP2, Fig. 6 and Fig. 10) marks the limit of the original surface. It is followed by an external fourth layer, consisting of friable and sometimes curly pale green corrosion products intermingled with soil products (CP1, Fig. 6 and Fig. 10 and 13). In heavily worked and fragile parts of the object a cleavage between the inner layers of blue and green corrosion is present, rendering the green corrosion vulnerable to loss (Fig. 11).

Table 2: Chemical composition of the corrosion crust from Fig. 10. SEM-EDS, Lab of Electronic Microscopy and Microanalysis, IMA (Néode) (+++: high concentration, ++ medium concentration, + low concentration, nd: not-detected).

Fig. 10: Micrograph of the metal sample from Fig. 4, unetched, dark field, 50x. Areas of Fig. 11 (bottom, corresponding to the stratigraphy of Fig. 5) and Figs. 12 and 13 (top, corresponding to the stratigraphy of Fig. 6) are marked by a rectangle. Codes are those of Fig. 6,

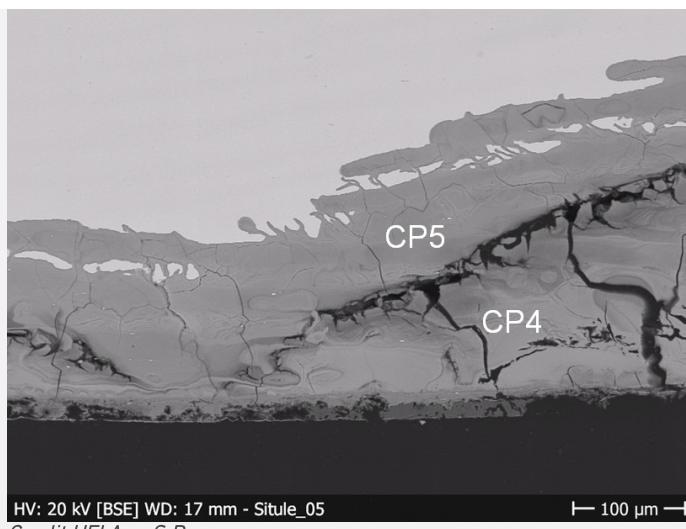
Fig. 11: SEM image, BSE-mode of the metal sample from Fig. 10 (detail) showing cleavage between the inner blue (CP5) and green (CP4) layers of Fig. 6,

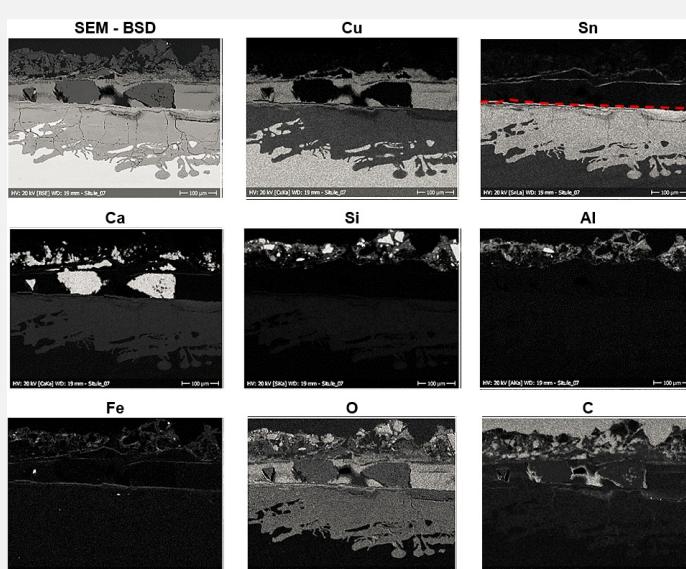
The inner layers (CP3-CP5) are Sn and O-rich and depleted in Cu (Table 2). The outer layers (CP1 and CP2) are Cu and O-rich, contain no Sn, and are contaminated with Ca, Si, Al and Fe coming from the soil (Fig. 12). The colour of the corrosion crust varies according to the content of Sn (the more Sn, the darker green or blue the corrosion). FTIR on the inner blue (CP5 and Fig. 14) and outer green (CP1 and Fig. 15) layers were difficult to interpret. Only malachite could be identified in both cases. XRD spectra could not be interpreted because of the deficiency of peaks.

Fig. 12: SEM image, SE-mode, and elemental chemical distribution of the selected area of Fig. 10. In red: the limit of the original surface highlighted by the enriched tin layer. Method of examination: SEM-EDS, Lab of Electronic Microscopy and Microanalysis, IMA (Néode), HEI Arc,

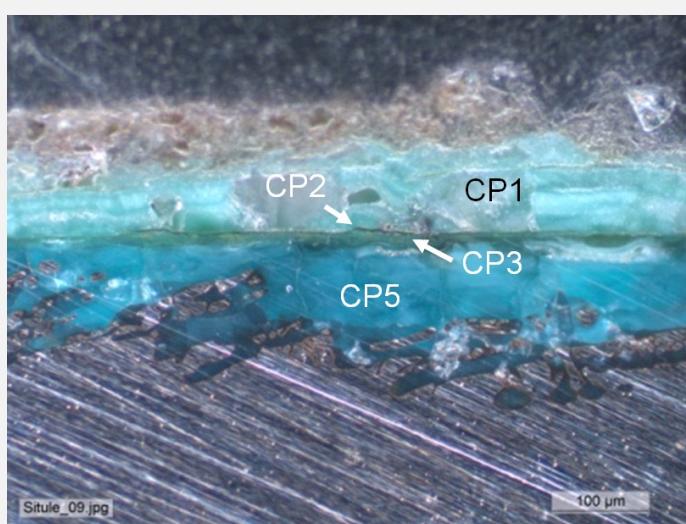
The limit of the original surface is well defined (interface of CP1 and CP2) but due to the fragility of the inner corrosion layers it was difficult to uncover.

Fig. 13: Micrograph of the metal/corrosion interface (detail of Fig. 10) unetched, dark field, 100x. The outer layer (CP1 of Fig. 6) incorporates soil material and the thin dark layer (CP2 of Fig. 6) highlights the limit of the original surface,

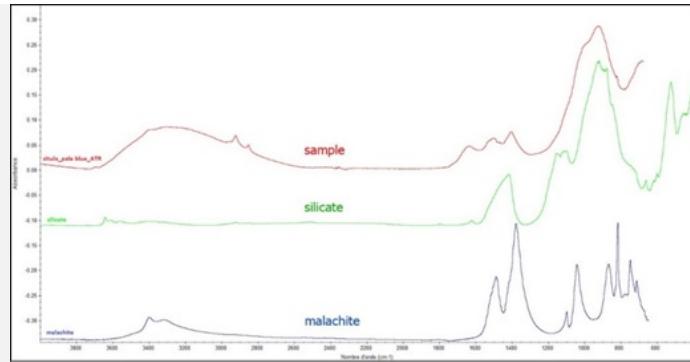
Fig. 14: FTIR spectrum (ATR mode) of the inner blue layer compared to the silicate and malachite standard spectrum. Method of analysis: FTIR spectroscopy, HE- Arc CR,

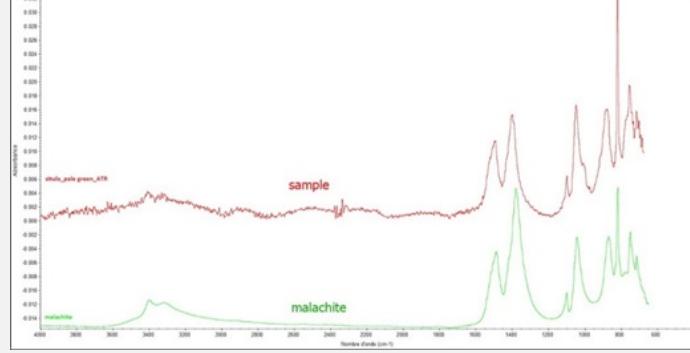
Fig. 15: FTIR spectrum (ATR mode) of the outer green layer compared to the malachite standard spectrum. Method of analysis: FTIR spectroscopy, HE-Arc CR.,

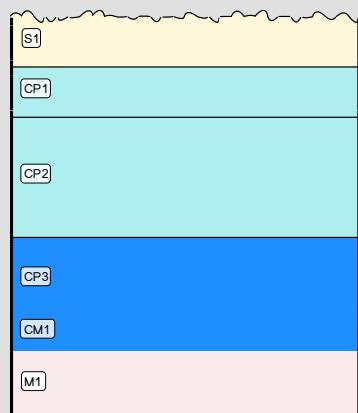
There are 2 stratigraphies (Fig. 5 corresponding to the interior face of the situla and Fig. 6 to its exterior face). The strata are similar in composition but their coding is different: CP1 to CP3 in Fig. 5 correspond to CP3 to CP5 in Fig. 6. Since the stratigraphy of Fig. 6 is more complete, the composition of each of its strata is given below.

Fig. 6: Stratigraphic representation of the object in cross-section using the MiCorr application. This representation shows the interior face and can be compared to Fig. 10 (top square).

Fig. 5: Stratigraphic representation of the object in cross-section using the MiCorr application. This representation shows the exterior face and can be compared to Fig. 10 (bottom square)

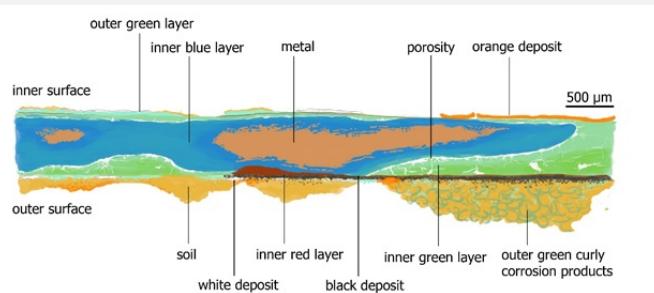
Fig. 16: Improved stratigraphic representation of the situla from visual observations and analyses,

Strata	Composition
Soil (S)	Ca, Si, Al, Fe
Black deposit (D1)	C
Orange deposit (D2)	Ferrous oxides
White deposit (D3)	Ca
Outer green curly corrosion product (CP1e)	Copper carbonates (curly malachite)
Inner red (CP2i)	Copper oxide (cuprite ?)
Outer green layer (CP3i)	Copper carbonates (malachite)
Inner green layer (CP4i)	Copper carbonates (?) + Sn
Inner blue layer (CP5i)	Copper carbonates (?) + Sn
Remnant metal phase (M)	Bronze (90%Cu, 10% Sn)
