SITULA EMT09-554.665 - TIN BRONZE - IRON AGE - SWITZERLAND

Artefact name Situla EMT09-554.665

Christian. Degrigny (HE-Arc CR, Neuchâtel, Neuchâtel, Switzerland) & Marie-Jeanne. Scholl (HE-Arc CR, Neuchâtel, **Authors**

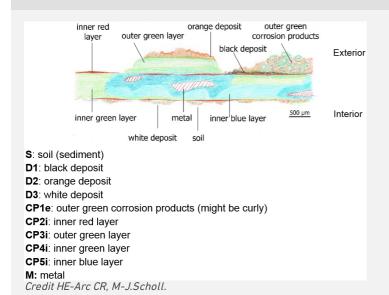
The schematic representation below gives an overview of the corrosion layers encountered on the situla from a first visual macroscopic observation (additional e and i within the coding correspond to strata in contact with the environment (e) and internal strata (i)).

Fig. 3: Stratigraphic representation of the situla in cross-section by macroscopic observation,

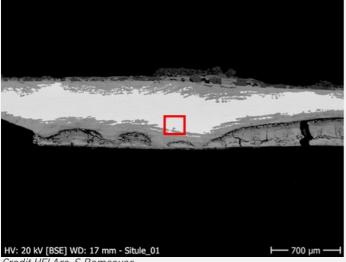
The remaining metal is a dense tin bronze (Fig. 7, Table 1), showing no inclusion. In bright field, the etched alloy shows a structure principally consisting of polygonal alpha phase grains (Fig. 8). Some of the grains include twin lines (Fig. 9). The presence of strain lines (slip lines) indicates a final cold work without annealing (Fig. 9).

> Fig. 7: SEM image, BSE-mode, of the metal sample from Fig. 4. Area of Fig. 8 is marked by a rectangle,

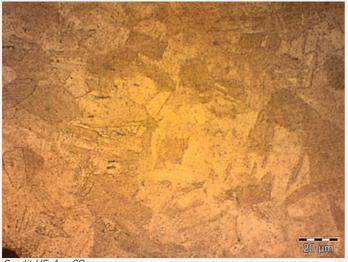
Fig. 9: Micrograph of the selected area of Fig. 8, etched, bright field, 500x. The grains show both twin and strain lines,

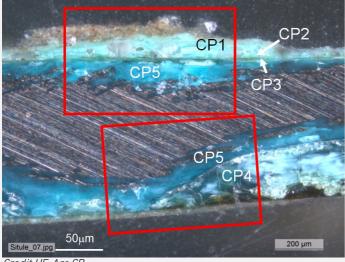
The corrosion crust is heterogeneous and has in places completely replaced the metal. The metal - corrosion products interface is irregular due to transgranular corrosion (Figs 7-8). In most cases, the corrosion crust can be divided in three main layers: an inner compact blue layer directly on the metal core (CP5, Figs. 6, 10 and 11 and CP3, Fig. 5). In areas of extensive corrosion this blue layer coexists with a friable green layer (CP4, Figs. 6, 10 and 11 and CP2, Fig. 5). Depending on the area either a very fine dark green (CP3, Fig. 6 and Fig. 10) or red corrosion layer (CP2, Fig. 6 and Fig. 10) marks the limit of the original surface. It is followed by an external fourth layer, consisting of friable and sometimes curly pale green corrosion products intermingled with soil products (CP1, Fig. 6 and Fig. 10 and 13). In heavily worked and fragile parts of the object a cleavage between the inner layers of blue and green corrosion is present, rendering the green corrosion vulnerable to loss (Fig. 11).

Fig. 10: Micrograph of the metal sample from Fig. 4, unetched, dark field, 50x. Areas of Fig. 11 (bottom, corresponding to the stratigraphy of Fig. 5) and Figs. 12 and 13 (top, corresponding to the stratigraphy of Fig. 6) are marked by a rectangle. Codes are those of Fig. 6,

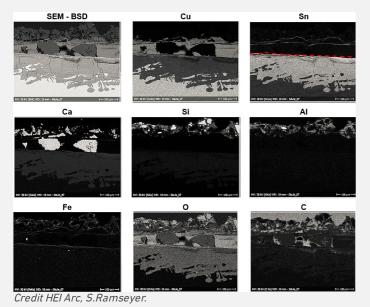
The inner layers (CP3-CP5) are Sn and O-rich and depleted in Cu (Table 2). The outer layers (CP1 and CP2) are Cu and O-rich, contain no Sn, and are contaminated with Ca, Si, Al and Fe coming from the soil (Fig. 12). The colour of the corrosion crust varies according to the content of Sn (the more Sn, the darker green or blue the corrosion). FTIR on the inner blue (CP5 and Fig. 14) and outer green (CP1 and Fig. 15) layers were difficult to interpret. Only malachite could be identified in both cases. XRD spectra could not be interpreted because of the deficiency of peaks.

The limit of the original surface is well defined (interface of CP1 and CP2) but due to the fragility of the inner corrosion layers it was difficult to uncover.

Fig. 12: SEM image, SE-mode, and elemental chemical distribution of the selected area of Fig. 10. In red: the limit of the original surface highlighted by the enriched tin layer. Method of examination: SEM-EDS, Lab of Electronic Microscopy and Microanalysis, IMA (Néode), HEI Arc,

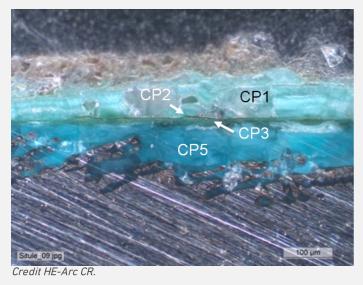
Fig. 13: Micrograph of the metal/corrosion interface (detail of Fig. 10) unetched, dark field, 100x. The outer layer (CP1 of Fig, 6) incorporates soil material and the thin dark layer (CP2 of Fig, 6) highlights the limit of the original surface,
