SITULA EMT09-554.665 – TIN BRONZE – IRON AGE – SWITZERLAND

Artefact name	Situla EMT09-554.665
Authors	Christian. Degrigny (HE-Arc CR, Neuchâtel, Neuchâtel, Switzerland) & Marie-Jeanne. Scholl (HE-Arc CR, Neuchâtel, Neuchâtel, Switzerland) & Valentin. Boissonnas (HE-Arc CR, Neuchâtel, Neuchâtel, Switzerland)
Url	/artefacts/340/

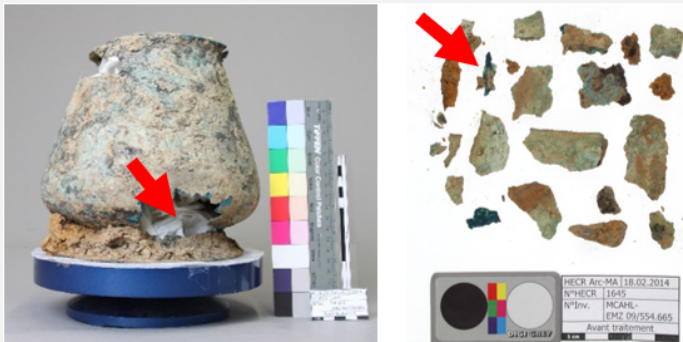
Fig. 2: Location of sampling area and sample selected from detached fragments,

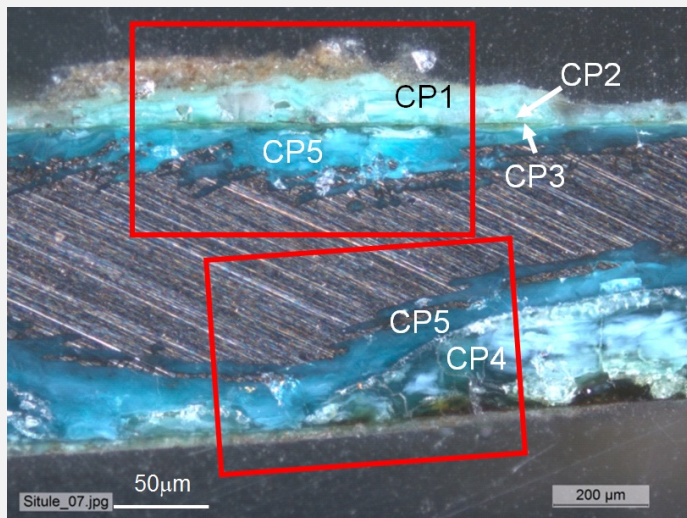
Table 2: Chemical composition of the corrosion crust from Fig. 10. SEM-EDS, Lab of Electronic Microscopy and Microanalysis, IMA (Néode) (+++: high concentration, ++ medium concentration, + low concentration, nd: not-detected).

Fig. 10: Micrograph of the metal sample from Fig. 4, unetched, dark field, 50x. Areas of Fig. 11 (bottom, corresponding to the stratigraphy of Fig. 5) and Figs. 12 and 13 (top, corresponding to the stratigraphy of Fig. 6) are marked by a rectangle. Codes are those of Fig. 6.

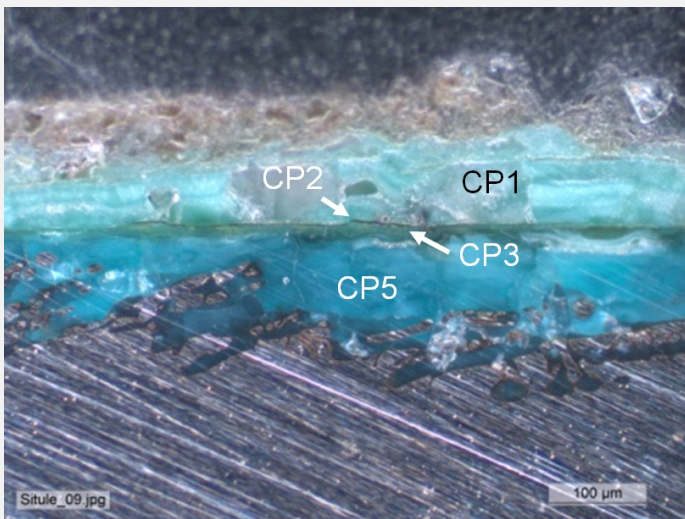
The limit of the original surface is well defined (interface of CP1 and CP2) but due to the fragility of the inner corrosion layers it was difficult to uncover.

Fig. 13: Micrograph of the metal/corrosion interface (detail of Fig. 10) unetched, dark field, 100x. The outer layer (CP1 of Fig. 6) incorporates soil material and the thin dark layer (CP2 of Fig. 6) highlights the limit of the original surface,
