SITULA EMT09-554.665 – TIN BRONZE – IRON AGE – SWITZERLAND

Artefact name	Situla EMT09-554.665
Authors	Christian. Degriigny (HE-Arc CR, Neuchâtel, Neuchâtel, Switzerland) & Marie-Jeanne. Scholl (HE-Arc CR, Neuchâtel, Neuchâtel, Switzerland) & Valentin. Boissonnas (HE-Arc CR, Neuchâtel, Neuchâtel, Switzerland)
Url	/artefacts/340/

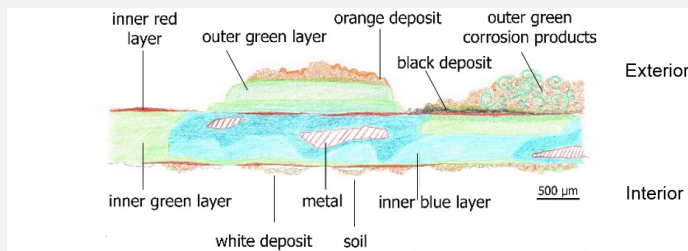
Fig. 3: Stratigraphic representation of the situla in cross-section by macroscopic observation,

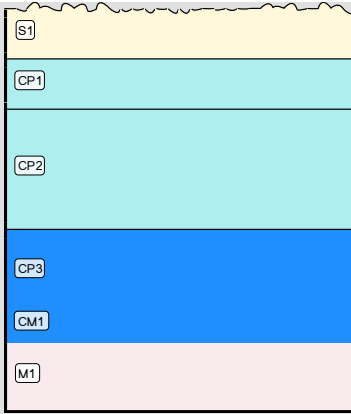
Fig. 5: Stratigraphic representation of the object in cross-section using the MiCorr application. This representation shows the exterior face and can be compared to Fig. 10 (bottom square)
