SITULA EMT09/554.665 – TIN BRONZE – IRON AGE – SWITZERLAND

Artefact name	Situla EMT09/554.665
Authors	Christian. Degriigny (HE-Arc CR, Neuchâtel, Neuchâtel, Switzerland) & Marie-Jeanne. Scholl (HE-Arc CR, Neuchâtel, Neuchâtel, Switzerland) & Valentin. Boissonnas (HE-Arc CR, Neuchâtel, Neuchâtel, Switzerland)
Url	/artefacts/340/

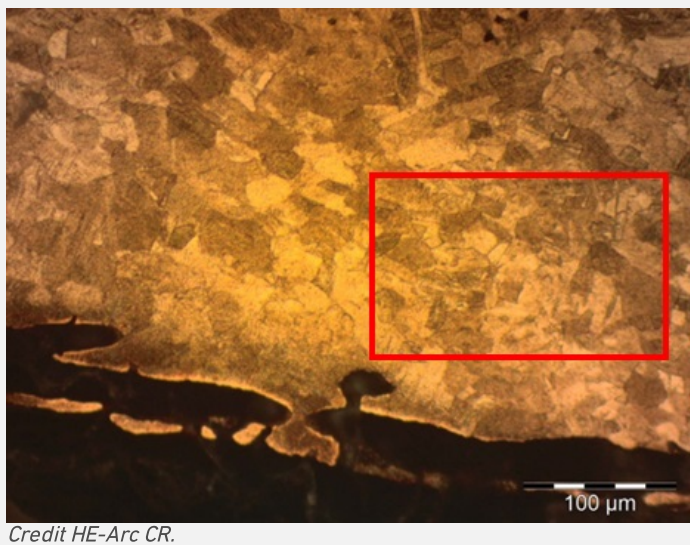
The remaining metal is a dense tin bronze (Fig. 7, Table 1), showing no inclusion. In bright field, the etched alloy shows a structure principally consisting of polygonal alpha phase grains (Fig. 8). Some of the grains include twin lines (Fig. 9). The presence of strain lines (slip lines) indicates a final cold work without annealing (Fig. 9).

Fig. 9: Micrograph of the selected area of Fig. 8, etched, bright field, 500x. The grains show both twin and strain lines,
