SITULA EMT09-554.665 – TIN BRONZE – IRON AGE – SWITZERLAND

Artefact name	Situla EMT09-554.665
Authors	Christian. Degrigny (HE-Arc CR, Neuchâtel, Neuchâtel, Switzerland) & Marie-Jeanne. Scholl (HE-Arc CR, Neuchâtel, Neuchâtel, Switzerland) & Valentin. Boissonnas (HE-Arc CR, Neuchâtel, Neuchâtel, Switzerland)
Url	/artefacts/340/

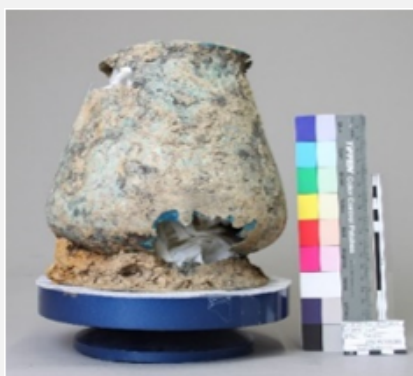
Fig. 1: Tin bronze Celtic situla (Archeodunum (Gollion), 2009) inverted as found in situ,

Description of the artefact	Copper alloy situla (Fig. 1). Attached to two riveted iron loops is an iron handle terminating in two swan heads (not shown here). Dimensions of the main body: Hmax = 340mm, Ømax = 220mm.
Type of artefact	Situla
Origin	Mormont sanctuary, La Sarraz, Vaud, Switzerland
Recovering date	Excavated in 2011
Chronology category	Iron Age
chronology tpq	<input type="text" value="140"/> B.C. ▾
chronology taq	<input type="text" value="30"/> B.C. ▾
Chronology comment	La Tène D (140BC _ 30BC)
Burial conditions / environment	Soil
Artefact location	Musée cantonal d'archéologie et d'histoire, Lausanne, Vaud
Owner	Musée cantonal d'archéologie et d'histoire, Lausanne, Vaud
Inv. number	EMT09/554.665

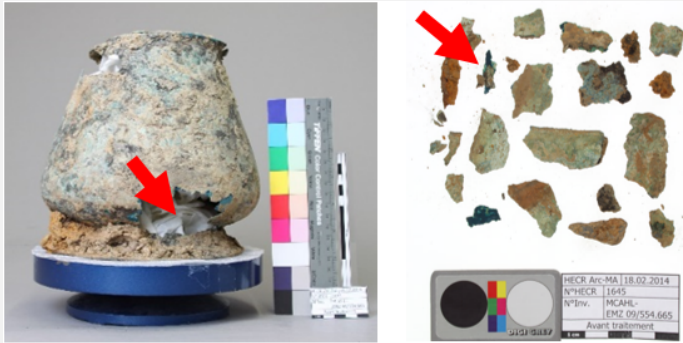
Fig. 2: Location of sampling area and sample selected from detached fragments,

Description of sample	The sample was cut from a detached fragment of the upper part of the main body of the situla in Fig. 2. The cross-section is representative of the entire thickness (0.5 mm) of the object's body where on the outside there is a thicker accumulation of corrosion including curly malachite clusters (Fig. 3). A metallic core is still present inside the corrosion products layers (Fig. 4).
Alloy	Tin Bronze
Technology	Cold worked (hammering on a counter-mould), annealed but no final annealing
Lab number of sample	None
Sample location	HE-Arc CR, Neuchâtel, Neuchâtel
Responsible institution	Musée cantonal d'archéologie et d'histoire, Lausanne, Vaud
Date and aim of sampling	2014, metallography and chemical analyses (FTIR, SEM-EDS)

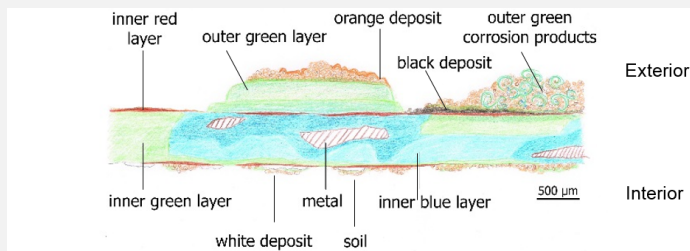
Fig. 3: Stratigraphic representation of the situla in cross-section by macroscopic observation,

- S:** soil (sediment)
- D1:** black deposit
- D2:** orange deposit
- D3:** white deposit
- CP1e:** outer green corrosion products (might be curly)
- CP2i:** inner red layer
- CP3i:** outer green layer
- CP4i:** inner green layer
- CP5i:** inner blue layer
- M:** metal

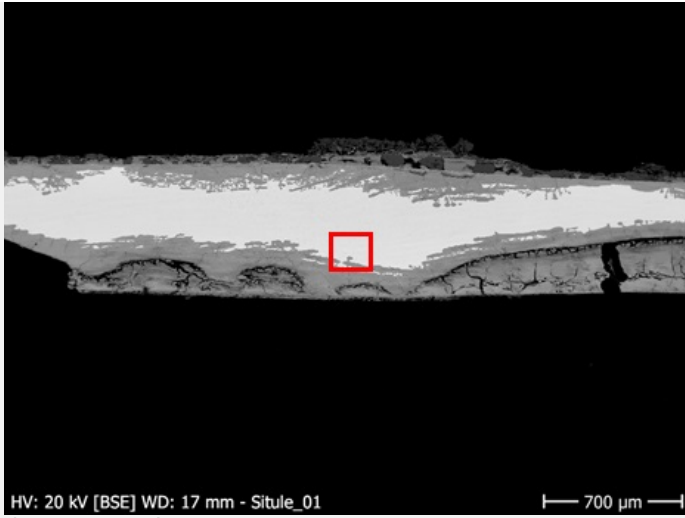
The remaining metal is a dense tin bronze (Fig. 7, Table 1), showing no inclusion. In bright field, the etched alloy shows a structure principally consisting of polygonal alpha phase grains (Fig. 8). Some of the grains include twin lines (Fig. 9). The presence of strain lines (slip lines) indicates a final cold work without annealing (Fig. 9).

Fig. 7: SEM image, BSE-mode, of the metal sample from Fig. 4. Area of Fig. 8 is marked by a rectangle,

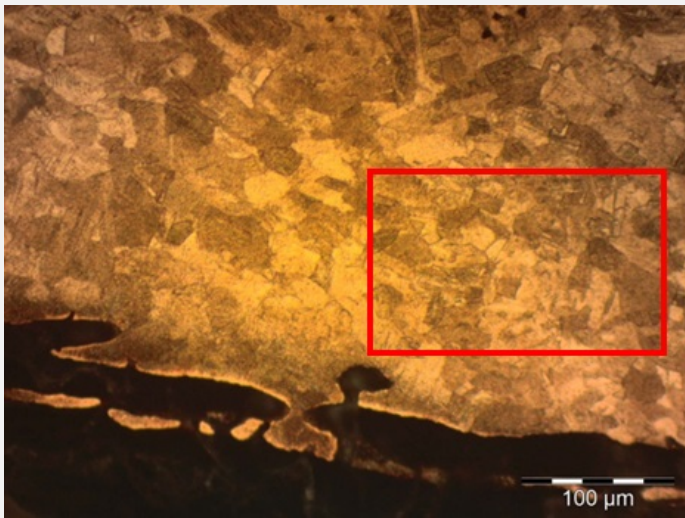
Fig. 8: Micrograph of the etched metal structure from Fig. 7 (detail), etched, bright field, 50x. The alpha phase of the alloy shows polygonal grains. Area of Fig. 9 is marked by a rectangle,

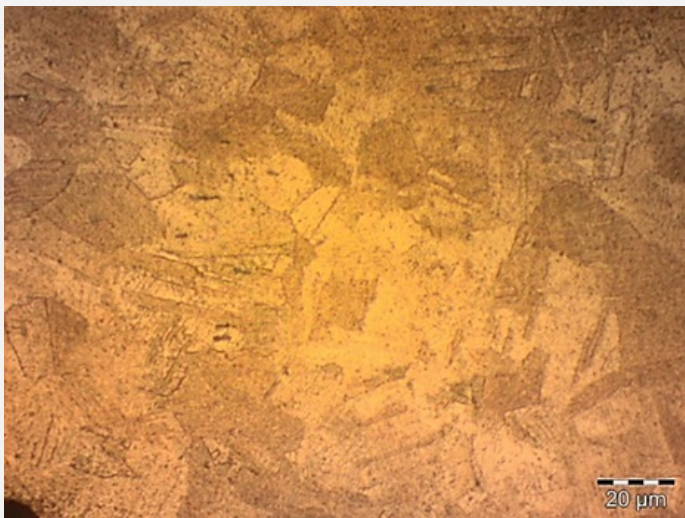
Fig. 9: Micrograph of the selected area of Fig. 8, etched, bright field, 500x. The grains show both twin and strain lines,

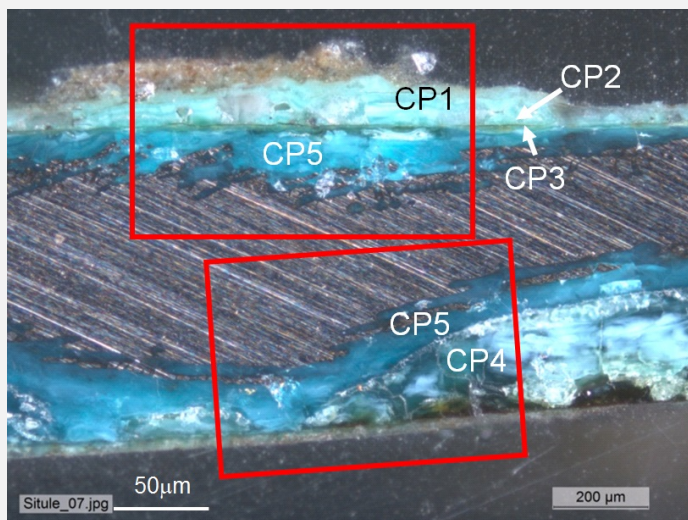
The corrosion crust is heterogeneous and has in places completely replaced the metal. The metal – corrosion products interface is irregular due to transgranular corrosion (Figs 7-8). In most cases, the corrosion crust can be divided in three main layers: an inner compact blue layer directly on the metal core (CP5, Figs. 6, 10 and 11 and CP3, Fig. 5). In areas of extensive corrosion this blue layer coexists with a friable green layer (CP4, Figs. 6, 10 and 11 and CP2, Fig. 5). Depending on the area either a very fine dark green (CP3, Fig. 6 and Fig. 10) or red corrosion layer (CP2, Fig. 6 and Fig. 10) marks the limit of the original surface. It is followed by an external fourth layer, consisting of friable and sometimes curly pale green corrosion products intermingled with soil products (CP1, Fig. 6 and Fig. 10 and 13). In heavily worked and fragile parts of the object a cleavage between the inner layers of blue and green corrosion is present, rendering the green corrosion vulnerable to loss (Fig. 11).

Fig. 10: Micrograph of the metal sample from Fig. 4, unetched, dark field, 50x. Areas of Fig. 11 (bottom, corresponding to the stratigraphy of Fig. 5) and Figs. 12 and 13 (top, corresponding to the stratigraphy of Fig. 6) are marked by a rectangle. Codes are those of Fig. 6.

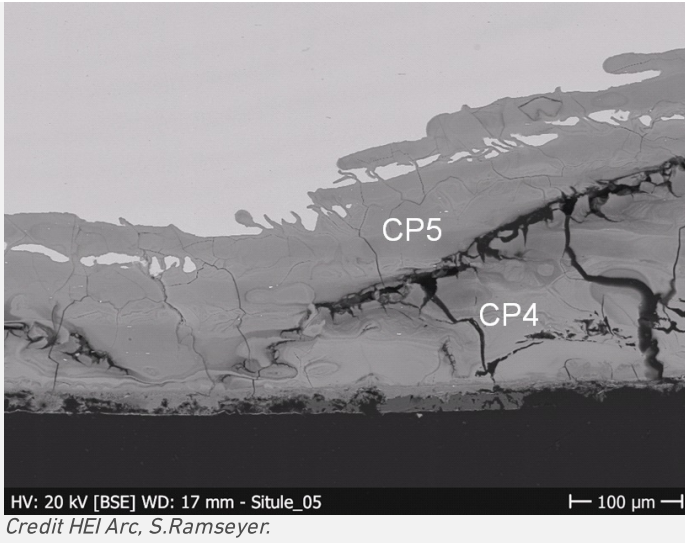
Fig. 11: SEM image, BSE-mode of the metal sample from Fig. 10 (detail) showing cleavage between the inner blue (CP5) and green (CP4) layers of Fig. 6,

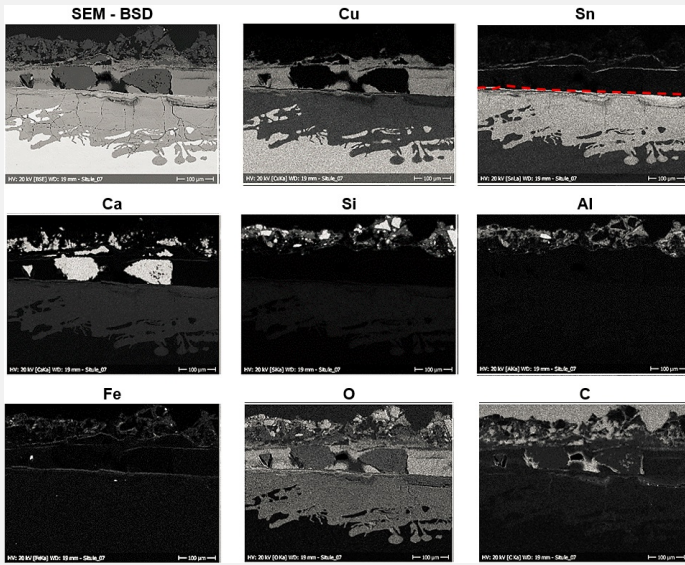
The inner layers (CP3-CP5) are Sn and O-rich and depleted in Cu (Table 2). The outer layers (CP1 and CP2) are Cu and O-rich, contain no Sn, and are contaminated with Ca, Si, Al and Fe coming from the soil (Fig. 12). The colour of the corrosion crust varies according to the content of Sn (the more Sn, the darker green or blue the corrosion). FTIR on the inner blue (CP5 and Fig. 14) and outer green (CP1 and Fig. 15) layers were difficult to interpret. Only malachite could be identified in both cases. XRD spectra could not be interpreted because of the deficiency of peaks.

Fig. 12: SEM image, SE-mode, and elemental chemical distribution of the selected area of Fig. 10. In red: the limit of the original surface highlighted by the enriched tin layer. Method of examination: SEM-EDS, Lab of Electronic Microscopy and Microanalysis, IMA (Néode), HEI Arc,

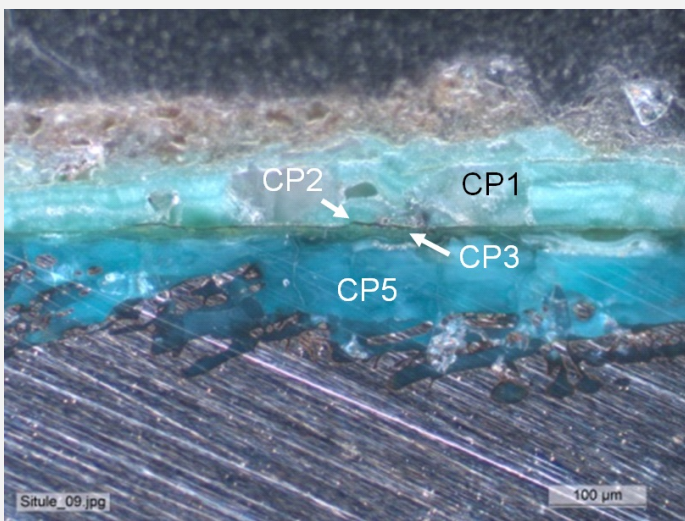
The limit of the original surface is well defined (interface of CP1 and CP2) but due to the fragility of the inner corrosion layers it was difficult to uncover.

Fig. 13: Micrograph of the metal/corrosion interface (detail of Fig. 10) unetched, dark field, 100x. The outer layer (CP1 of Fig. 6) incorporates soil material and the thin dark layer (CP2 of Fig. 6) highlights the limit of the original surface,

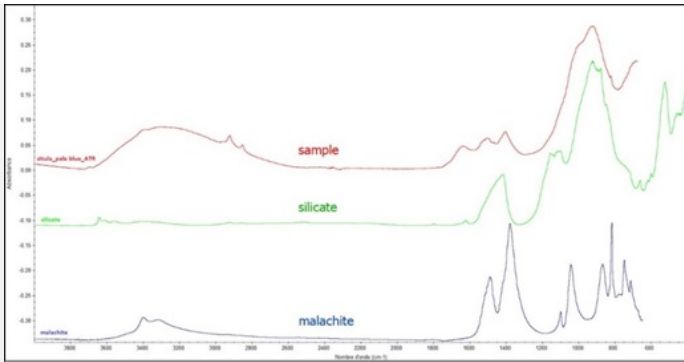
Fig. 14: FTIR spectrum (ATR mode) of the inner blue layer compared to the silicate and malachite standard spectrum. Method of analysis: FTIR spectroscopy, HE- Arc CR,

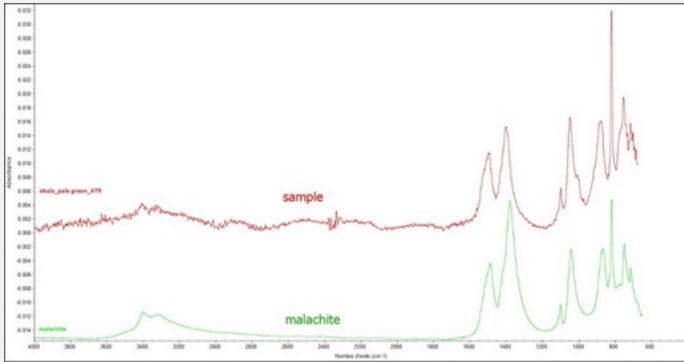
Fig. 15: FTIR spectrum (ATR mode) of the outer green layer compared to the malachite standard spectrum. Method of analysis: FTIR spectroscopy, HE-Arc CR.,

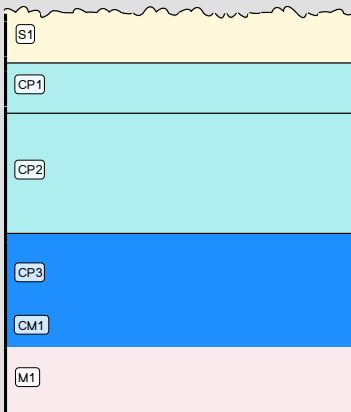
There are 2 stratigraphies (Fig. 5 corresponding to the interior face of the situla and Fig. 6 to its exterior face). The strata are similar in composition but their coding is different: CP1 to CP3 in Fig. 5 correspond to CP3 to CP5 in Fig. 6. Since the stratigraphy of Fig. 6 is more complete, the composition of each of its strata is given below.

Fig. 6: Stratigraphic representation of the object in cross-section using the MiCorr application. This representation shows the interior face and can be compared to Fig. 10 (top square).

Fig. 5: Stratigraphic representation of the object in cross-section using the MiCorr application. This representation shows the exterior face and can be compared to Fig. 10 (bottom square)

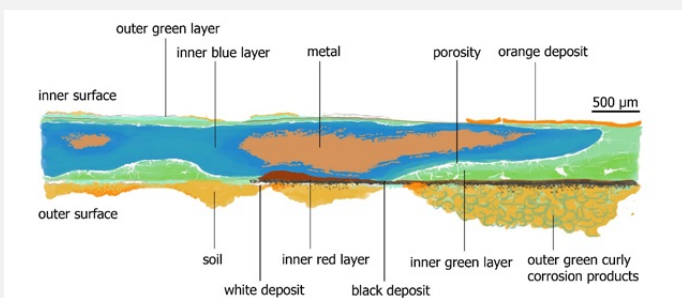
Fig. 16: Improved stratigraphic representation of the situla from visual observations and analyses,

Strata	Composition
Soil (S)	Ca, Si, Al, Fe
Black deposit (D1)	C
Orange deposit (D2)	Ferrous oxides
White deposit (D3)	Ca
Outer green curly corrosion product (CP1e)	Copper carbonates (curly malachite)
Inner red (CP2i)	Copper oxide (cuprite ?)
Outer green layer (CP3i)	Copper carbonates (malachite)
Inner green layer (CP4i)	Copper carbonates (?) + Sn
Inner blue layer (CP5i)	Copper carbonates (?) + Sn
Remnant metal phase (M)	Bronze (90%Cu, 10% Sn)
