# FUNERAL MASK IVC 11595 – CU/AG, WITH SURFACE ENRICHMENT (AG)

**Artefact name** Funeral mask Ivc 11595

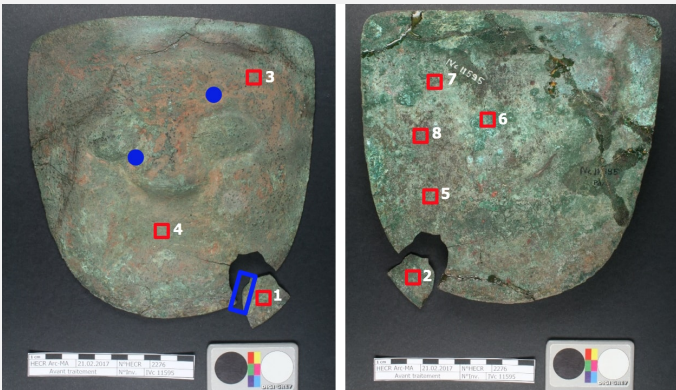
Fig. 2: Location of XRF analyses (red squares), cross-section area (blue square) and sampling areas for SEM-EDS (blue points),

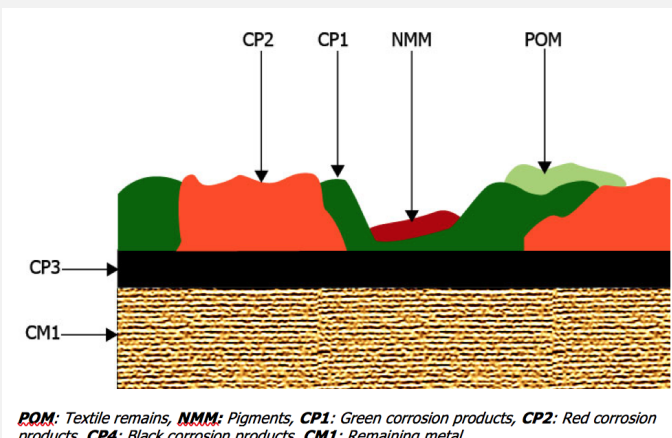
**POM:** Textile remains, **NMM:** Pigments, **CP1:** Green corrosion products, **CP2:** Red corrosion products, **CP4:** Black corrosion products, **CM1:** Remaining metal  
Credit HE-Arc CR, N. Gutknecht.

Fig. 3a: Stratigraphic representation of the artefact in cross-section by macroscopic observation, face of the object,

Fig. 3b: Stratigraphic representation of the artefact in cross-section by macroscopic observation, back of the object,

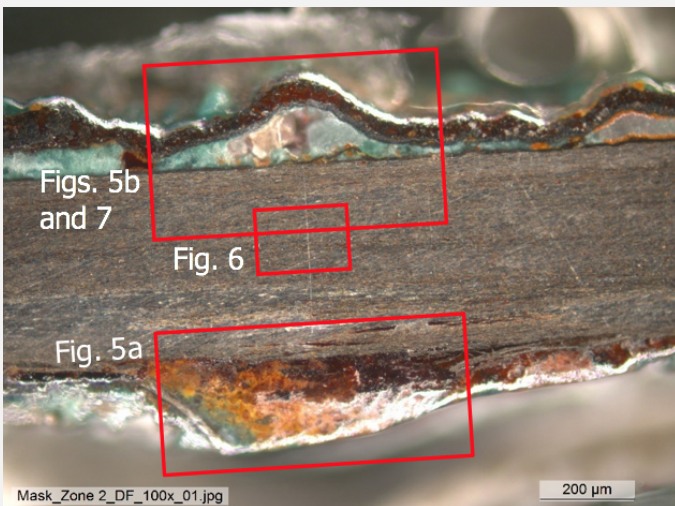
Fig. 4: Micrograph of the cross-section showing the locations of Figs. 5a (corresponding to the front of the object), Fig. 5b (back of the object), Figs. 6 and 7,

A polished section was made from an already detached fragment that was temporarily embedded in resin (Fig. 2). On Fig. 4 the upper part of the sample corresponds to the exterior (front) face of the object. Both sides have developed subsequent layers of corrosion. In areas, these have buckled and become detached.

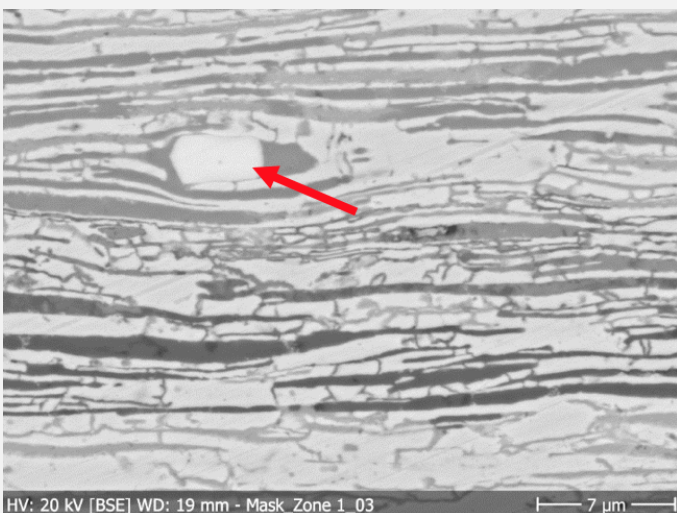
The XRF analysis is a surface analysis that was done without any removal of the copper corrosion products. The proportions are given for the oxide on the surface. The SEM/EDS analysis shows that there are Cu-rich phases alternating with Ag-rich phases. There are inclusions of Pb and As (Fig. 6). Cl has been detected throughout the entire corroded metal, most likely in the form of Cu and Ag corrosion products.

Fig. 6: SEM image (BSE-mode) of a selected area in the middle of the cross-section from Fig. 4 (detail), the elongated grains are the result of repeated hammering. Absence of strain lines indicates that the metal is annealed. The darker areas are Cu-rich phases and the lighter areas are Ag-rich phases. The arrow shows an As- and Pb inclusion,

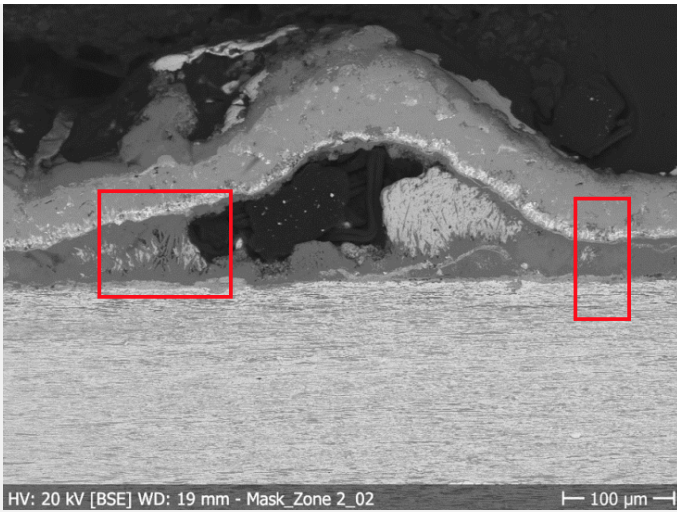
A layer of mercury can be seen with EDS (Figs. 7 and 8). Mercury was not used by the pre-Columbians in metallic form (Scott, D. (2000) and McEwan, C (ed.) (2000)) but was common as a pigment in form of mercury sulfide (cinnabar).

Fig. 8: SEM image of a partially refilled structural void with a silver-, copper- and mercury-rich layer (red arrow),

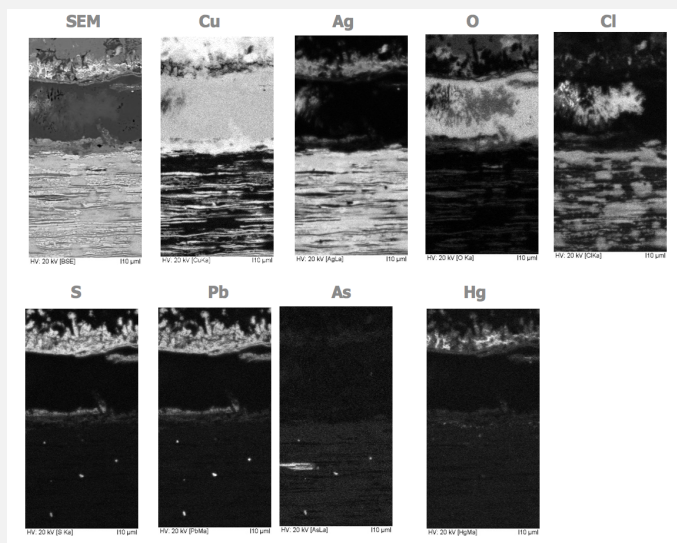
The remaining metal shows a preferential corrosion of copper and a presence of chlorides (Fig. 9, Table 1). There is a preferential corrosion of copper that has fragilized the structure of the sheet metal.

Fig. 9: SEM image (BSE-mode) and elemental chemical distribution of the selected area on Fig. 7. Method of examination: SEM/EDS,

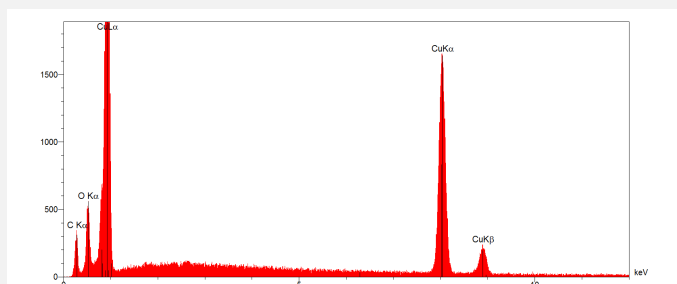
The silver enriched surface is entirely covered with copper corrosion products. The outer green layer (CP1) is a copper carbonate (Fig. 12, Table 1), while the red layers (CP2 in Fig. 5a ; CP4 and CP5 in Fig. 5b) are consisting of a copper oxide, most likely cuprite (Fig. 10). Below the cuprite and above the silver enriched surface on the front face a thin black layer is present (appears grey under polarized light). SEM-EDS analysis shows that in that stratum the mercury of the pigment (Fig. 14) has been transformed into a mercury-silver compound (Figs. 8 and 11a and b) which according to Raman spectrometry (Fig. 15) is not cinnabar anymore. In areas this silver- and mercury-rich surface has been pulled off by raising the corrosion layers, leaving structural voids that were subsequently filled by secondary corrosion products, most likely copper carbonates (Figs. 7 and 8)

Fig. 10: EDS analysis of the red corrosion layer (Fig. 4). Method of analysis: SEM-EDS, Lab of Electronic Microscopy and Microanalysis, IMA (Néode), HEI Arc,

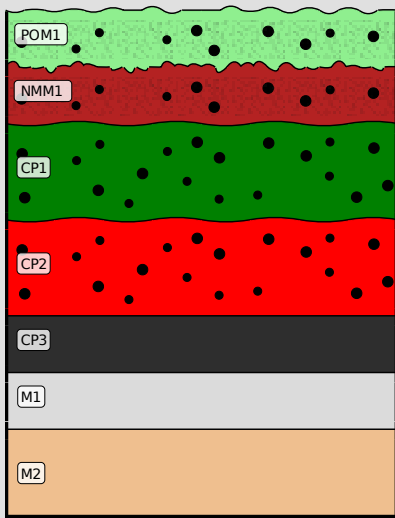
Fig. 5a: Schematic interpretation of the cross-section from 3a (front of the object), Credit HE-Arc CR, N. Gutknecht.

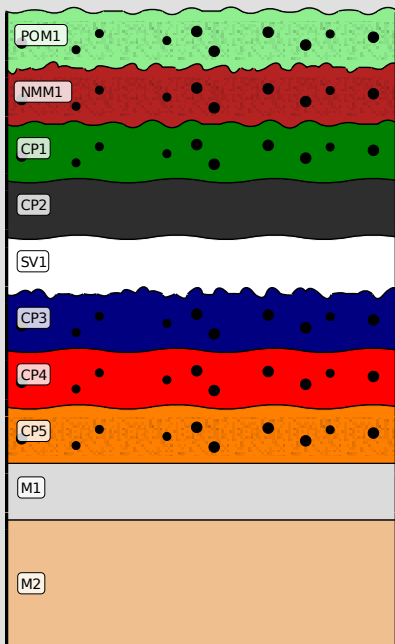
Fig. 5b: Schematic interpretation of the cross-section from 3b (back of the object), Credit HE-Arc CR, N. Gutknecht.

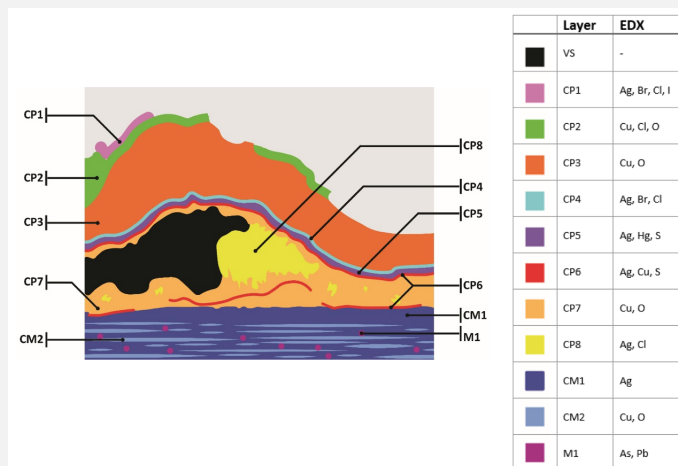
Fig. 16: Stratigraphic representation of Fig. 7 based on the results from the SEM-EDS analysis,
