FUNERAL MASK IVC 11595 – CU/AG, WITH SURFACE ENRICHMENT (AG)

Artefact name Funeral mask Ivc 11595

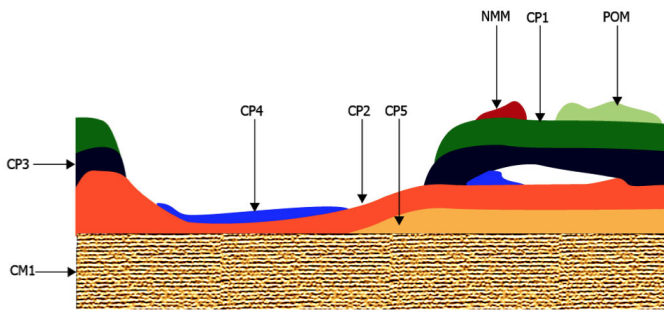
Fig. 3b: Stratigraphic representation of the artefact in cross-section by macroscopic observation, back of the object,

POM: Textile remains, **NMM:** Pigments, **CP1:** Green corrosion products, **CP2:** Red/orange corrosion products, **CP3:** Black corrosion product, **CP4:** blue corrosion product, **CP5:** Orange corrosion, **CM1:** Remaining metal
 Credit HE-Arc CR, N. Gutknecht

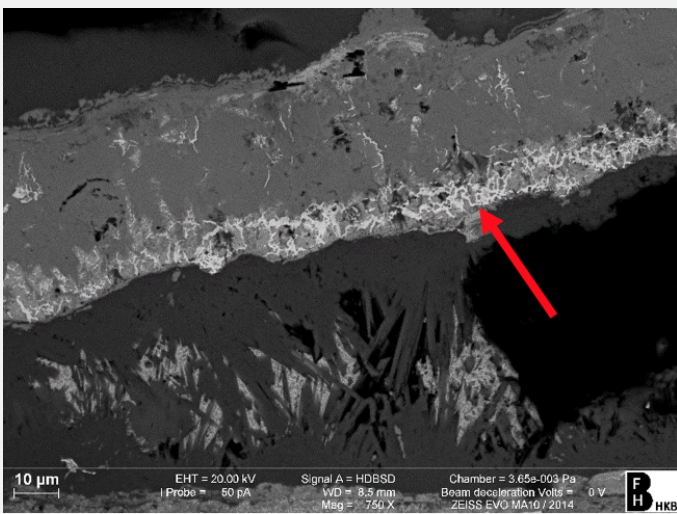
A layer of mercury can be seen with EDS (Figs. 7 and 8). Mercury was not used by the pre-Columbians in metallic form (Scott, D. (2000) and McEwan, C (ed.) (2000)) but was common as a pigment in form of mercury sulfide (cinnabar).

Fig. 8: SEM image of a partially refilled structural void with a silver-, copper- and mercury-rich layer (red arrow),

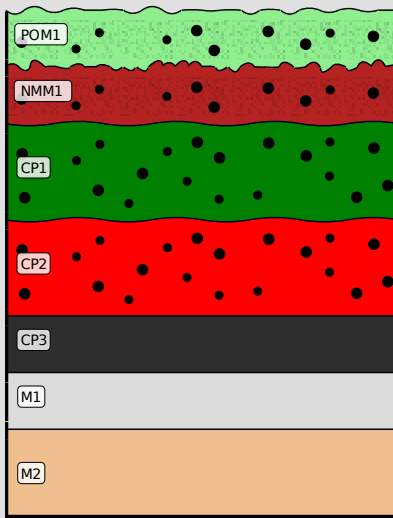
Fig. 5a: Schematic interpretation of the cross-section from 3a (front of the object), Credit HE-Arc CR, N. Gutknecht.

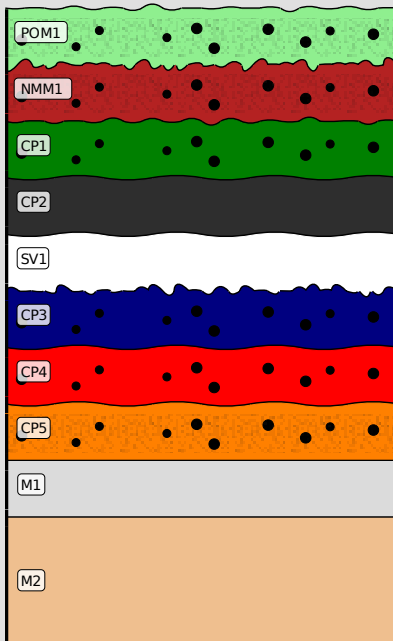
Fig. 5b: Schematic interpretation of the cross-section from 3b (back of the object), Credit HE-Arc CR, N. Gutknecht.
