# FUNERAL MASK IVC 11595 – CU/AG, WITH SURFACE ENRICHMENT (AG)

**Artefact name** Funeral mask Ivc 11595

Peru, north coast

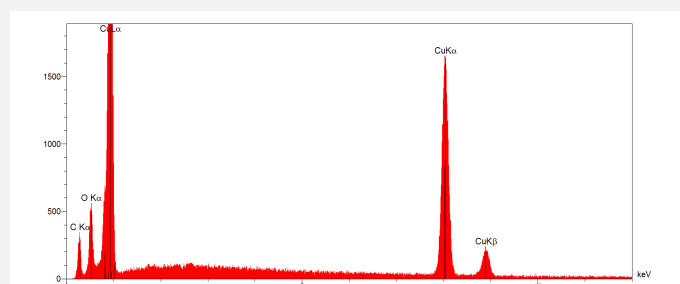
Fig. 10: EDS analysis of the red corrosion layer (Fig. 4). Method of analysis: SEM-EDS, Lab of Electronic Microscopy and Microanalysis, IMA (Néode), HEI Arc,

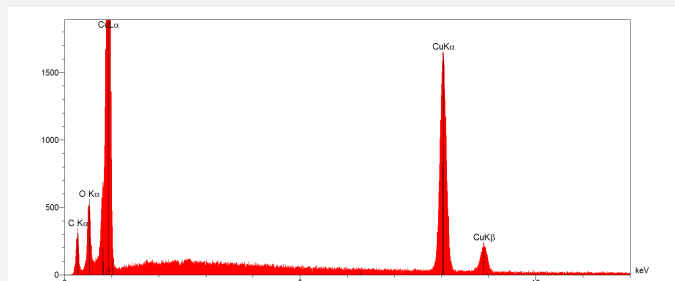
Fig. 12: EDS analysis of the green corrosion layer that has filled the structural void (Fig. 4). Method of analysis: SEM-EDS, Lab of Electronic Microscopy and Microanalysis, IMA (Néode), HEI Arc,

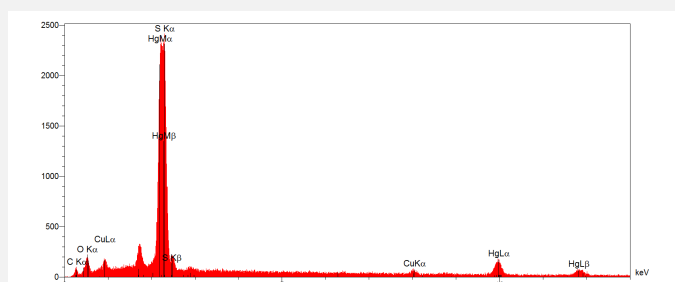
Fig. 13: EDS analysis of the red surface pigment from a surface sample. Method of analysis: SEM-EDS, Lab of Electronic Microscopy and Microanalysis, IMA (Néode), HEI Arc,

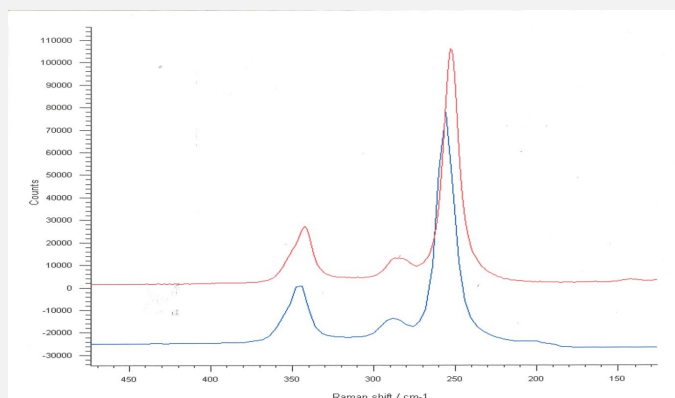
The silver sulphide (HgS, cinnabar, Fig. 14), present as a red pigment on the silver surface, could have been reduced through an electrochemical process in the presence of chlorides (Keune, K. (2005)). The released sulfur recombined with the silver to form black silver sulphide. Above that layer a porous mercury- and silver rich stratum has formed (see Hg & Ag on cartography Fig. 9). It remains unclear if the limitos is located in the silver enriched surface or within this silver-mercury compound (Fig. 8).

Fig. 14: Raman analysis of the red pigment on the surface (red line) and the references for cinnabar (blue line). Method of analysis: Raman spectroscopy, HKB,

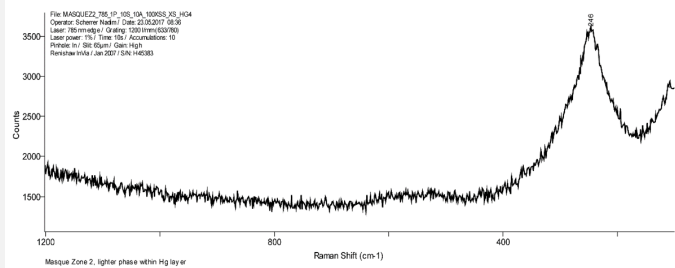
Fig. 15: Raman analysis of the mercury compounds from the cross section. Method of analysis: Raman spectroscopy, HKB,

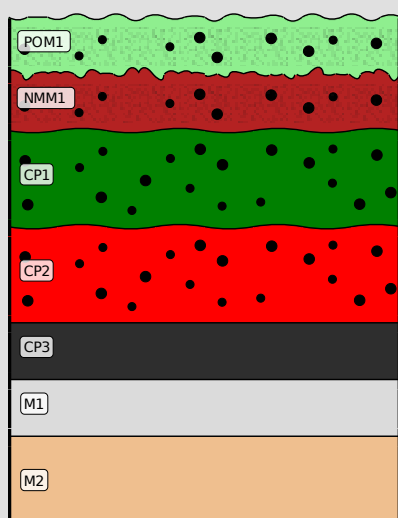
Fig. 5a: Schematic interpretation of the cross-section from 3a (front of the object), Credit HE-Arc CR, N. Gutknecht.

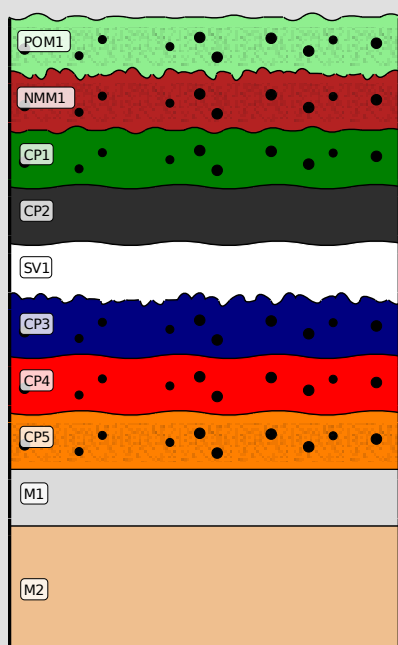
Fig. 5b: Schematic interpretation of the cross-section from 3b (back of the object), Credit HE-Arc CR, N. Gutknecht.

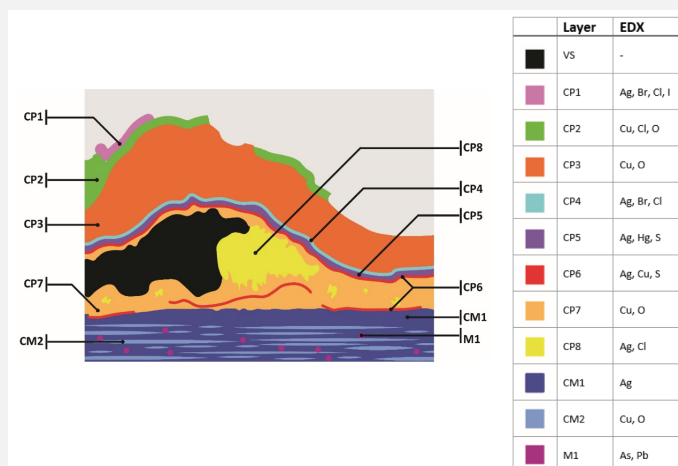
Fig. 16: Stratigraphic representation of Fig. 7 based on the results from the SEM-EDS analysis,
