# CORRODED METAL SHEET FN 655.13.01 - FE ALLOY - MODERN TIMES - SWITZERLAND

**Artefact name** Corroded metal sheet FN 655.13.01

**Authors** Marianne. Senn (EMPA, Dübendorf, Zurich, Switzerland) & Christian. Degrigny (HE-Arc CR, Neuchâtel, Neuchâtel, Switzerland)

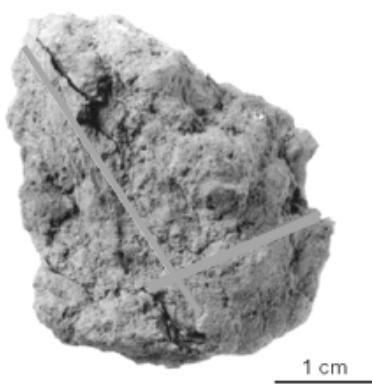
Fig. 1: Iron (and steel) sheet (after Senn Bischofberger 2005, 137),

**Description of the artefact** Iron sheet with middle rib. The shape is no longer discernible (Fig. 1). The metal is covered by a thick corrosion crust. Dimensions: L = 4.5cm; WT = 35g.

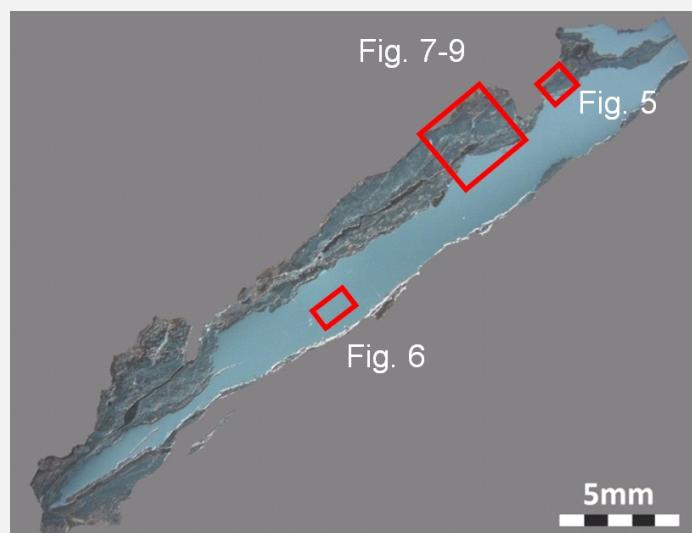
Fig. 3: Micrograph of the cross-section showing the location of Figs. 5 to 9,

A longitudinal cut has been made through the sheet (Fig. 2). Large parts of the corrosion crust fell off during sampling (Fig. 3).

The corrosion is massive and large parts of the outer corrosion layers have been lost during the sample preparation. The heavily cracked corrosion crust represents about one third of the thickness of the sample (Fig. 3) and is located on one side of the metal

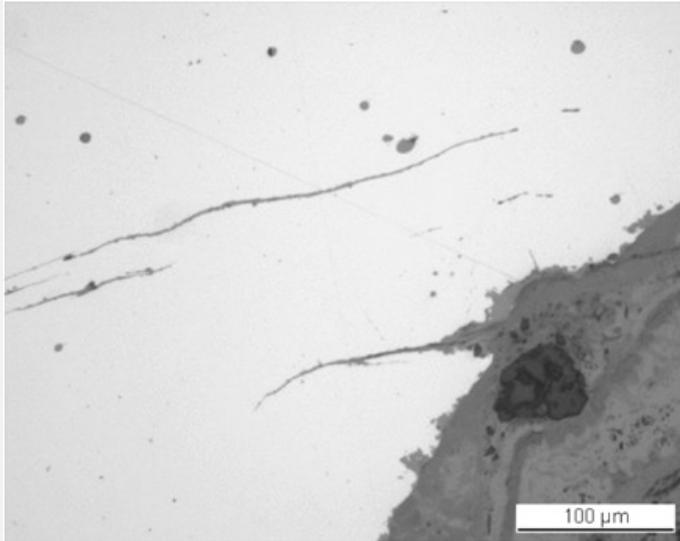
The remaining metal is an iron containing elevated (more than 1g/kg) concentrations of Co and Ni (Table 1), small round slag inclusions and cracks resulting from corrosion and deformation (Fig. 5). The composition of the round, elongated slag inclusions is similar to wüstite-FeO (Table 2). Iron reduced in the direct smelting process never contains such pure compounds and only FeO inclusions. In modern steels FeO occurs in low carbon alloys and Armco-iron (Schumann 1991, 474). After etching, the cross-section shows a heavily deformed ferritic microstructure from cold working (Fig. 6). The cracks have the same orientation as the deformation. The average hardness of the metal is HV1 195.

Table 2: Chemical composition (mass %) of some of the round inclusions of Fig. 5. Method of analysis: SEM/EDS, Laboratory of Analytical Chemistry, Empa.

Fig. 5: Micrograph of metal sample from Fig. 3 (inverted picture, detail), unetched, bright field. In white the metal with round slag inclusions as well as cracks filled with corrosion products,

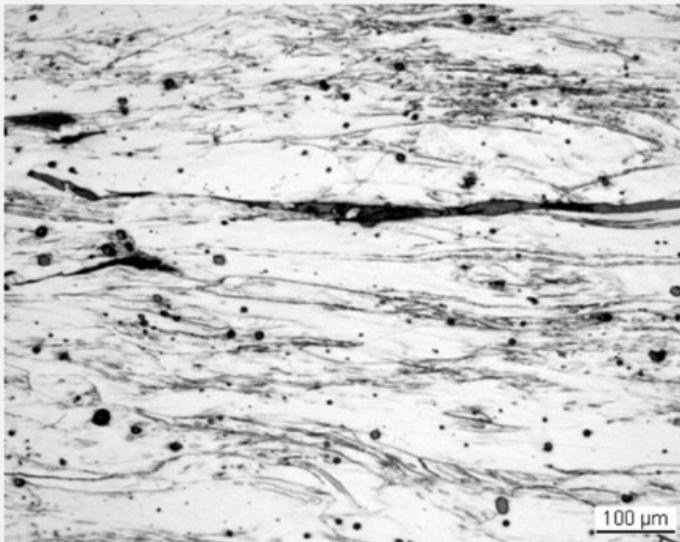
Fig. 6: Micrograph of metal sample from Fig. 3 (detail), etched, bright field. The heavily cold worked metal shows elongated grains with nearly invisible grain boundaries and cracks parallel to the grains,

**Microstructure** Heavily deformed ferritic microstructure

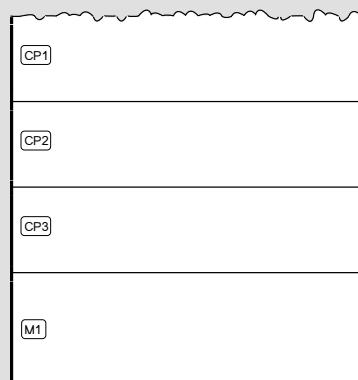
Fig. 4: Stratigraphic representation of the object in cross-section using the MiCorr application. This representation can be compared to Figs. 7 and 8.

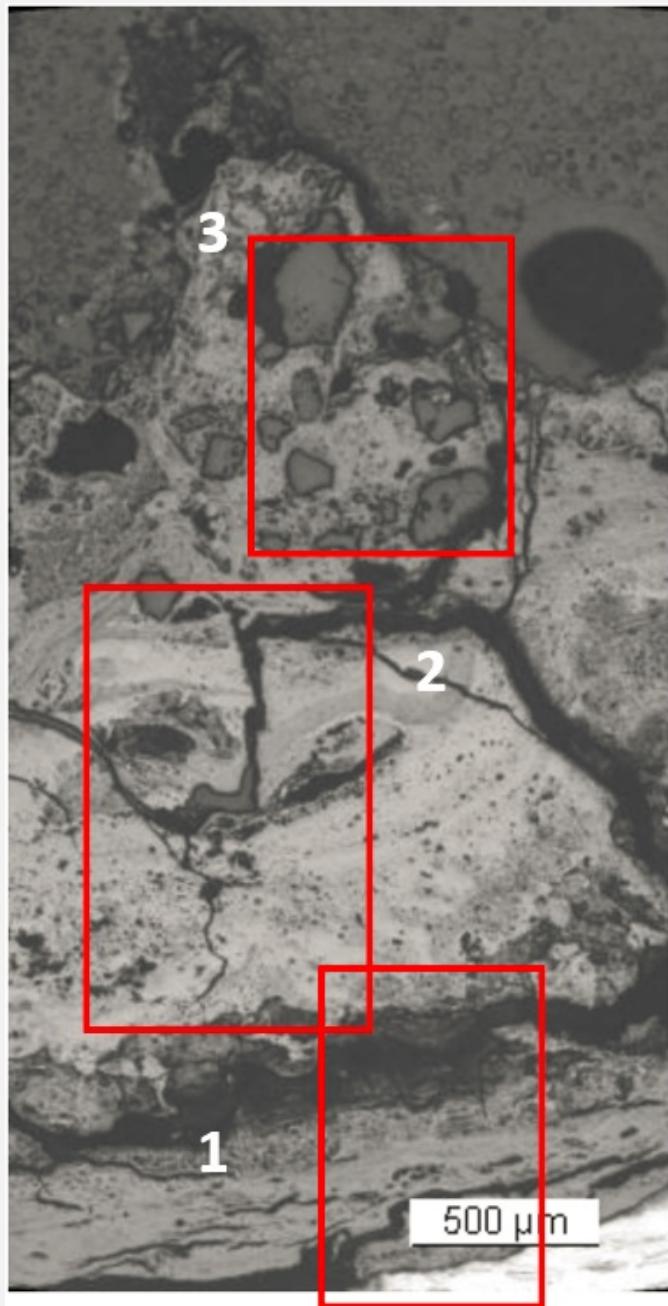
(the rest having been lost during the cutting process). It does not show well defined layers. Despite this, three areas can be distinguished (Figs. 7 and 8). Adhering to the metal (area 1), we find an orange-red-brown layer enriched in Cl (CP3 in Fig. 4, Fig. 9 and Table 3). The dark or violet middle area 2 is richer in Fe (CP2 in Fig. 4). The outer area 3 is red-brown (CP1 in Fig. 4) and strongly contaminated by soil material (rock fragment inclusion and elements like Si, Al, P etc.). This layer is enriched in O (Fig. 9).

Fig. 7: Micrograph of the corrosion layer from Fig. 3 showing the metal - corrosion crust interface (detail, rotated by 45°) and corresponding to the stratigraphy of Fig. 4, unetched, bright field. Areas 1 (inner layer, CP3) to 3 (outer layer, CP1) are indicated,

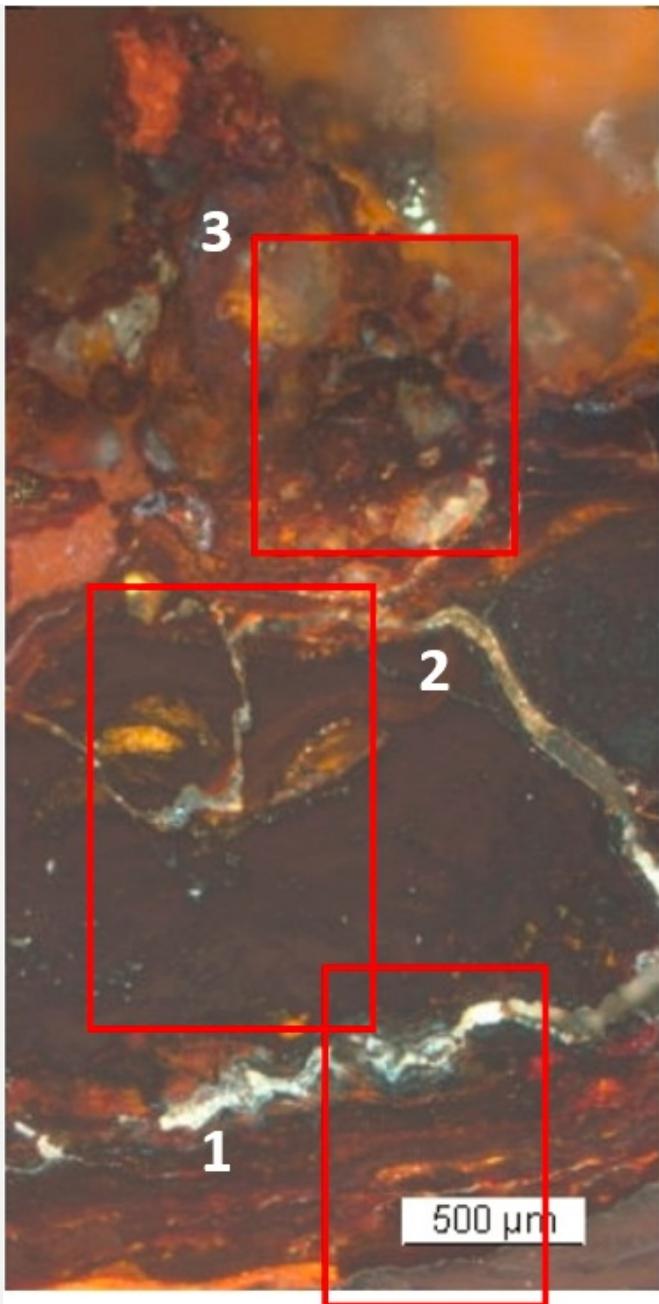
Fig. 8: Micrograph (same as Fig.7) and corresponding to the stratigraphy of Fig. 4, polarised light. The inner layer (CP3) is red-brown, area 2 is brown-violet (CP2) and the outer pale brown area contains rock fragment inclusions (CP1),

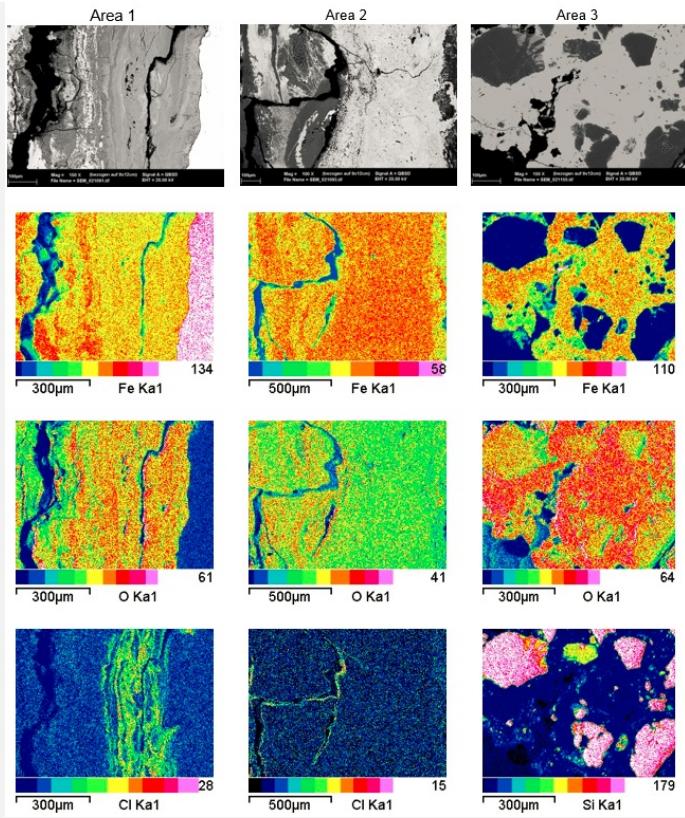
Fig. 9: SEM images, BSE-mode, and elemental chemical distribution of the selected areas from Fig. 8 (reversed picture rotated by 270°, details). First column: mapping on area 1 (CP3) where an inner layer enriched in Cl appears near the metal surface. 2nd column: area 2 (CP2) where iron oxides prevail. 3rd column: area 3 (CP1) where the outer O-rich layer includes rock fragments rich in Si. Method of examination: SEM/EDS, Lab. Anal. Chem. Empa.

This iron sheet is entirely cold worked and hard compared to an annealed metal. The corrosion is massive and masks the shape of the object. The presence of Cl adjacent to the metal surface indicates that the corrosion front is potentially active. The very thick top corrosion layers may have slowed down the corrosion. The object was mentioned as being Roman in Senn Bischofberger 2005, however the chemical composition of the slag inclusions shows that it is a product of the 20<sup>th</sup> century AD which has been accidentally introduced into a Roman layer.
