# CORRODED METAL SHEET FN 655.13.01 – FE ALLOY – MODERN TIMES – SWITZERLAND

<b>Artefact name</b>	Corroded metal sheet FN 655.13.01
<b>Authors</b>	Marianne. Senn (EMPA, Dübendorf, Zurich, Switzerland) & Christian. Degriigny (HE-Arc CR, Neuchâtel, Neuchâtel, Switzerland)
<b>Url</b>	/artefacts/350/

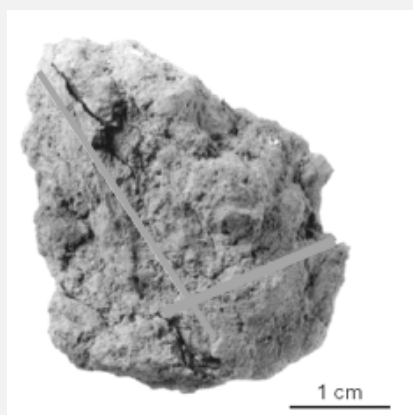
Fig. 1: Iron (and steel) sheet (after Senn Bischofberger 2005, 137),

<b>Description of the artefact</b>	Iron sheet with middle rib. The shape is no longer discernible (Fig. 1). The metal is covered by a thick corrosion crust. Dimensions: L = 4.5cm; WT = 35g.
<b>Type of artefact</b>	Iron (and steel) sheet
<b>Origin</b>	Steinmöri, Neftenbach / Dorf Neftenbach, Zurich, Switzerland
<b>Recovering date</b>	Excavation of the Roman villa, 1986-1990, phase S2, StbII.2 (2nd/3rd century AD)
<b>Chronology category</b>	Modern Times
<b>chronology tpq</b>	<input type="text" value="1986"/> A.D. ▾
<b>chronology taq</b>	<input type="text" value="1990"/> A.D. ▾
<b>Chronology comment</b>	20th century (1986 _ 1990)
<b>Burial conditions / environment</b>	Soil
<b>Artefact location</b>	Kantonsarchäologie, Dübendorf, Zurich
<b>Owner</b>	Kantonsarchäologie, Dübendorf, Zurich

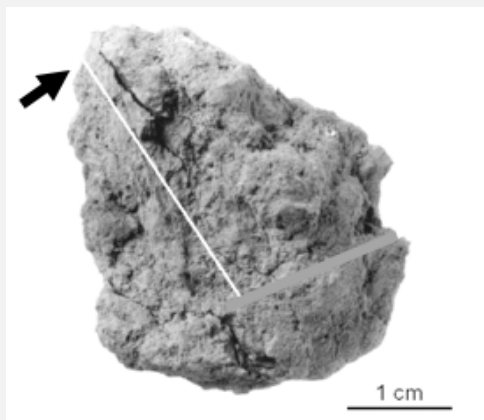
Fig. 2: Location of sampling area,

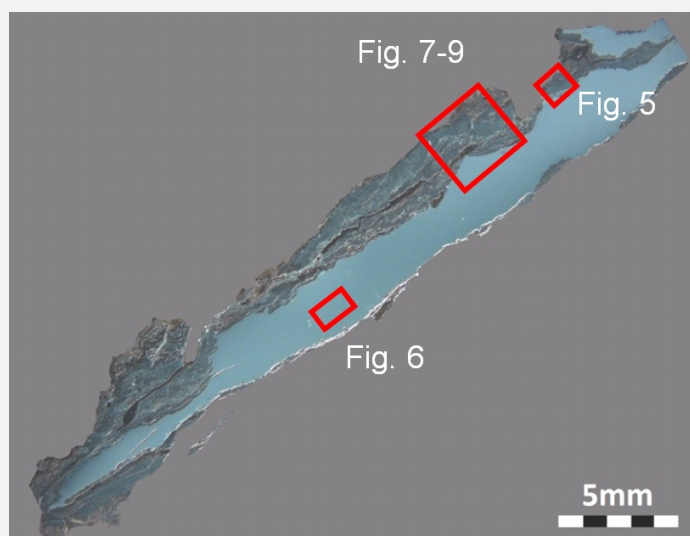
Fig. 3: Micrograph of the cross-section showing the location of Figs. 5 to 9,

<b>Description of sample</b>	A longitudinal cut has been made through the sheet (Fig. 2). Large parts of the corrosion crust fell off during sampling (Fig. 3).
<b>Alloy</b>	Fe Alloy
<b>Technology</b>	Forged with final cold work
<b>Lab number of sample</b>	NEF 655
<b>Sample location</b>	Empa (Marianne Senn)
<b>Responsible institution</b>	Kantonsarchäologie, Dübendorf, Zurich
<b>Date and aim of sampling</b>	2000, metallography

The corrosion is massive and large parts of the outer corrosion layers have been lost during the sample preparation. The heavily cracked corrosion crust represents about one third of the thickness of the sample (Fig. 3) and is located on one side of the metal

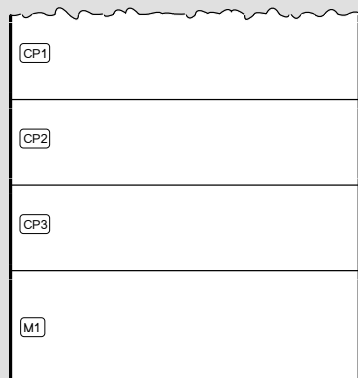
Fig. 4: Stratigraphic representation of the object in cross-section using the MiCorr application. This representation can be compared to Figs. 7 and 8.
