CORRODED METAL SHEET FN 655.13.01 – FE ALLOY – MODERN TIMES – SWITZERLAND

Artefact name Corroded metal sheet FN 655.13.01

Authors Marianne. Senn (EMPA, Dübendorf, Zurich, Switzerland) & Christian. Degriigny (HE-Arc CR, Neuchâtel, Neuchâtel, Switzerland)

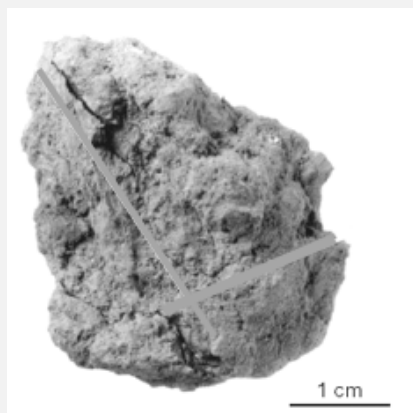
Fig. 1: Iron (and steel) sheet (after Senn Bischofberger 2005, 137),

Description of the artefact	Iron sheet with middle rib. The shape is no longer discernible (Fig. 1). The metal is covered by a thick corrosion crust. Dimensions: L = 4.5cm; WT = 35g.
Type of artefact	Iron (and steel) sheet
Origin	Steinmöri, Neftenbach / Dorf Neftenbach, Zurich, Switzerland
Recovering date	Excavation of the Roman villa, 1986-1990, phase S2, StbII.2 (2nd/3rd century AD)
Chronology category	Modern Times
chronology tpq	<input type="text" value="1986"/> A.D. ▾
chronology taq	<input type="text" value="1990"/> A.D. ▾
Chronology comment	20th century (1986 _ 1990)
Burial conditions / environment	Soil
Artefact location	Kantonsarchäologie, Dübendorf, Zurich
Owner	Kantonsarchäologie, Dübendorf, Zurich

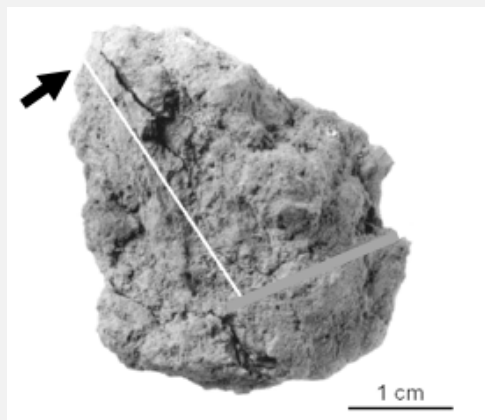
Fig. 2: Location of sampling area,

Description of sample	A longitudinal cut has been made through the sheet (Fig. 2). Large parts of the corrosion crust fell off during sampling (Fig. 3).
Alloy	Fe Alloy
Technology	Forged with final cold work
Lab number of sample	NEF 655
Sample location	Empa (Marianne Senn)
Responsible institution	Kantonsarchäologie, Dübendorf, Zurich
Date and aim of sampling	2000, metallography

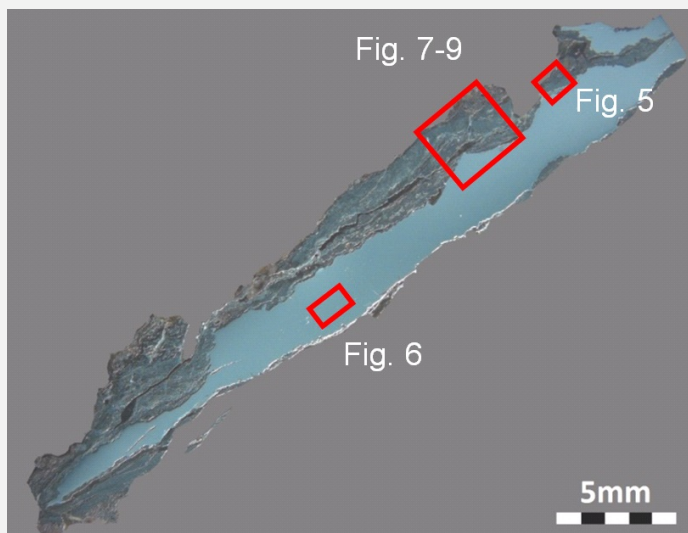
Fig. 3: Micrograph of the cross-section showing the location of Figs. 5 to 9,

The corrosion is massive and large parts of the outer corrosion layers have been lost during the sample preparation. The heavily cracked corrosion crust represents about one third of the thickness of the sample (Fig. 3) and is located on one side of the metal

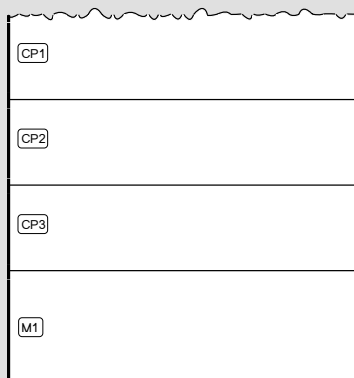
Fig. 4: Stratigraphic representation of the object in cross-section using the MiCorr application. This representation can be compared to Figs. 7 and 8.
