CORRODED METAL SHEET FN 655.13.01 – FE ALLOY – MODERN TIMES – SWITZERLAND

Artefact name Corroded metal sheet FN 655.13.01

Authors Marianne. Senn (EMPA, Dübendorf, Zurich, Switzerland) & Christian. Degriigny (HE-Arc CR, Neuchâtel, Neuchâtel, Switzerland)

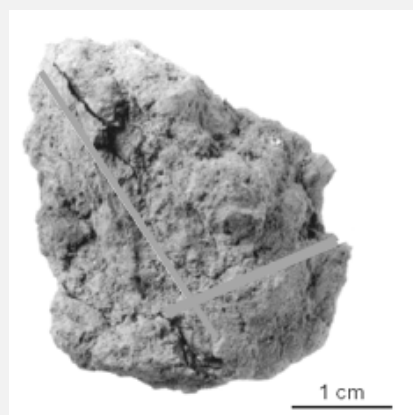
Fig. 1: Iron (and steel) sheet (after Senn Bischofberger 2005, 137),

Description of the artefact	Iron sheet with middle rib. The shape is no longer discernible (Fig. 1). The metal is covered by a thick corrosion crust. Dimensions: L = 4.5cm; WT = 35g.
Type of artefact	Iron (and steel) sheet
Origin	Steinmöri, Neftenbach / Dorf Neftenbach, Zurich, Switzerland
Recovering date	Excavation of the Roman villa, 1986-1990, phase S2, StbII.2 (2nd/3rd century AD)
Chronology category	Modern Times
chronology tpq	<input type="text" value="1986"/> A.D. ▼
chronology taq	<input type="text" value="1990"/> A.D. ▼
Chronology comment	20th century (1986 _ 1990)
Burial conditions / environment	Soil
Artefact location	Kantonsarchäologie, Dübendorf, Zurich
Owner	Kantonsarchäologie, Dübendorf, Zurich

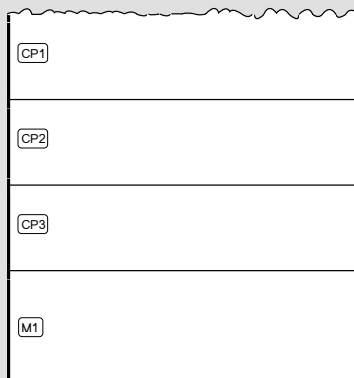
Fig. 4: Stratigraphic representation of the object in cross-section using the MiCorr application. This representation can be compared to Figs. 7 and 8.
