CORRODED METAL SHEET FN 655.13.01 – FE ALLOY – MODERN TIMES – SWITZERLAND

Artefact name Corroded metal sheet FN 655.13.01

Authors Marianne. Senn (EMPA, Dübendorf, Zurich, Switzerland) & Christian. Degriigny (HE-Arc CR, Neuchâtel, Neuchâtel, Switzerland)

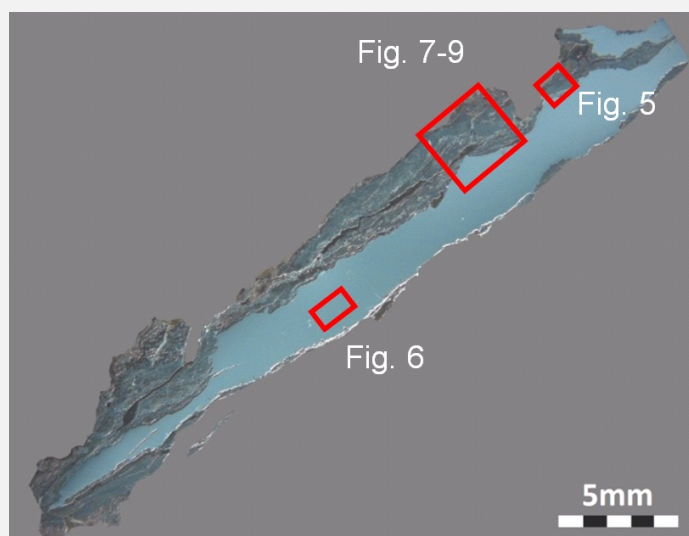
Fig. 3: Micrograph of the cross-section showing the location of Figs. 5 to 9,

Description of sample	A longitudinal cut has been made through the sheet (Fig. 2). Large parts of the corrosion crust fell off during sampling (Fig. 3).
Alloy	Fe Alloy
Technology	Forged with final cold work
Lab number of sample	NEF 655
Sample location	Empa (Marianne Senn)
Responsible institution	Kantonsarchäologie, Dübendorf, Zurich
Date and aim of sampling	2000, metallography

The corrosion is massive and large parts of the outer corrosion layers have been lost during the sample preparation. The heavily cracked corrosion crust represents about one third of the thickness of the sample (Fig. 3) and is located on one side of the metal

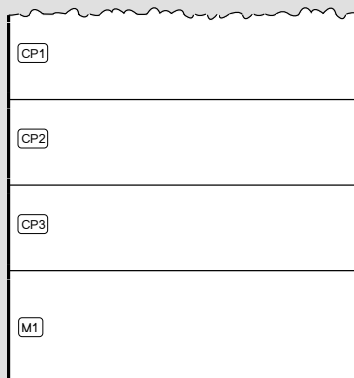
(the rest having been lost during the cutting process). It does not show well defined layers. Despite this, three areas can be distinguished (Figs. 7 and 8). Adhering to the metal (area 1), we find an orange-red-brown layer enriched in Cl (CP3 in Fig. 4, Fig. 9 and Table 3). The dark or violet middle area 2 is richer in Fe (CP2 in Fig. 4). The outer area 3 is red-brown (CP1 in Fig. 4) and strongly contaminated by soil material (rock fragment inclusion and elements like Si, Al, P etc.). This layer is enriched in O (Fig. 9).

Fig. 4: Stratigraphic representation of the object in cross-section using the MiCorr application. This representation can be compared to Figs. 7 and 8.
