CORRODED METAL SHEET FN 655.13.01 – FE ALLOY – MODERN TIMES – SWITZERLAND

Artefact name Corroded metal sheet FN 655.13.01

Authors Marianne. Senn (EMPA, Dübendorf, Zurich, Switzerland) & Christian. Degriigny (HE-Arc CR, Neuchâtel, Neuchâtel, Switzerland)

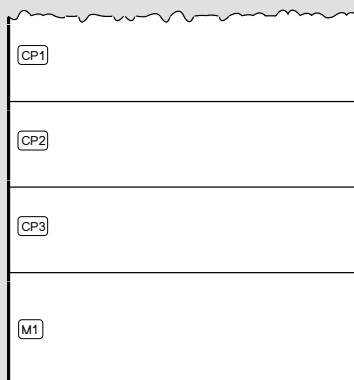
Fig. 4: Stratigraphic representation of the object in cross-section using the MiCorr application. This representation can be compared to Figs. 7 and 8.
