# FITTING ON BACK PANEL OF A MILITARY CARRIAGE – THOMAS STEEL – MODERN TIMES – SWITZERLAND

Artefact name	Fitting on back panel of a military carriage
Authors	Marianne. Senn (EMPA, Dübendorf, Zurich, Switzerland) & Christian. Degryny (HE-Arc CR, Neuchâtel, Neuchâtel, Switzerland)
Url	/artefacts/353/

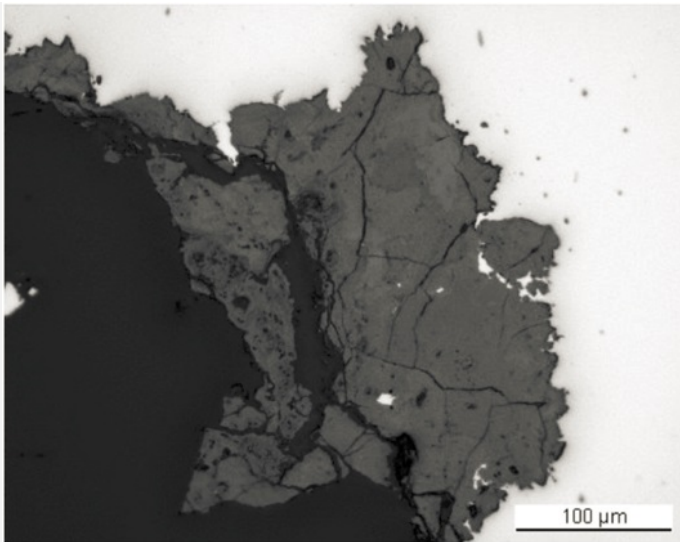
The average thickness of the corrosion products is about 80µm (Figs. 5 and 9). In bright field they appear grey, marbled and heavily cracked (Fig. 9). Under polarised light, the corrosion products appear orange to dark-brown (Fig. 10). At the metal - corrosion products interface they are dark-brown (CP3). The middle part (CP2) is red-orange and the outer part is bright orange (CP1). The elemental mapping of the corrosion layers shows no distinctive stratification, but areas near the metal - corrosion crust interface (CP3) as well as the top surface of the corrosion layer (CP1) seem to have a lower O content (Fig. 11). The O content indicates the presence of iron hydroxides (Table 3). Soil materials (such as rock fragments and dust) are found in the welding seams near the surface.

Fig. 9: Micrograph showing the metal - corrosion crust interface from Fig. 3 (rotated by 270°, detail), unetched, bright field. We observe in white the metal, in grey the corrosion products and in black the resin,

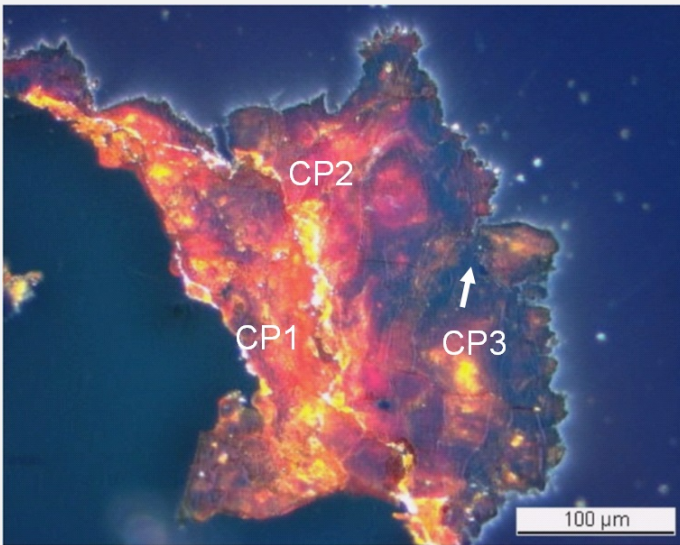
Fig. 10: Micrograph (same as Fig. 9) and corresponding to the stratigraphy of Fig. 4, unetched, polarised light. The corrosion products are dark-brown at the metal - corrosion crust interface and red-orange on the outside,

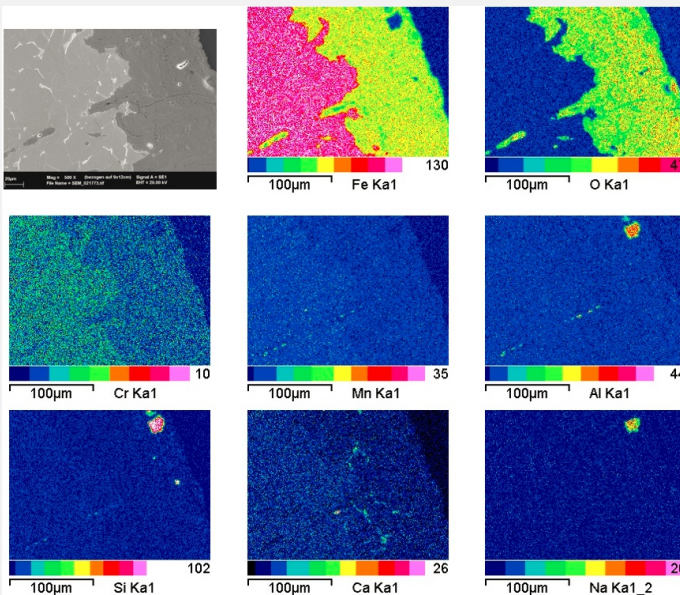
Fig. 11: SEM image, BSE-mode, and elemental chemical distribution of the selected area from Fig. 5 (rotated by 270°, detail). Method of examination: SEM/EDS, Laboratory of Analytical Chemistry, Empa.

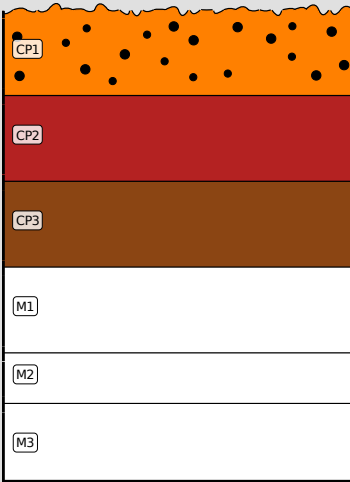
Fig. 4: Stratigraphic representation of the object in cross-section using the MiCorr application. This representation showing for the metal part a welding seam (M2) can be compared to Fig. 10.
