FITTING ON BACK PANEL OF A MILITARY CARRIAGE – THOMAS STEEL – MODERN TIMES – SWITZERLAND

Artefact name	Fitting on back panel of a military carriage
Authors	Marianne. Senn (EMPA, Dübendorf, Zurich, Switzerland) & Christian. Degryny (HE-Arc CR, Neuchâtel, Neuchâtel, Switzerland)
Url	/artefacts/353/

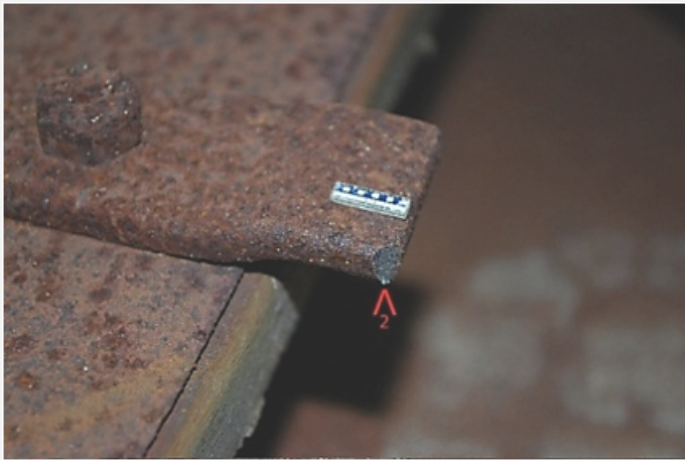
Fig. 2: Location of sampling area,

This sample is a cut from the corner of one of the two fittings on the back panel (Fig. 2). The metal is covered by a thin corrosion layer (Fig. 3).
Alloy	Thomas steel
Technology	Piled from several strips, hot rolled and annealed
Lab number of sample	POINT-Fe2
Sample location	Empa (Marianne Senn)
Responsible institution	Historical Swiss Army Material Foundation, Burgdorf, Bern
Date and aim of sampling	05/2009 metallography

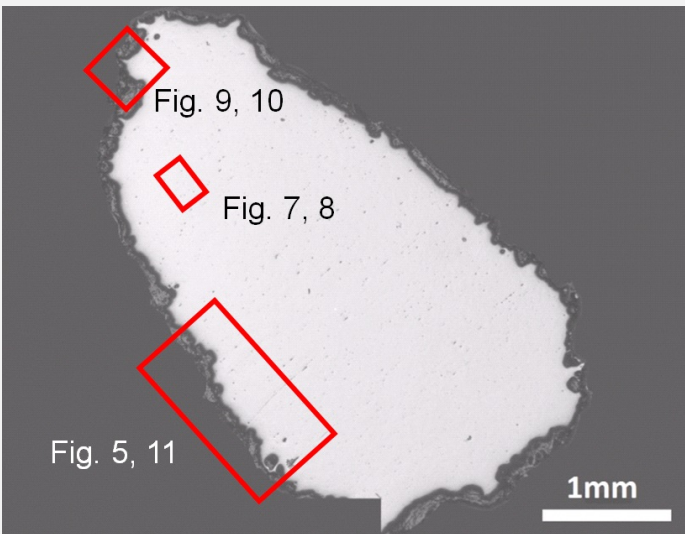
Fig. 3: Micrograph of the cross-section showing the location of Figs. 5 and 7 to 11,

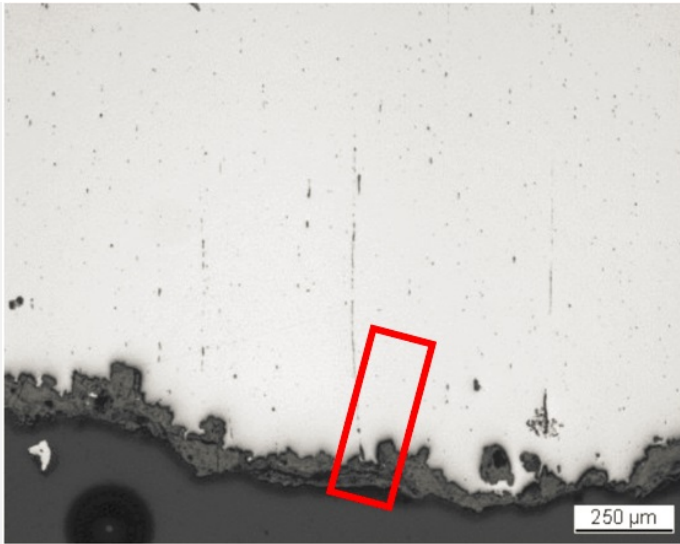
The remaining metal is a Mn-rich soft steel (C content around 0.1 mass%) containing manganese sulphide inclusions with a varying Fe content (Tables 1 and 2). The numerous inclusions form parallel rows (Fig. 5). This orientation is typical for hot rolled metal. After etching with Oberhoffer’s reagent, three main welding seams (P-rich) become visible (Fig. 6). Near the surface they are also outlined by corrosion (Figs. 5 and 11). After nital etching, the metal shows a ferritic structure with tertiary cementite and lamellar pearlite at the grain boundaries (Figs. 7 and 8). The grains are small with an ASTM grain size of 10 and are recrystallized due to annealing after hot rolling. The average hardness of the metal is HV1 165. The hardness is slightly high for such a structure and this is due to the Mn content of the metal. The chemical composition, especially the Mn content and the presence of carbo-nitrides (not analysed here), is typical for Thomas steel.

Fig. 5: Micrograph of the metal sample from Fig. 3 (rotated by 270°, detail), unetched, bright field. We observe the metal including welding seams outlined by corrosion products and MnS inclusions. The mapped area of Fig. 11 is marked by the rectangle,

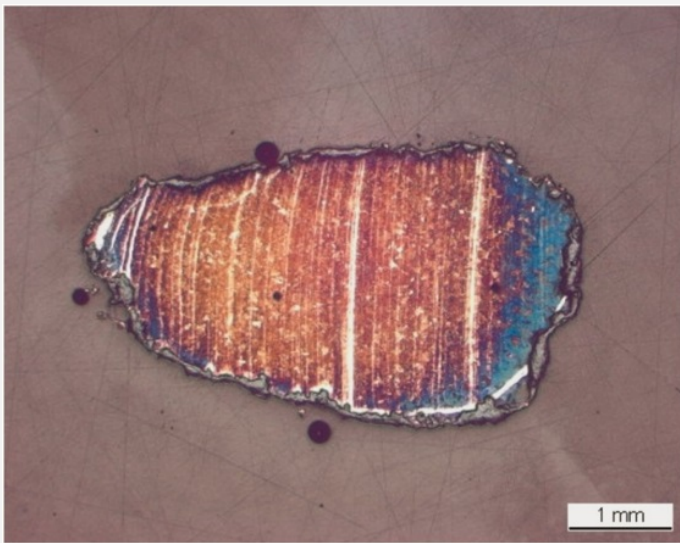
Fig. 6: Micrograph of the metal sample from Fig. 3, etched with Oberhoffer's reagent, bright field. We observe three P-rich welding seams in white,

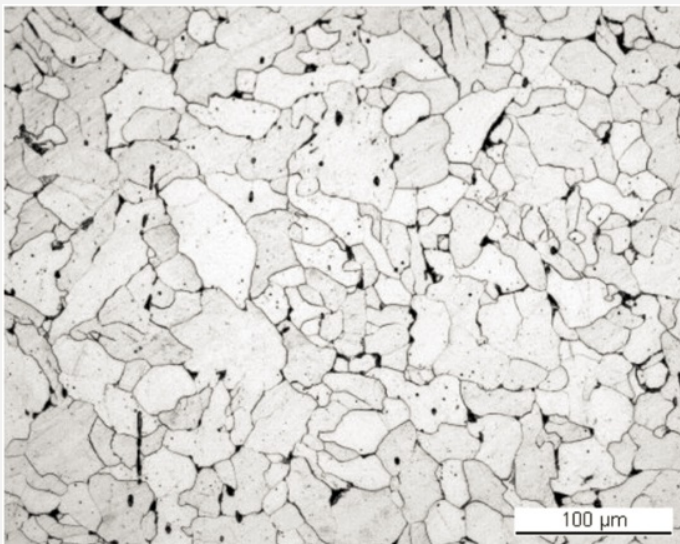
Fig. 7: Micrograph of the metal sample, nital etched, bright field. We observe tertiary cementite (black) on the grain boundaries,

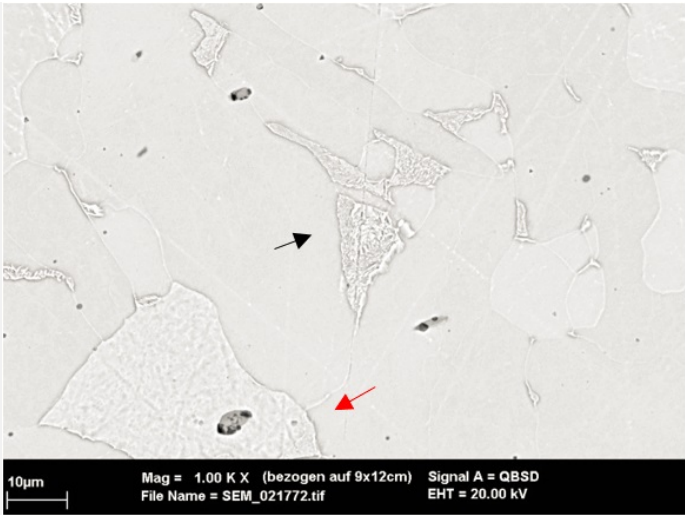
Fig. 8: SEM image of the metal sample from Fig. 3 (detail), BSE-mode, nital etched, bright field. The white ferrite grains contain lamellar pearlite (black arrow) and lenticular grey MnS inclusions (red arrow) in between the grain boundaries,

Microstructure	Recrystallized grain structure with tertiary cementite
First metal element	Fe
Other metal elements	C, Mn

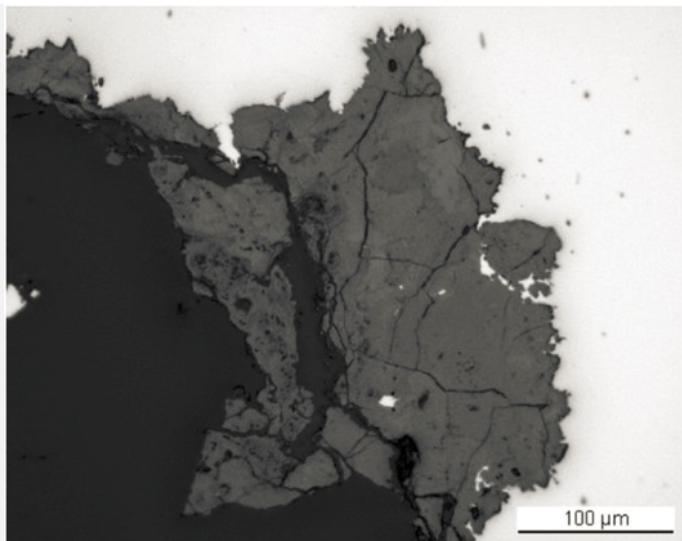
The average thickness of the corrosion products is about 80µm (Figs. 5 and 9). In bright field they appear grey, marbled and heavily cracked (Fig. 9). Under polarised light, the corrosion products appear orange to dark-brown (Fig. 10). At the metal - corrosion products interface they are dark-brown (CP3). The middle part (CP2) is red-orange and the outer part is bright orange (CP1). The elemental mapping of the corrosion layers shows no distinctive stratification, but areas near the metal - corrosion crust interface (CP3) as well as the top surface of the corrosion layer (CP1) seem to have a lower O content (Fig. 11). The O content indicates the presence of iron hydroxides (Table 3). Soil materials (such as rock fragments and dust) are found in the welding seams near the surface.

Fig. 9: Micrograph showing the metal - corrosion crust interface from Fig. 3 (rotated by 270°, detail), unetched, bright field. We observe in white the metal, in grey the corrosion products and in black the resin,

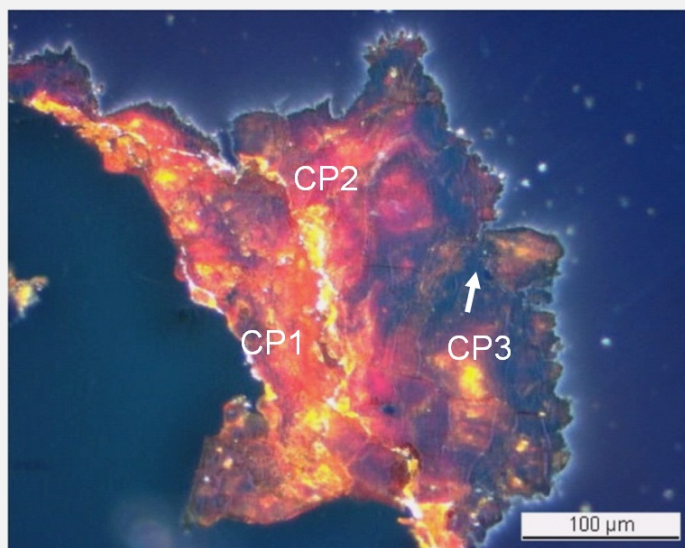
Fig. 10: Micrograph (same as Fig. 9) and corresponding to the stratigraphy of Fig. 4, unetched, polarised light. The corrosion products are dark-brown at the metal - corrosion crust interface and red-orange on the outside,

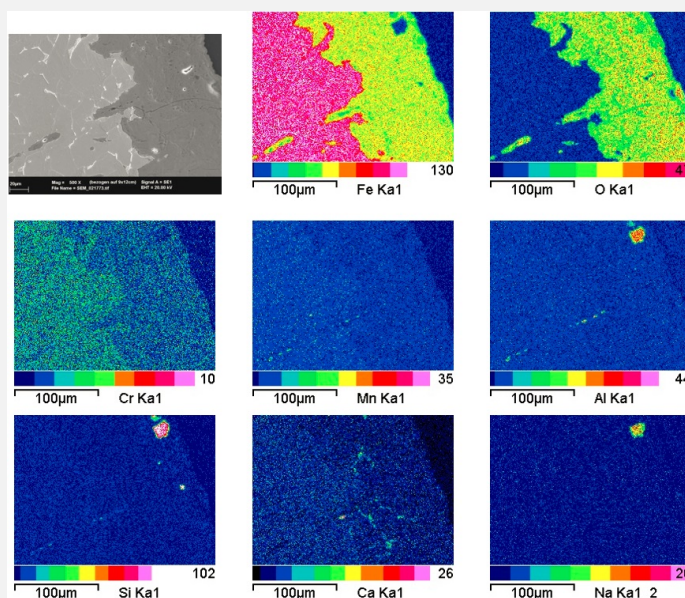
Table 3: Chemical composition (mass %) of the corrosion layer (from Fig. 11). Method of analysis: SEM/EDS, Laboratory of Analytical Chemistry, Empa.

Fig. 11: SEM image, BSE-mode, and elemental chemical distribution of the selected area from Fig. 5 (rotated by 270°, detail). Method of examination: SEM/EDS, Laboratory of Analytical Chemistry, Empa.

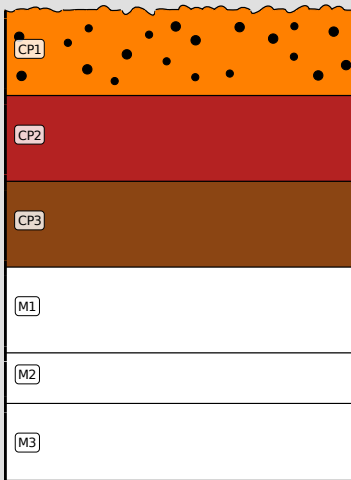
Fig. 4: Stratigraphic representation of the object in cross-section using the MiCorr application. This representation showing for the metal part a welding seam (M2) can be compared to Fig. 10.
