RAIN GUTTER FRAGMENT – GREY CAST IRON – MODERN TIMES – FRANCE

Artefact name	Rain gutter fragment
Authors	Christian. Degriigny (HE-Arc CR, Neuchâtel, Neuchâtel, Switzerland) & Mathea. Hovind (University of Oslo, Department of archaeology, conservation and history (IAKH-UiO), Oslo, Oslo, Norway)
Url	/artefacts/358/

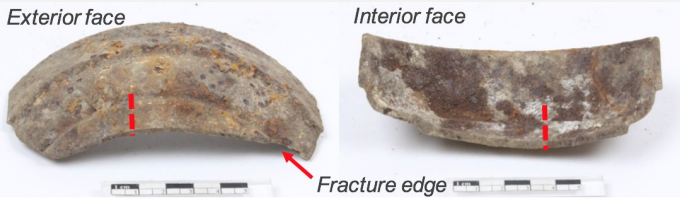
Fig. 2. The exterior and interior faces before sampling. The dotted line represents the sample location (a cross-section of the metal). The fracture edge corresponds to the edge that was formerly attached to the remaining artefact,

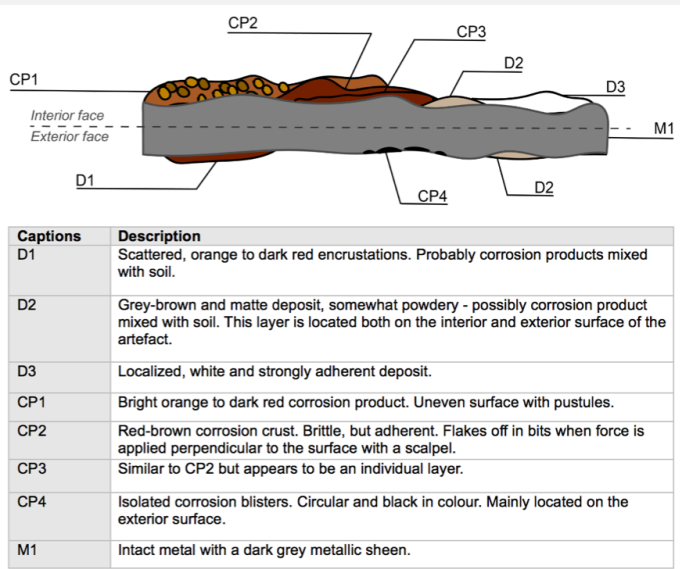
Fig. 3. Preliminary stratigraphy corresponding to the overall surface of the artefact. The interior surface is shown above the stippled line and the exterior surface below. D = Deposit, CP = Corrosion products, M = Metal,

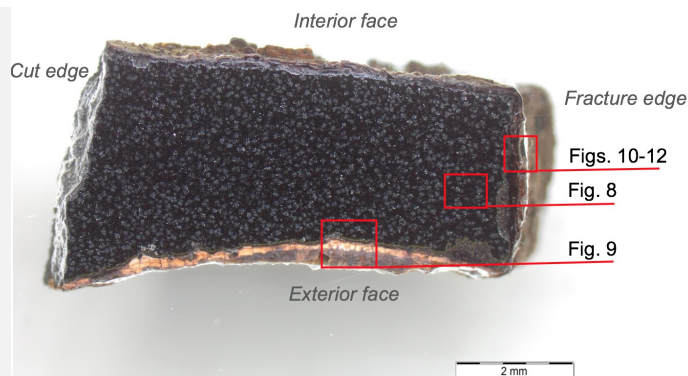
Fig. 4. Micrograph of the sample (a cross-section of the metal) showing its orientation relative to the artefact and the locations of Figs. 8-12,

The sample consists of a rectangular section (Fig. 4) which was cut out from the fractured edge of the gutter fragment. It is representative of three surfaces: the exterior and interior surface, as well as the fracture edge.

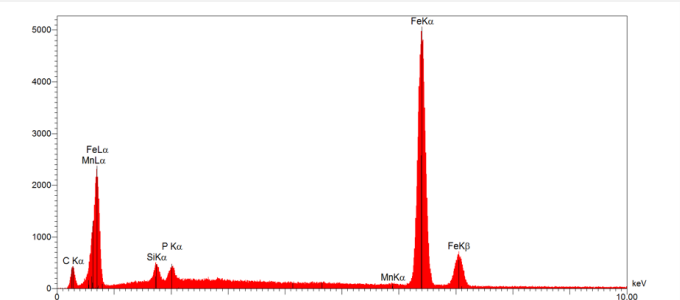
The metal is a P-rich grey cast iron with Si and Mn (Fig. 7). Its microstructure is characterized by evenly distributed graphite flakes in a matrix composed of dendrites and an interdendritic eutectic phase (Fig. 8). What appears to be irregular graphite flakes/porosity is in fact deformed graphite flakes; graphite is soft and prone to destruction by smearing and/or preferential removal during polishing (Scott 1991:38-39).

Fig. 7: EDS-spectrum showing the chemical composition of the metal. Method of analysis: SEM-EDS. Lab. of Electronic Microscopy and Microanalysis, Néode, HEI Arc,

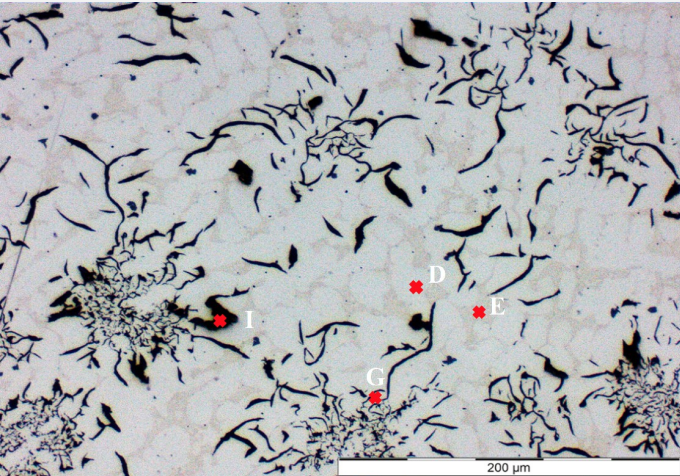
The dendrites appear light grey under polarized light, while the eutectic phase appear light brown (Fig. 8). The eutectic phase is rich in Fe and P and contains small amounts of C and Si, whereas the dendritic phase contains much less P (Table 1).

Fig. 8: Micrograph of the metal sample from Fig. 4 (detail). Unetched, bright field. Graphite flakes (G) in black, the dendrites (D) in light grey and the eutectoid phase (E) in light brown. Deformed graphite flakes are visible as irregular black inclusions (I),

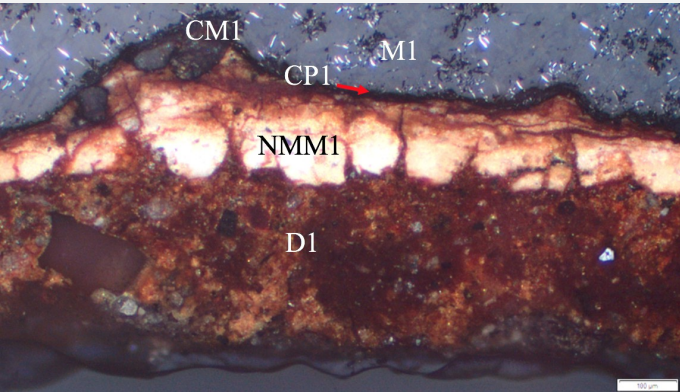
The exterior face (Figs. 2, 4 and 9) consists of a white cracked layer (NMM1 in Fig. 5) superimposed by a layer of deposit mixed with orange-red corrosion products (D1 in Fig. 5). Punctual analysis by SEM-EDS (Table 2) revealed that the white layer is rich in Ba, O, S, Fe, C and Zn. It has a chemical composition similar to Lithopone (BaSO4 ZnS), a preparatory paint layer. Fe is probably a contamination from the superimposed deposit/corrosion product D1 (Table 2). The latter (D1) is Fe- and O-rich and contains Si, Al and some Ca, in addition to a range of elements (K, P, Na, Cl, S and Ti) present in minor

amounts (Table 2). A thin layer of corrosion products (CP1) is located just beneath the paint layer, appearing dark grey under polarized light (Fig. 9). This layer is followed by a corroded metal phase (CM1). Their exact composition was not analyzed but is likely to correspond to the corroded metal phase of the fracture edge, described below.

Fig. 9. Micrograph of the metal sample from Fig. 4 (detail), unetched, polarized light, 5x. The stratigraphy of the exterior surface, from top to bottom: the metal (M1) in grey, a thin layer of corroded metal (CM1) and a white cracked layer (NMM1) superimposed by a porous dark-red deposit (D1),

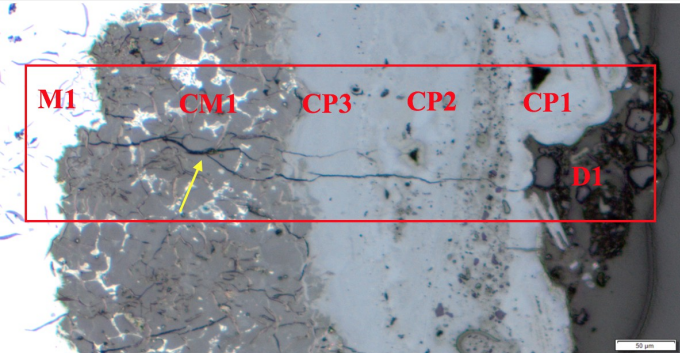
The interior face (Figs. 2 and 4) shows similar characteristics but does not include a white layer similar to NMM1. The fracture edge however (Figs. 2, 4 and 10), shows a more complex stratigraphy consisting of a dense product layer which can be further divided into two individual strata (CP3 and CP2), superimposed by a porous corrosion crust appearing orange under polarized light (CP1) (Fig. 11). The corroded metal (CM1) is located just beneath CP3 and contains remnants of the P-rich eutectic phase (Figs. 10-12). The M/CP ratio (metal to corrosion products) is rather high, implying extensive internal corrosion. Furthermore, a simple crack is traversing the corrosion layers – indicating a fragilization of the structure. As for the composition of the corrosion products CP1, CP2 and CP3, they all contain Fe and O (Fig. 12). A marbling effect within CP2 and CP3 indicates a variation in the concentration of Fe and O (particularly visible in bright field - Fig. 10). The white deposit (D1 in Fig. 6) might originate from exposure to calcareous water (Table 2). The presence of exogenous elements such as Si, Ca, Al, Na and O (Table 2) was confirmed by elemental mapping (Fig. 12).

Fig. 10. Micrograph of the metal sample from Fig. 4 (detail), unetched, bright field. From left to right: intact metal (M1) in white, followed by preferentially corroded metal (CM1) and dense product layers (CP3 and CP2) in various shades of grey. CP1 is slightly porous and covered by grain-like particles (D1). The red square corresponds to the area selected for SEM-EDS elementary mapping (Fig. 12). A simple crack (yellow arrow) is traversing the corrosion layers,

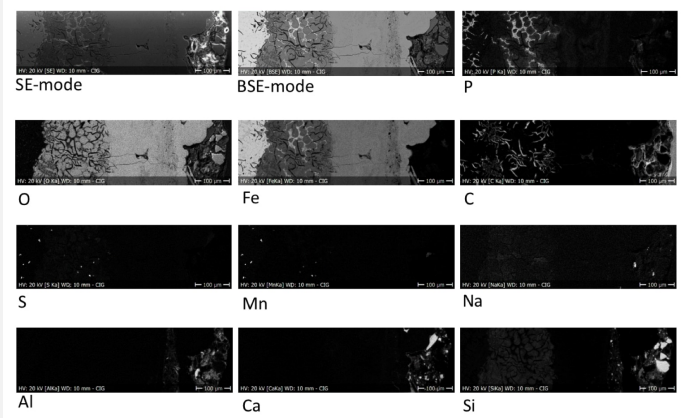
Fig. 12: SEM image and elemental chemical distribution of the selected area from Fig. 10. Method of analysis: SEM-EDS. Lab. of Electronic Microscopy and Microanalysis, Néode, HEI Arc,

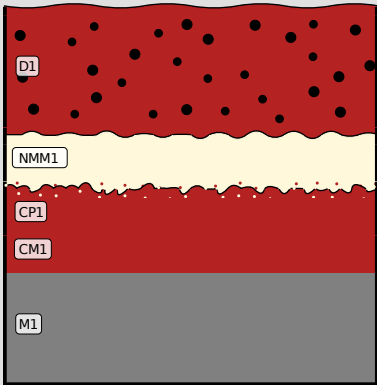
Fig. 5. MiCorr stratigraphy of the exterior face, to be related to the micrograph of Fig. 9. CP1 corresponds to CP2 in Fig. 3, Credit UiO-IAKH, M.Hovind.

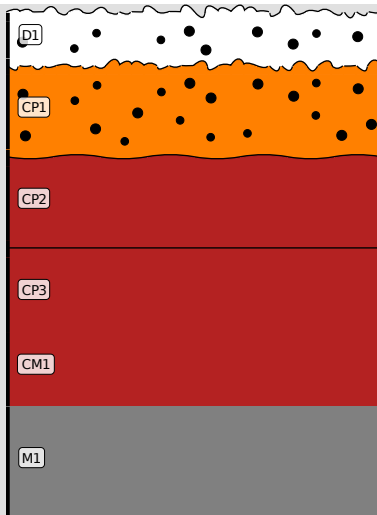
Fig. 6. MiCorr stratigraphy of the fractured edge, to be related to the micrograph of Fig. 11. D1 corresponds to D3 in Fig. 3, Credit UiO-IAKH, M.Hovind.

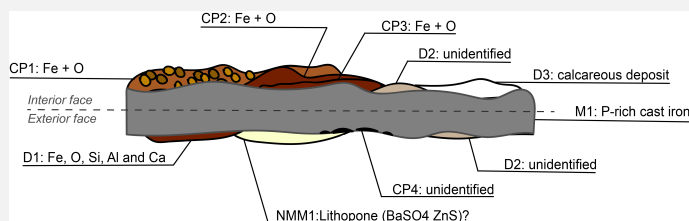
Fig. 13. Corrected stratigraphic representation with results of SEM-EDS analysis and visual microscopic observation,

The rain gutter fragment is a grey cast iron with a microstructure consisting of graphite flakes and a P-rich eutectic phase. The exterior surface contains a preparatory paint layer, located beneath a layer of corrosion products mixed with soil. It seems likely that the cast iron gutter has been covered with a protective layer of paint (e.g. Lithopone) to slow down the rate of atmospheric corrosion. The presence of Lithopone reinforces the suggested dating of the artefact (20th century) as this pigment was developed and used from the 1880s and onwards (Lithopone 2007). It seems however that the protective layer has none or only very limited effect as (pitting) corrosion is present also in these areas.

The corrosion layers consist mainly of Fe and O, indicating atmospheric corrosion with presence of none or only a very small amount of contaminants/pollution. The scattered white deposit is possibly originating from exposure to calcareous water as it is localized mainly on the interior face of the fragment, where rain water would hit the metal before entering the ground.
