RAIN GUTTER FRAGMENT – GREY CAST IRON – MODERN TIMES – FRANCE

Artefact name	Rain gutter fragment
Authors	Christian. Degriigny (HE-Arc CR, Neuchâtel, Neuchâtel, Switzerland) & Mathea. Hovind (University of Oslo, Department of archaeology, conservation and history (IAKH-UiO), Oslo, Oslo, Norway)
Url	/artefacts/358/

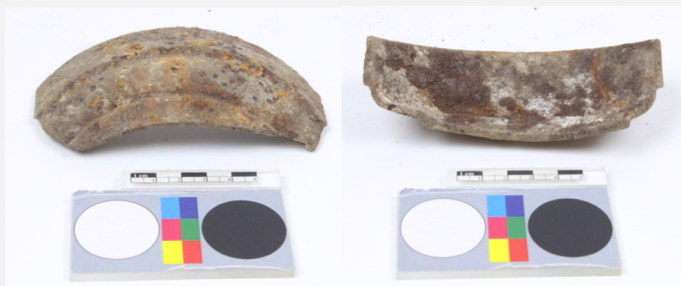
Fig. 1. Cast iron gutter fragment, exterior and interior faces (to the left and right, respectively),

Description of the artefact	<p>Rain gutter fragment (Fig. 1), possibly part of the extension of a roof drain pipe. Both the exterior and interior surfaces are covered by heterogeneous corrosion crusts. The underlying metal seems however to be well preserved, including features such as a difference in thickness etc.</p> <p>L = 55mm; W (interior) = 120mm; Tmax. = 6mm; WT = 176g</p>
Type of artefact	Architectural element
Origin	Château de Germolles, Mellecey, Bourgogne, France
Recovering date	Date unknown
Chronology category	Modern Times
chronology tpq	<input type="text" value="1801"/> A.D. ▼
chronology taq	<input type="text" value="2000"/> A.D. ▼
Chronology comment	19th - 20th century
Burial conditions / environment	Outdoor atmosphere
Artefact location	Haute Ecole Arc Conservation-Restauration

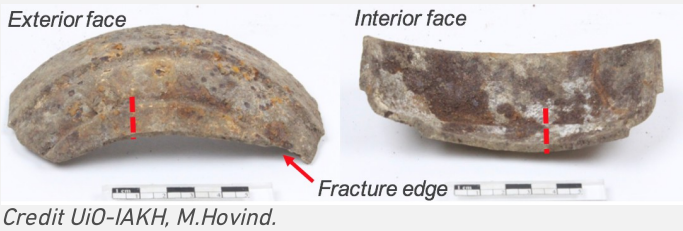
Fig. 2. The exterior and interior faces before sampling. The dotted line represents the sample location (a cross-section of the metal). The fracture edge corresponds to the edge that was formerly attached to the remaining artefact,

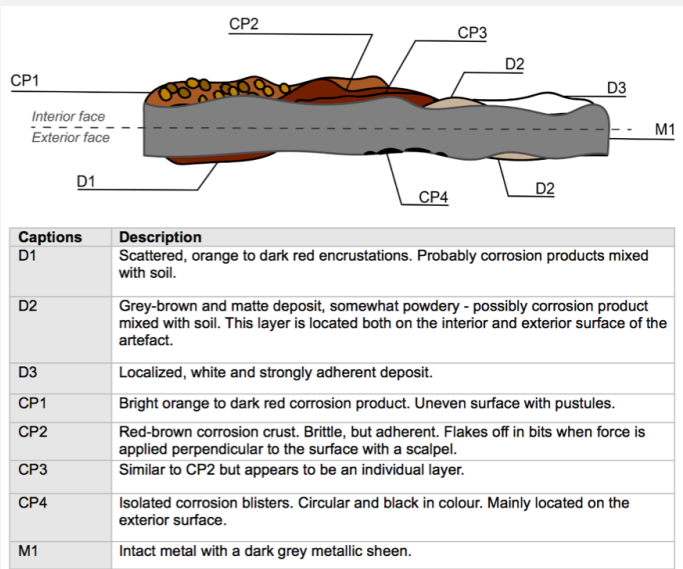
Fig. 3. Preliminary stratigraphy corresponding to the overall surface of the artefact. The interior surface is shown above the stippled line and the exterior surface below. D = Deposit, CP = Corrosion products, M = Metal,

Captions	Description
D1	Scattered, orange to dark red encrustations. Probably corrosion products mixed with soil.
D2	Grey-brown and matte deposit, somewhat powdery - possibly corrosion product mixed with soil. This layer is located both on the interior and exterior surface of the artefact.
D3	Localized, white and strongly adherent deposit.
CP1	Bright orange to dark red corrosion product. Uneven surface with pustules.
CP2	Red-brown corrosion crust. Brittle, but adherent. Flakes off in bits when force is applied perpendicular to the surface with a scalpel.
CP3	Similar to CP2 but appears to be an individual layer.
CP4	Isolated corrosion blisters. Circular and black in colour. Mainly located on the exterior surface.
M1	Intact metal with a dark grey metallic sheen.

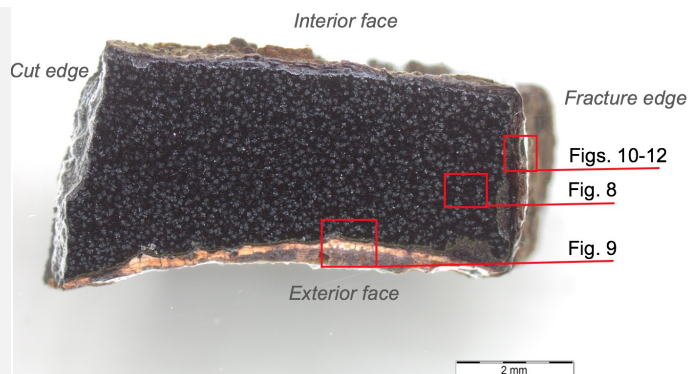
Fig. 4. Micrograph of the sample (a cross-section of the metal) showing its orientation relative to the artefact and the locations of Figs. 8-12,

The sample consists of a rectangular section (Fig. 4) which was cut out from the fractured edge of the gutter fragment. It is representative of three surfaces: the exterior and interior surface, as well as the fracture edge.

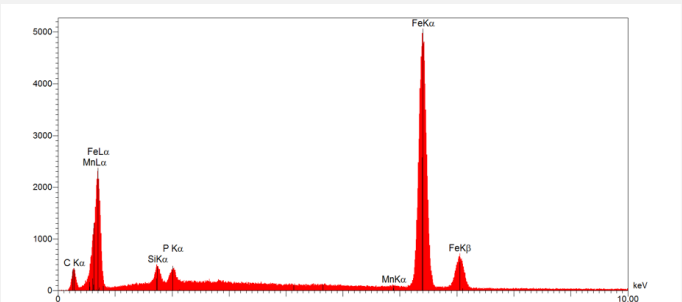
The metal is a P-rich grey cast iron with Si and Mn (Fig. 7). Its microstructure is characterized by evenly distributed graphite flakes in a matrix composed of dendrites and an interdendritic eutectic phase (Fig. 8). What appears to be irregular graphite flakes/porosity is in fact deformed graphite flakes; graphite is soft and prone to destruction by smearing and/or preferential removal during polishing (Scott 1991:38-39).

Fig. 7: EDS-spectrum showing the chemical composition of the metal. Method of analysis: SEM-EDS. Lab. of Electronic Microscopy and Microanalysis, Néode, HEI Arc,

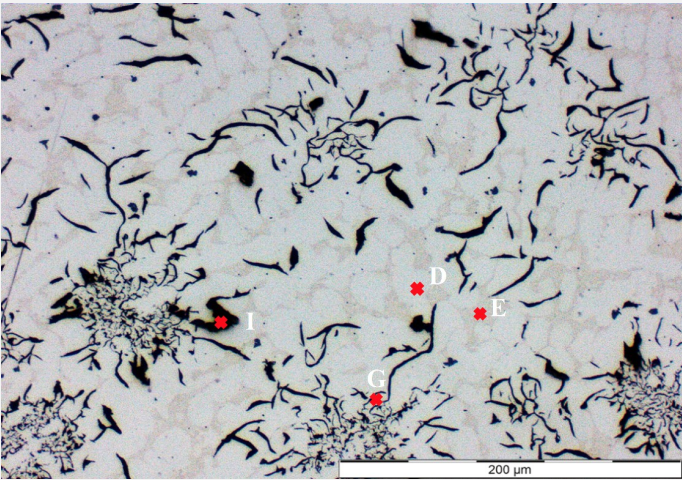
The dendrites appear light grey under polarized light, while the eutectic phase appear light brown (Fig. 8). The eutectic phase is rich in Fe and P and contains small amounts of C and Si, whereas the dendritic phase contains much less P (Table 1).

Fig. 8: Micrograph of the metal sample from Fig. 4 (detail). Unetched, bright field. Graphite flakes (G) in black, the dendrites (D) in light grey and the eutectoid phase (E) in light brown. Deformed graphite flakes are visible as irregular black inclusions (I),

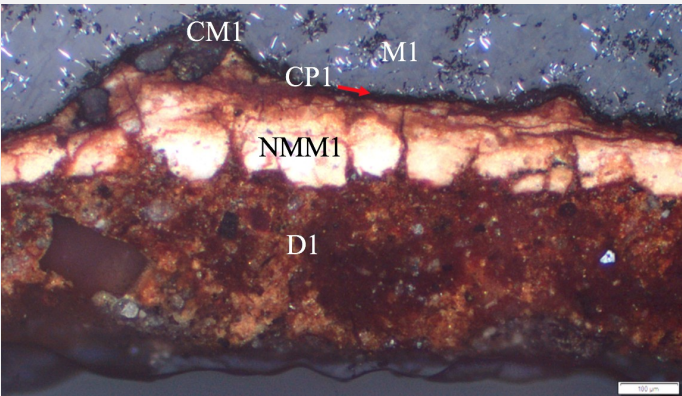
The exterior face (Figs. 2, 4 and 9) consists of a white cracked layer (NMM1 in Fig. 5) superimposed by a layer of deposit mixed with orange-red corrosion products (D1 in Fig. 5). Punctual analysis by SEM-EDS (Table 2) revealed that the white layer is rich in Ba, O, S, Fe, C and Zn. It has a chemical composition similar to Lithopone (BaSO₄ ZnS), a preparatory paint layer. Fe is probably a contamination from the superimposed deposit/corrosion product D1 (Table 2). The latter (D1) is Fe- and O-rich and contains Si, Al and some Ca, in addition to a range of elements (K, P, Na, Cl, S and Ti) present in minor

amounts (Table 2). A thin layer of corrosion products (CP1) is located just beneath the paint layer, appearing dark grey under polarized light (Fig. 9). This layer is followed by a corroded metal phase (CM1). Their exact composition was not analyzed but is likely to correspond to the corroded metal phase of the fracture edge, described below.

Fig. 9. Micrograph of the metal sample from Fig. 4 (detail), unetched, polarized light, 5x. The stratigraphy of the exterior surface, from top to bottom: the metal (M1) in grey, a thin layer of corroded metal (CM1) and a white cracked layer (NMM1) superimposed by a porous dark-red deposit (D1),

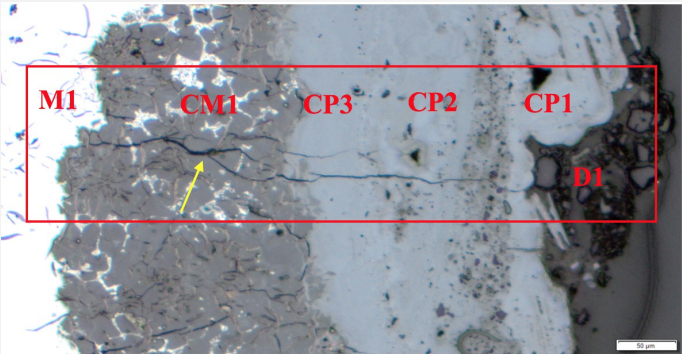
The interior face (Figs. 2 and 4) shows similar characteristics but does not include a white layer similar to NMM1. The fracture edge however (Figs. 2, 4 and 10), shows a more complex stratigraphy consisting of a dense product layer which can be further divided into two individual strata (CP3 and CP2), superimposed by a porous corrosion crust appearing orange under polarized light (CP1) (Fig. 11). The corroded metal (CM1) is located just beneath CP3 and contains remnants of the P-rich eutectic phase (Figs. 10-12). The M/CP ratio (metal to corrosion products) is rather high, implying extensive internal corrosion. Furthermore, a simple crack is traversing the corrosion layers – indicating a fragilization of the structure. As for the composition of the corrosion products CP1, CP2 and CP3, they all contain Fe and O (Fig. 12). A marbling effect within CP2 and CP3 indicates a variation in the concentration of Fe and O (particularly visible in bright field - Fig. 10). The white deposit (D1 in Fig. 6) might originate from exposure to calcareous water (Table 2). The presence of exogenous elements such as Si, Ca, Al, Na and O (Table 2) was confirmed by elemental mapping (Fig. 12).

Fig. 10. Micrograph of the metal sample from Fig. 4 (detail), unetched, bright field. From left to right: intact metal (M1) in white, followed by preferentially corroded metal (CM1) and dense product layers (CP3 and CP2) in various shades of grey. CP1 is slightly porous and covered by grain-like particles (D1). The red square corresponds to the area selected for SEM-EDS elementary mapping (Fig. 12). A simple crack (yellow arrow) is traversing the corrosion layers,

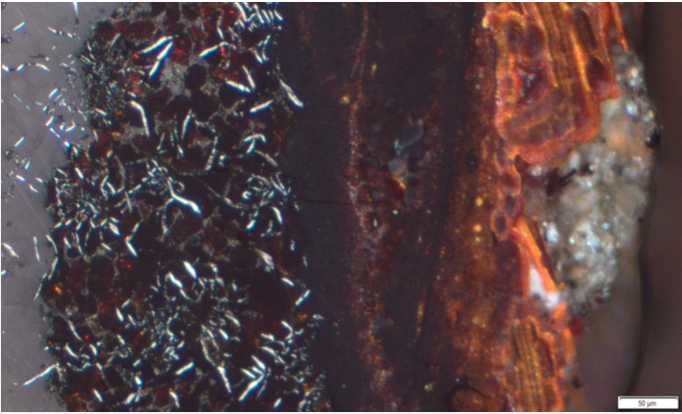
Fig. 11. Micrograph similar to Fig. 10 but under polarized light. The external deposit (D1) appears grey-white, CP1 in bright orange, while CP2 and CP3 appear dark red to brown. The corroded metal (CM1) contains remnants of graphite flakes (in white) and the P-rich eutectic (in grey),

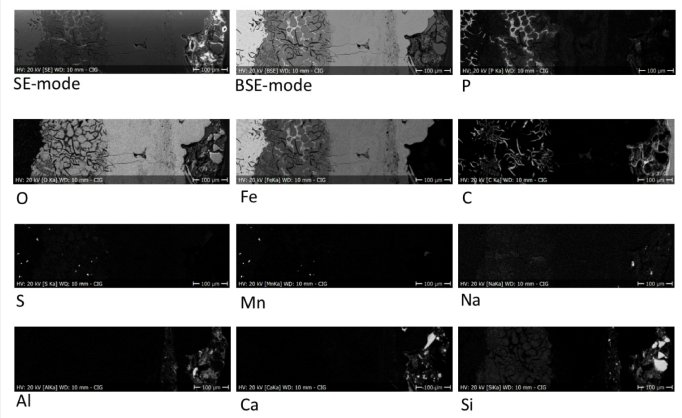
Fig. 12: SEM image and elemental chemical distribution of the selected area from Fig. 10. Method of analysis: SEM-EDS. Lab. of Electronic Microscopy and Microanalysis, Néode, HEI Arc,

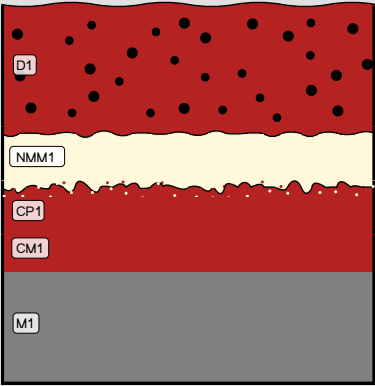
Fig. 5. MiCorr stratigraphy of the exterior face, to be related to the micrograph of Fig. 9. CP1 corresponds to CP2 in Fig. 3, Credit UiO-IAKH, M.Hovind.

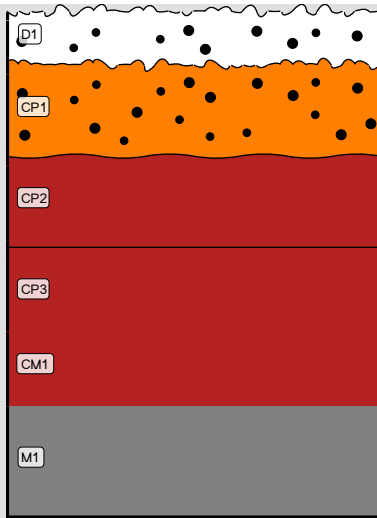
Fig. 6. MiCorr stratigraphy of the fractured edge, to be related to the micrograph of Fig. 11. D1 corresponds to D3 in Fig. 3, Credit UiO-IAKH, M.Hovind.
