RAIN GUTTER FRAGMENT – GREY CAST IRON – MODERN TIMES – FRANCE

Artefact name	Rain gutter fragment
Authors	Christian. Degriigny (HE-Arc CR, Neuchâtel, Neuchâtel, Switzerland) & Mathea. Hovind (University of Oslo, Department of archaeology, conservation and history (IAKH-UiO), Oslo, Oslo, Norway)
Url	/artefacts/358/

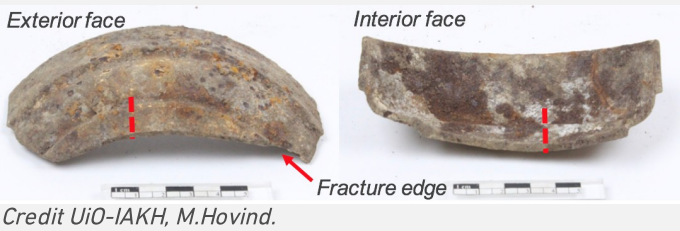
Fig. 2. The exterior and interior faces before sampling. The dotted line represents the sample location (a cross-section of the metal). The fracture edge corresponds to the edge that was formerly attached to the remaining artefact,

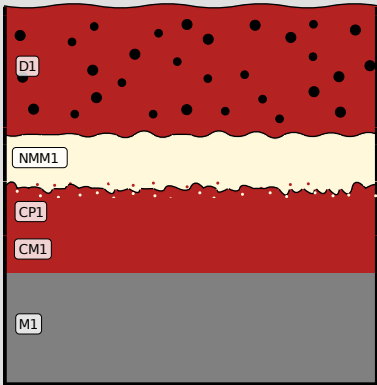
Fig. 5. MiCorr stratigraphy of the exterior face, to be related to the micrograph of Fig. 9. CP1 corresponds to CP2 in Fig. 3, Credit UiO-IAKH, M.Hovind.

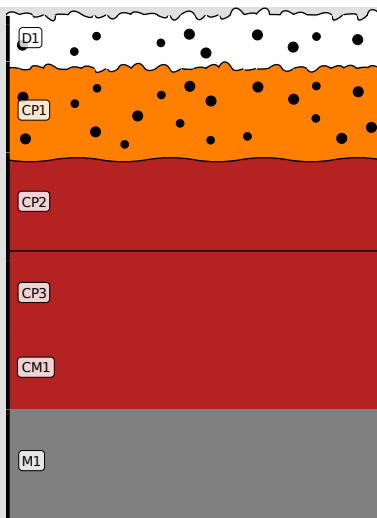
Fig. 6. MiCorr stratigraphy of the fractured edge, to be related to the micrograph of Fig. 11. D1 corresponds to D3 in Fig. 3, Credit UiO-IAKH, M.Hovind.

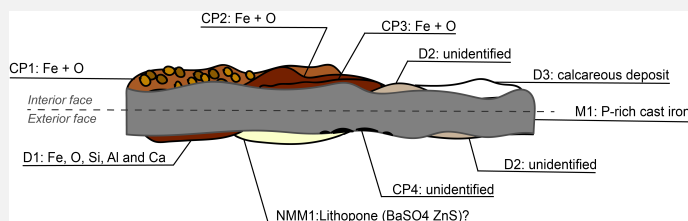
Fig. 13. Corrected stratigraphic representation with results of SEM-EDS analysis and visual microscopic observation,

The rain gutter fragment is a grey cast iron with a microstructure consisting of graphite flakes and a P-rich eutectic phase. The exterior surface contains a preparatory paint layer, located beneath a layer of corrosion products mixed with soil. It seems likely that the cast iron gutter has been covered with a protective layer of paint (e.g. Lithopone) to slow down the rate of atmospheric corrosion. The presence of Lithopone reinforces the suggested dating of the artefact (20th century) as this pigment was developed and used from the 1880s and onwards (Lithopone 2007). It seems however that the protective layer has none or only very limited effect as (pitting) corrosion is present also in these areas.

The corrosion layers consist mainly of Fe and O, indicating atmospheric corrosion with presence of none or only a very small amount of contaminants/pollution. The scattered white deposit is possibly originating from exposure to calcareous water as it is localized mainly on the interior face of the fragment, where rain water would hit the metal before entering the ground.
