# SACRIFICIAL ANODE VHS-8339 – ZN ALLOY – MODERN TIMES

Artefact name	Sacrificial anode VHS-8339
Authors	Marianne. Senn (EMPA, Dübendorf, Zurich, Switzerland) & Christian. Degriy (HE-Arc CR, Neuchâtel, Neuchâtel, Switzerland)
Url	/artefacts/367/

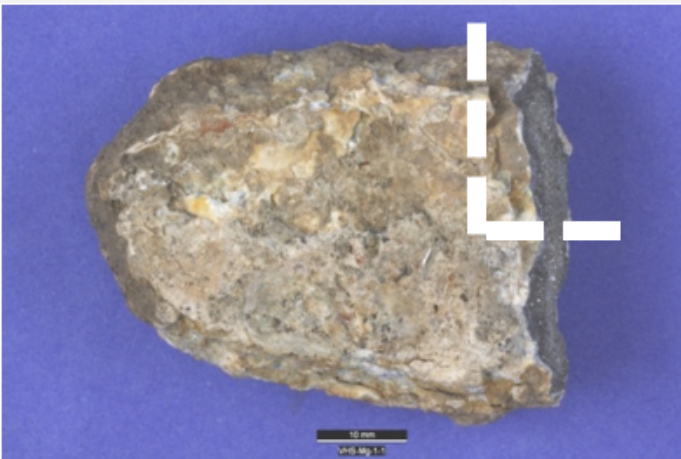
Fig. 2: Location of sampling area,

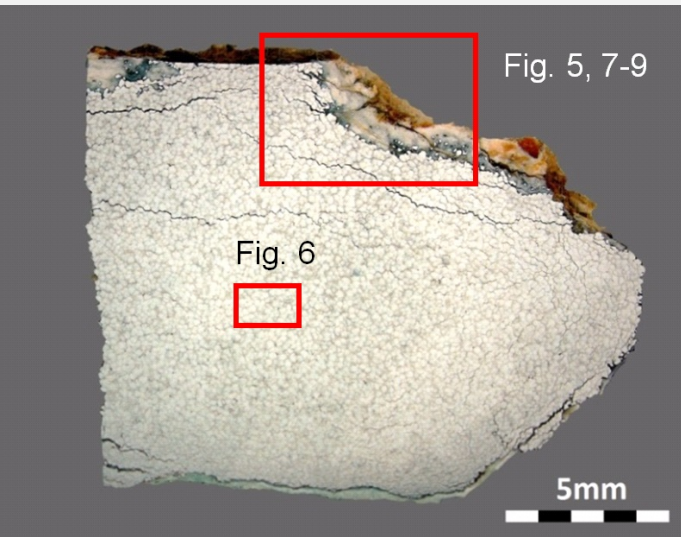
Fig. 3: Micrograph of the cross-section showing the location of Figs. 5 to 9,

The sample (Fig. 3) shows a cross-section from the sacrificial anode (Fig. 2). The thickness of the corrosion crust is variable. Dimensions: L = 17mm; W = 14mm.

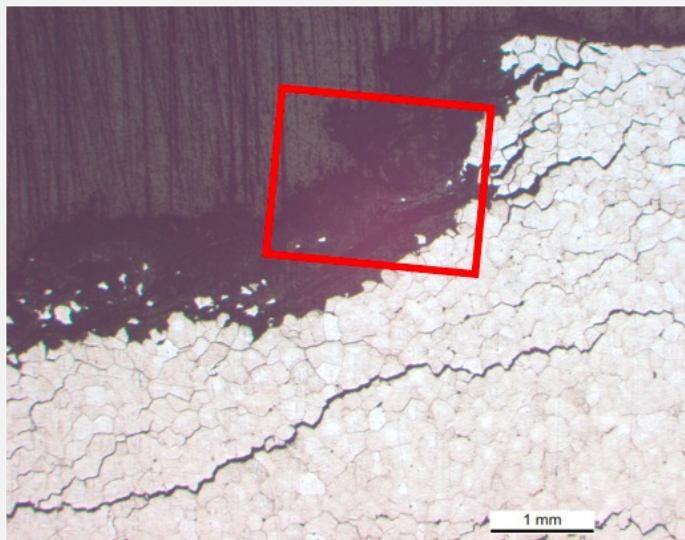
Fig. 5: Micrograph of the metal sample from Fig. 3 (reversed picture, detail), unetched, bright field. Extensive intergranular corrosion is visible. The rectangle marks Fig. 7,

Extended intergranular corrosion has developed in the metal structure (Figs. 5, 6). The metal is covered by a corrosion crust that is hardly visible in bright field and which contains remnant metal (Fig. 5). On most of the sample the corrosion crust is uniform. In areas we see cracks (Fig. 7) appearing as brown lines separating the corrosion crust (Fig. 8). In bright field the corrosion crust appears grey containing dark-grey zones (Fig. 7). Under polarized light, the corrosion crust appears white with darker parts including remnant metal (Fig. 8). It contains Zn and O as well as S along some cracks (Table 2 and Fig. 9).

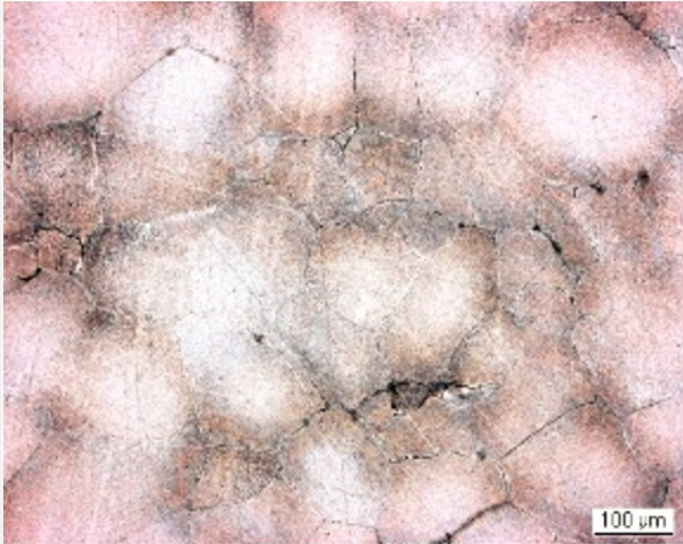
The remaining metal is an almost pure zinc alloy (Table 1). The oxygen content is not from the original alloy, but is due to secondary corrosion. The metal grains are visible without etching and present a polygonal structure (Figs. 5 and 6). The structure is recrystallised after annealing. The recrystallization of zinc alloys begins at room temperature.

Fig. 6: Micrograph of the metal sample from Fig. 3 (detail), etched,

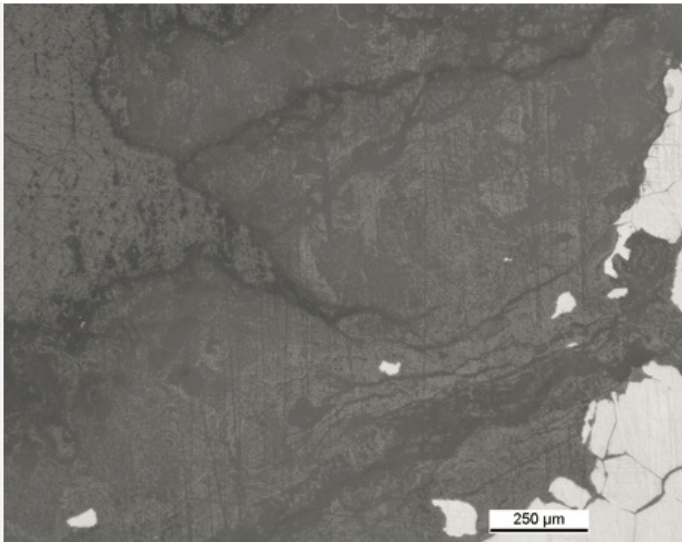
Fig. 7: Micrograph showing the metal - corrosion products interface from Fig. 5 (detail), unetched, bright field,

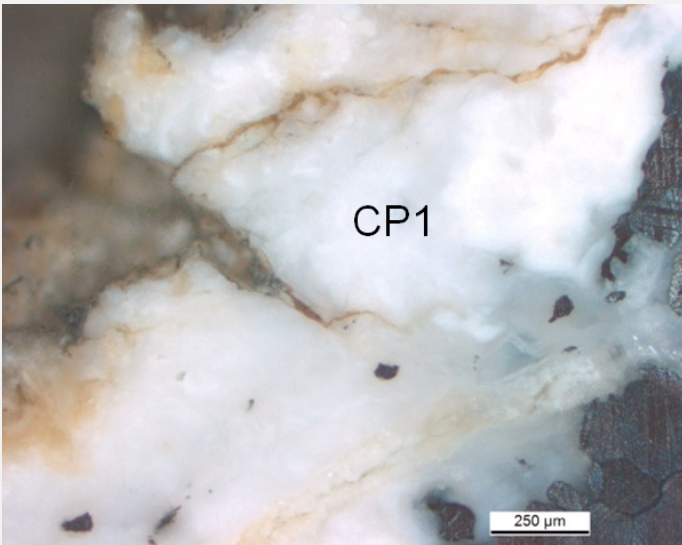
Fig. 8: Micrograph (same as Fig. 7) corresponding to the stratigraphy of Fig. 4, unetched, polarised light. We observe in dark-grey the metal, in white the corrosion crust separated by brown cracks including remnant metal,

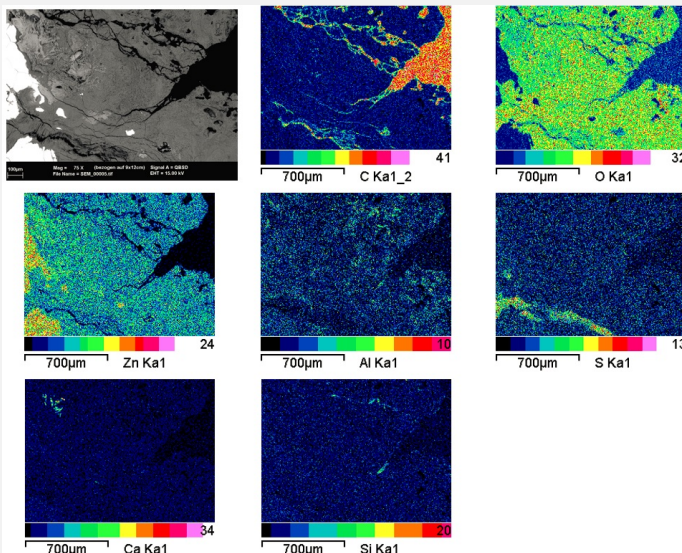
Table 2. Chemical composition (mass %) of the corrosion layer from Figs. 7 and 9. Method of analysis: SEM/EDS, Laboratory of Analytical Chemistry, Empa.

Fig. 9: SEM image, BSE-mode, and elemental chemical distribution of most of the area of Fig. 7 (reversed picture). Method of examination: SEM/EDS, Laboratory of Analytical Chemistry, Empa,
